PlanGrid Task Report - Sep 19, 2024

8 tasks in this report.

L05224 Coconut Palm FSU [Princeton (FL) FSU]

11250 Southwest 248th Street, Homestead, Florida

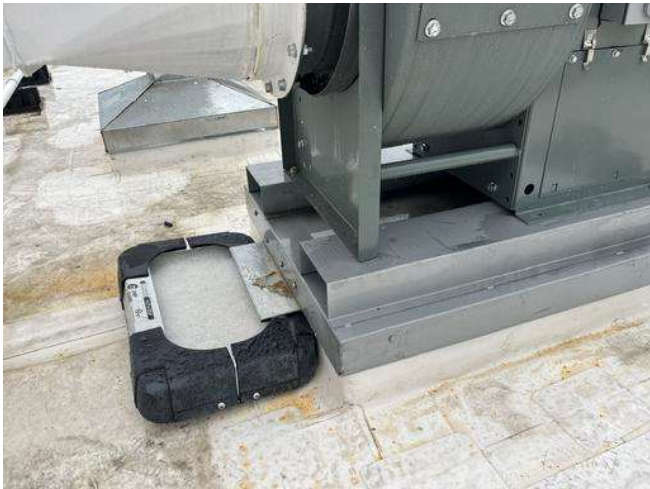
IMG_8388

#8 [EXHA 124] Exhaust fan drain line.

Exhaust fan drain is not installed. Once installed pvc pipe shuld be glued together and routed to center of drip guard.

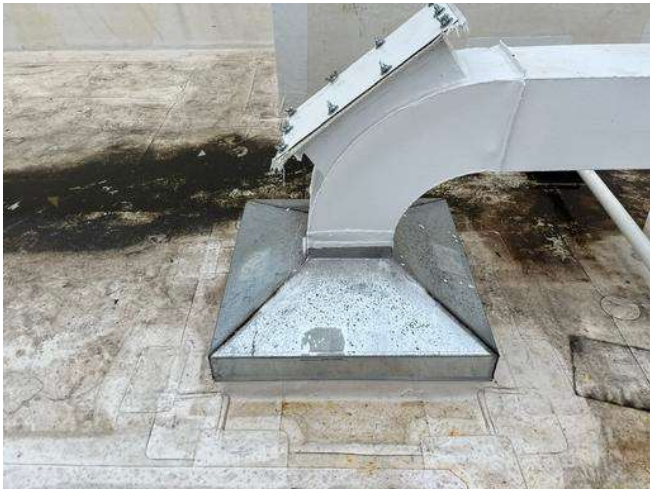
IMG_8389

#7 [EXHA 126] Grease exhaust duct is not painted.

Exposed grease exhaust duct is to be painted per specification on kitchen hood exhaust fan detail. Duct curb caps should be painted.

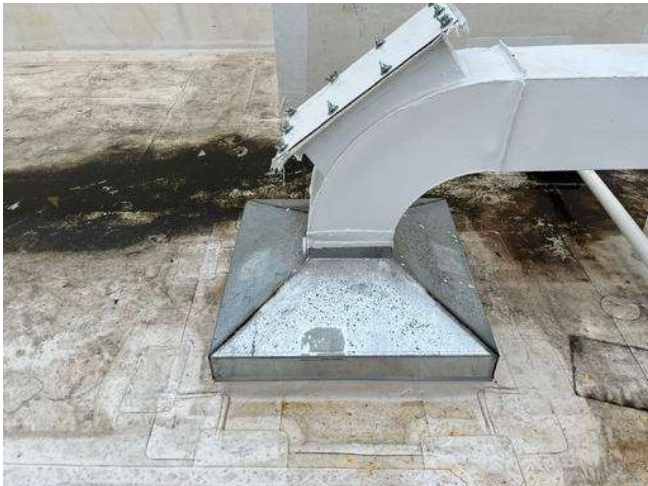
IMG_8389

#6 [EXHA 128] Grease exhaust duct curb cap.

Grease duct curb cap is to be screwed at all corners along with a full perimeter weld between curb cap and duct.

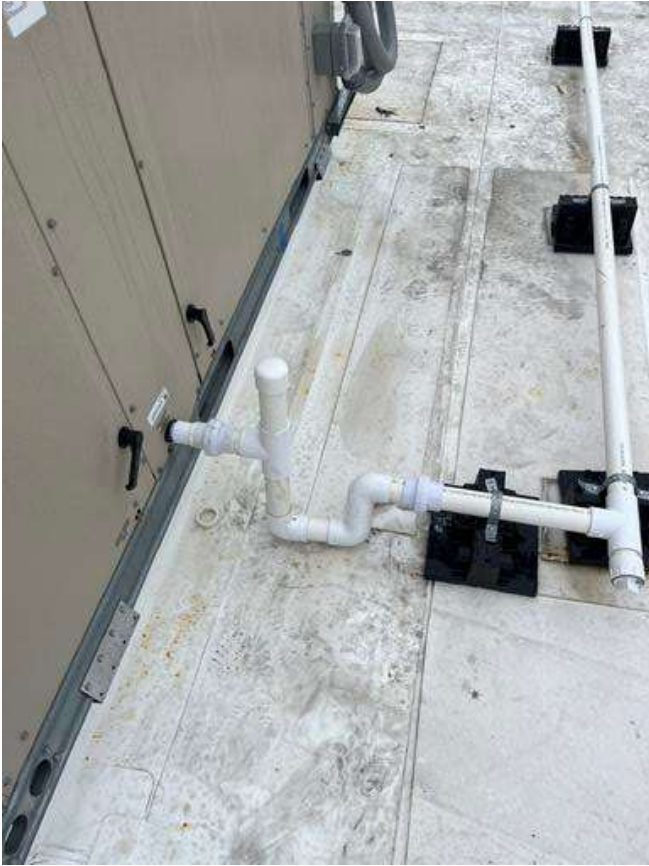
IMG_8390

#5 [UNIT 167] Condensate piping construction.

Equipment condensate piping or p-trap is not constructed per normal CFA specifications as shown on P-250. Upper and lower T needs to be added on opposite side of trap.. Celanout plug needs to be added at lower t once installed.

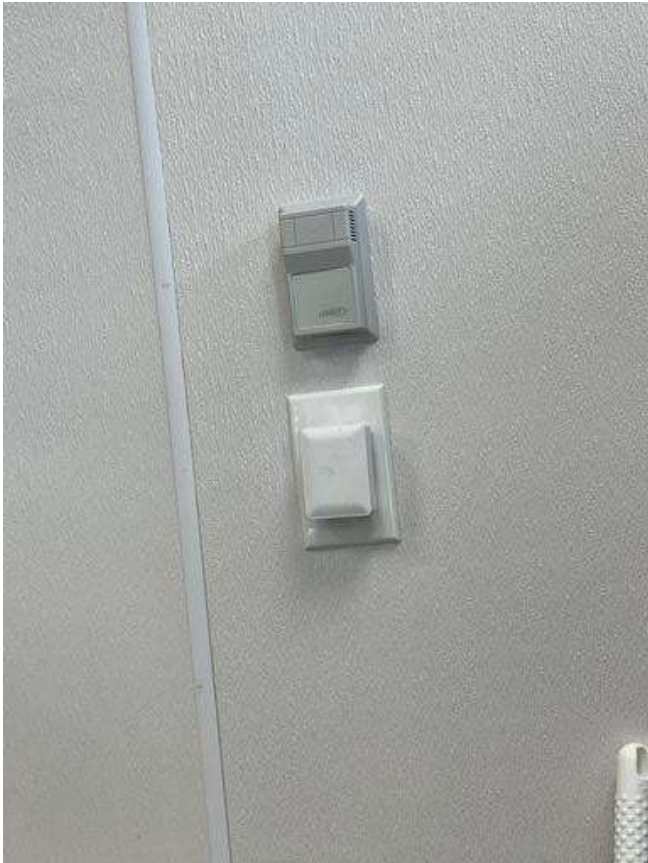
IMG_8378

#4 [CNTL 097] Controls labeling.

Label all sensors,
humidistats on AC#2

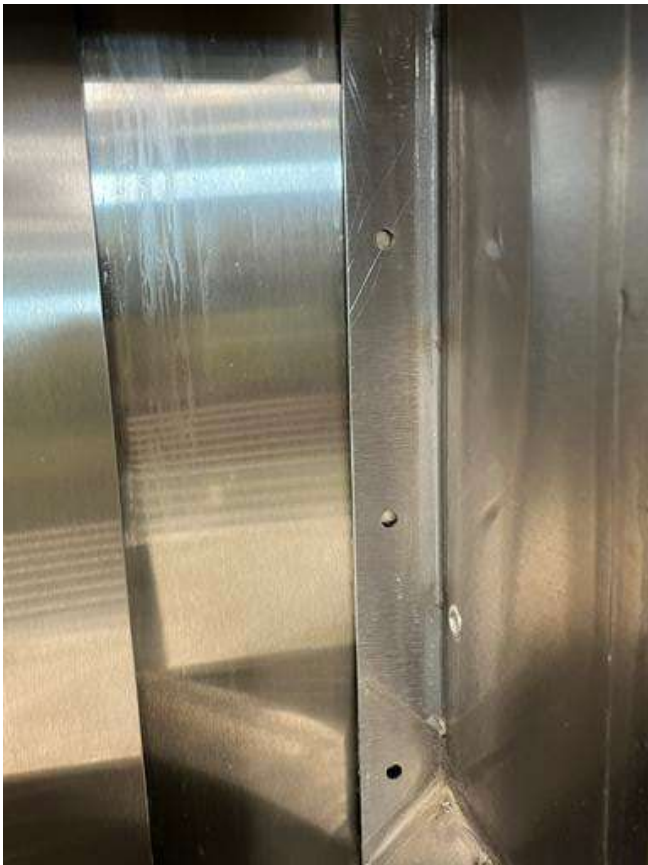
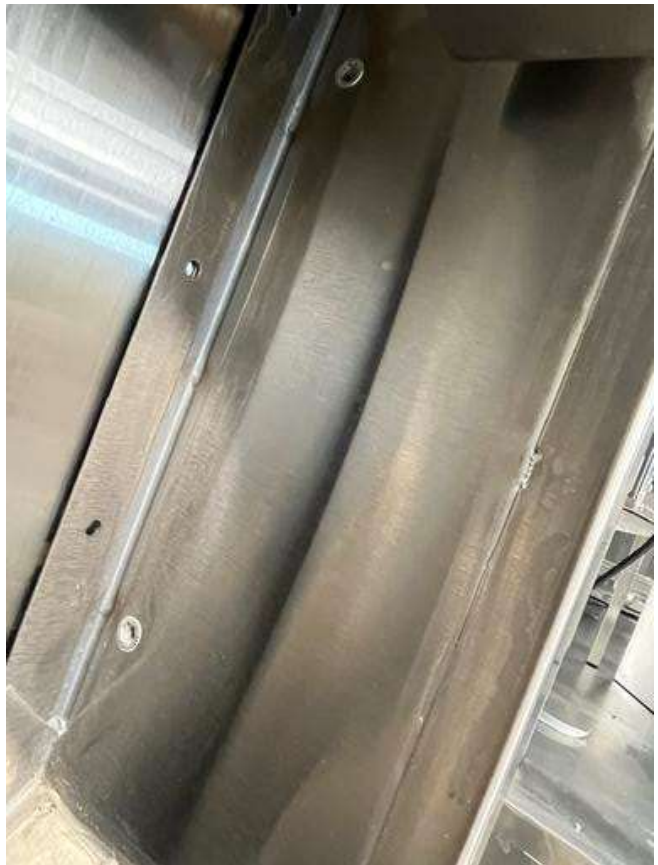
IMG_8374

#3 [HOOD 143] Hood back panes.

Hoods are to be secured to back panes via pre-punch holes with stainless steel screws.

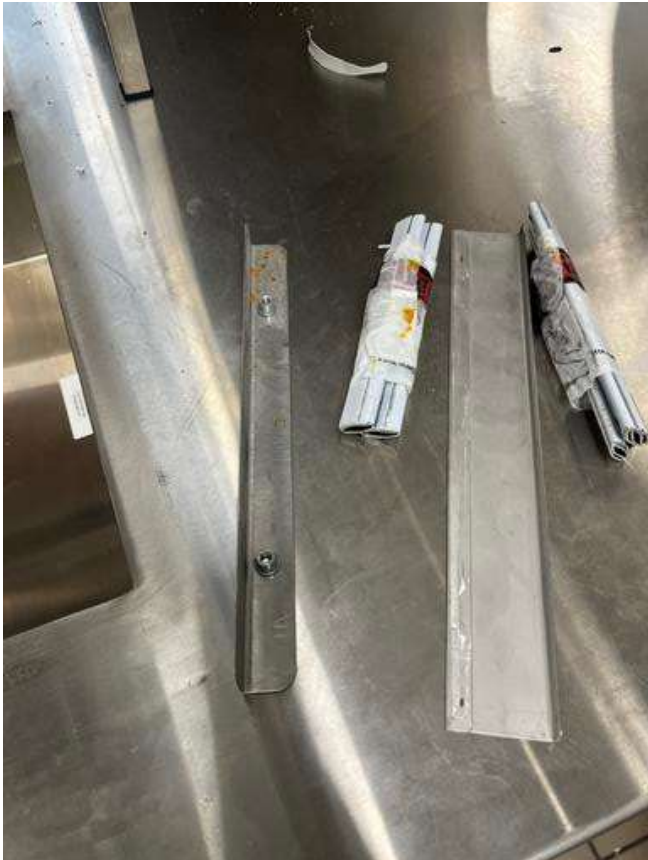
IMG_8377

#2 [HOOD 145] Hood 1L/1R hardware.

Hoods 1L/1R are missing bolting hardware to secure in place slider filter brackets. Screws switched around hoods during balancing in order to get accurate data.
