# PlanGrid Task Report - Mar 11, 2025

# #128 [HOOD 508] [NEW] Sidejet arm angle bracket.

L05290\_Maumee FSU (OH)

603 Pointe Blvd., Maumee, OH

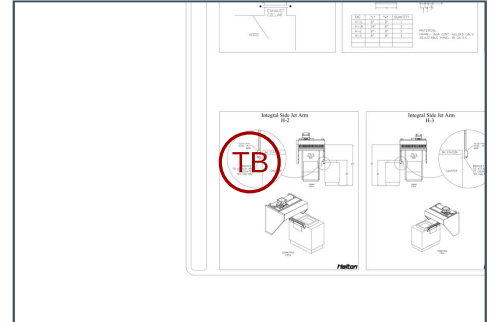
MH-1.1

The Halton supplied angle bracket that connects the integral sidejet arm to the counter is missing or not installed correctly. Secure bracket to arm and bracket to counter underneath removeable fry dump via stainless steel rivets.

The bracket can not be riveted. if it is not removable the fryer will not be able to be pulled out. Also, this would void warranty.

Re-opened for lack of documentation. See plans, bracket connects sidearm capture jet to counter, not to fryer.

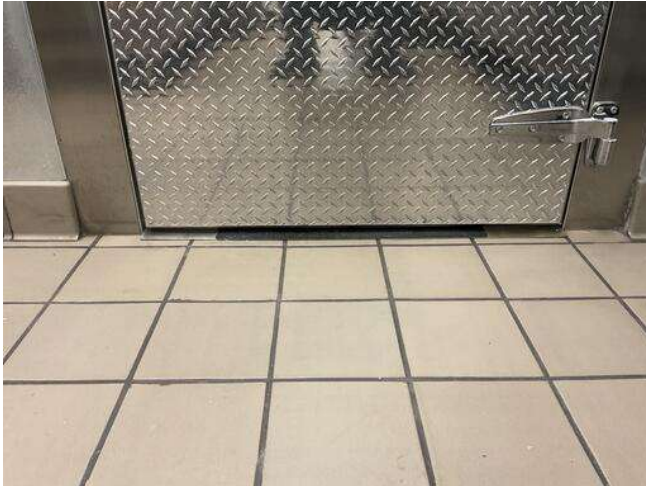
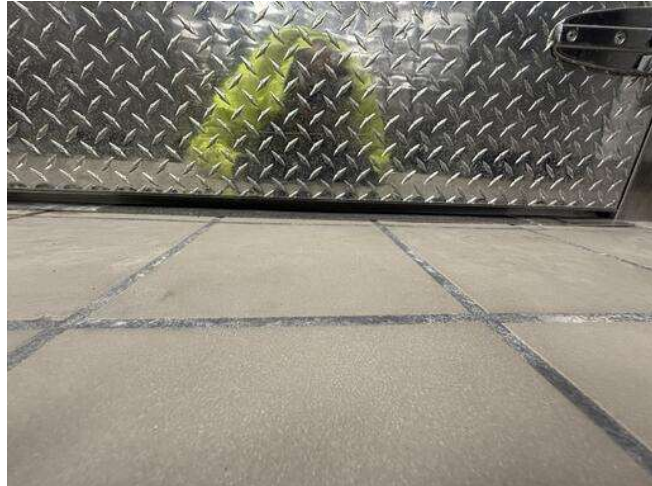
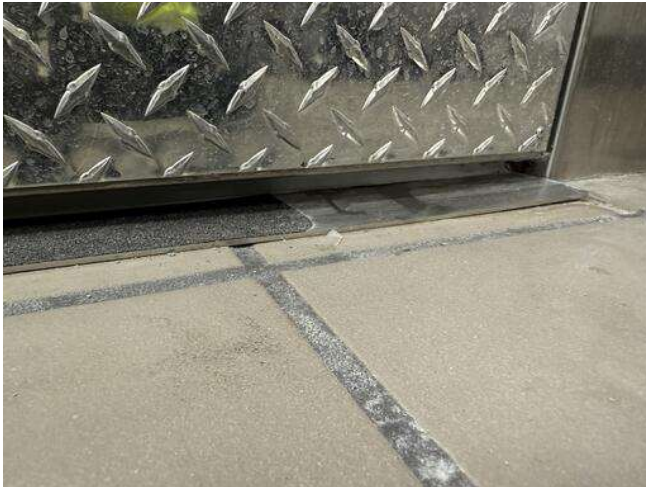
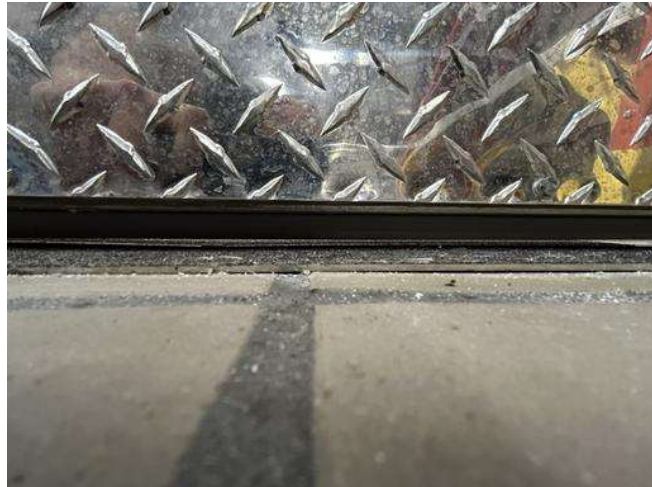
WIF door sweep is not sealed tightly with threshold when door is closed. No light should be present inspecting from the inside out with box lights off.

Re-opened for insufficient documentation. Need a photo from inside with the light off.

Refrigeration company adjusted the threshold and seal. Ready for inspection.
