Report: TAB Report
Function: Test, Adjust, & Balance
Date: 10/23/2025
Completed By: National TAB

PROJECT
10-06-25 QT #1109 ANDERSON, SC

2901 N MAIN ST

Project: 10-06-25 QT #1109 ANDERSON, SC

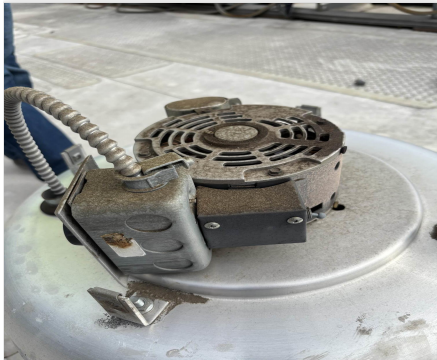
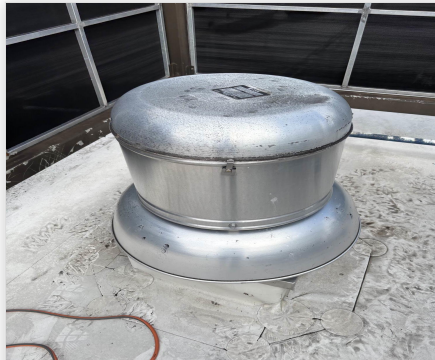
Issue Name : NEITHER EF WORKING
Description : Neither of the exhaust fans are running. Balancing could not take place, both units have power.
Created By : National TAB **Assigned To :** National TAB - Brianna Biggs
Status : Open
Priority : Urgent **Asset Tag :**
Originated Date : 10/10/2025 - Christian Moller - National TAB

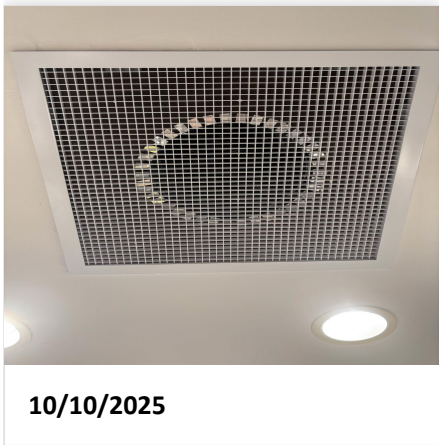
Issue Name : RTU 3 WRONG COOK LINE DIFFUSERS
Description : The diffusers for RTU 3 in front of the hood are wrong. Plans call for 4 double deflection grilles.
Created By : National TAB **Assigned To :** National TAB - Brianna Biggs
Status : Open
Priority : Low **Asset Tag :** RT-3
Originated Date : 10/10/2025 - Christian Moller - National TAB

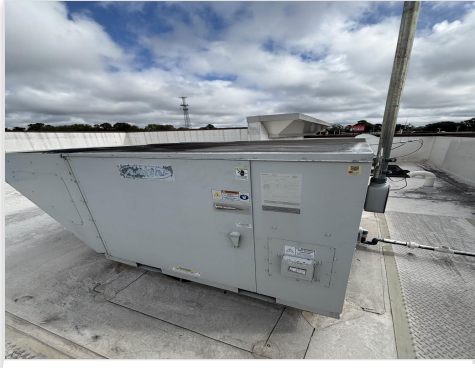
Unit Data - PHOTO LOG

Test Data		
	Design	Actual
SF CFM	4200	4158
SF RPM	-	
RA CFM	3400	
OA CFM	800	744
RL Voltage	-	211/211/209
RL Amperage	-	4.5/3.8/4.3
SF Rotation	-	CCW
SF System SetPt	-	LOW; 25Hz HIGH; 33.9Hz
RA Damper Position	-	HOODS OFF; 77.8% HOODS ON; 74%
Min OA Damper Position	-	HOODS OFF; 26% HOODS ON; 22.2%
Min OA Damper Type	-	ECON
OA Enthalpy Setpt	-

Performance Data		
	Design	Actual
MA Plenum SP	-	-0.36"
Fan Suction SP	-	-0.49"
Fan Discharge SP	-	0.47"
Total ESP	-	0.85"
Fan Total SP	-	0.96"

General	
	Actual
Fan Rotation Correct	YES
Unit Filters Clean	YES
Condensate Drain Installed	YES

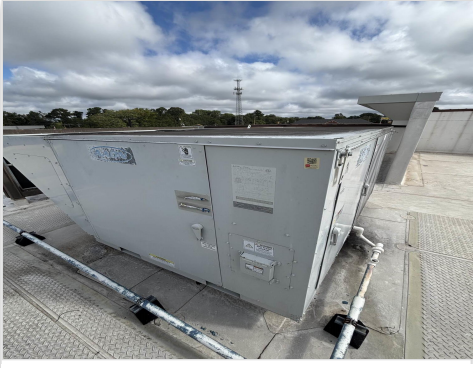
Unit Data - PHOTO LOG

Test Data		
	Design	Actual
SF CFM	4200	4373
SF RPM	-	
RA CFM	3400	
OA CFM	800	765
RL Voltage	-	209/211/210
RL Amperage	-	5.0/5.0/4.1
SF Rotation	-	CCW
SF System SetPt	-	LOW; 20.4 Hz HIGH; 34.9Hz
RA Damper Position	-	LOW; 74% HIGH; 77.8Hz
Min OA Damper Position	-	LOW; 26% HIGH; 22.2%
Min OA Damper Type	-	ECON
OA Enthalpy Setpt	-

Performance Data		
	Design	Actual
MA Plenum SP	-	-0.40"
Fan Suction SP	-	-0.57"
Fan Discharge SP	-	0.62"
Total ESP	-	0.97"
Fan Total SP	-	1.19"

General	
	Actual
Fan Rotation Correct	YES
Unit Filters Clean	YES
Condensate Drain Installed	YES

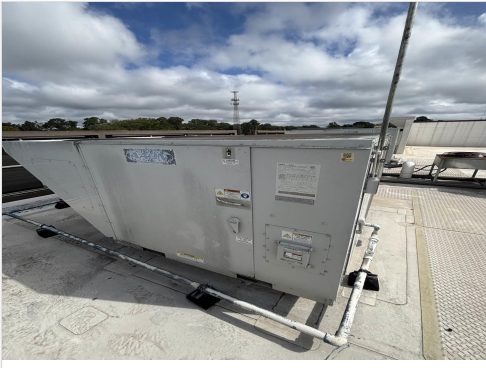
Unit Data - PHOTO LOG

Test Data		
	Design	Actual
SF CFM	4200	4054
RA CFM	3400	3296
OA CFM	800	758
RL Voltage	-	211/211/209
RL Amperage	-	4.5/4.8/5.1
SF Rotation	-	CCW
SF System SetPt	-	LOW; 14.4Hz HIGH; 34.9Hz
RA Damper Position	-	LOW; 74% HIGH; 77.83%
Min OA Damper Position	-	LOW; 26% HIGH; 22.17%
Min OA Damper Type	-	ECON

Performance Data		
	Design	Actual
MA Plenum SP	-	-0.50"
Fan Suction SP	-	-0.63"
Fan Discharge SP	-	0.66"
Total ESP	-	1.13"
Fan Total SP	-	1.29"

General	
	Actual
Fan Rotation Correct	YES
Unit Filters Clean	YES
Condensate Drain Installed	YES

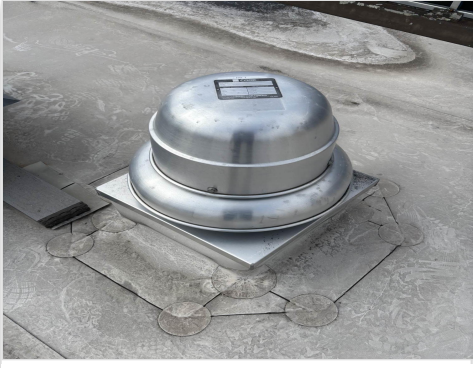
Unit Data - PHOTO LOG

Test Data		
	Design	Actual
CFM	225	0
Fan RPM	-	0
Motor RPM	-	0
System SetPt	-	OFF
RL Voltage	-	0
RL Amperage	-	0
Total ESP	-	0

[1] FAN NOT OPERATIONAL; NEEDS SERVICE.

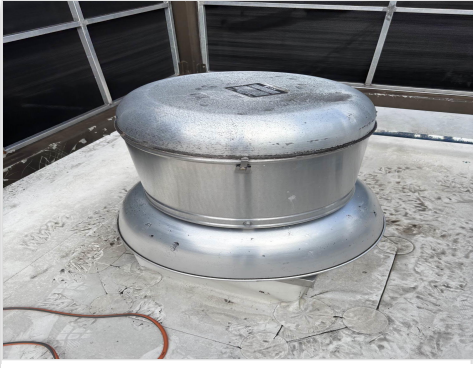
Unit Data - PHOTO LOG

Test Data		
	Design	Actual
CFM	525	0
Fan RPM	-	0
Motor RPM	-	0
System SetPt	-	OFF
RL Voltage	-	0
RL Amperage	-	0
Total ESP	-	0

[1] FAN NOT OPERATIONAL; NEEDS SERVICE.

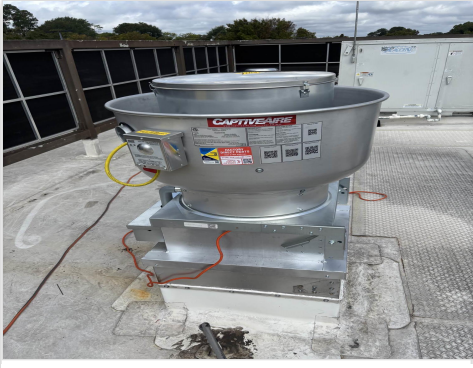
Unit Data - PHOTO LOG

Test Data		
	Design	Actual
CFM	1350	1310
Fan Rotation	-	CCW
System SetPt	-	HMI/55.8Hz
RL Voltage	-	206
RL Amperage	-	2.7
Total ESP	-	NR
Fan Inlet SP	-	NR
Fan Discharge SP	-	ATM

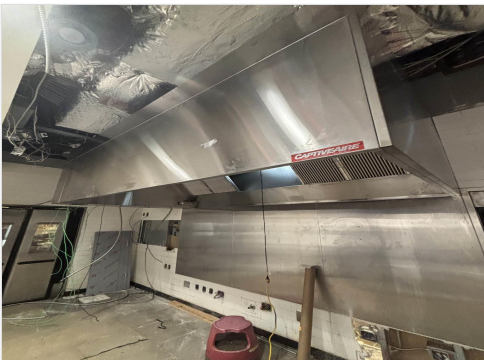
Unit Data - PHOTO LOG

Unit Data		
	Design	Actual
MFG	CAPTIVEAIRE	CAPTIVEAIRE
Model Num	6030ND-2-F	6030ND-2-F
Job / Serial Num	-	7657307
Type	-	UPBLAST
Hood length	-	122"
Hood Width	-	60"

Test Data Exhaust		
	Design	Actual
Filter Type	-	BAFFLE FILTERS
Filter Size 1	-	16x20
Filter Qty 1	-	6
Filter AK factor size 1	-	2.08
Filter Total AK Area	-	12.48
Filter1 FPM	-	99
Filter2 FPM	-	112
Filter3 FPM	-	107
Filter4 FPM	-	105
Filter5 FPM	-	109
Filter6 FPM	-	108
Filter Ave FPM(corr)	-	107
CFM	1350	1310

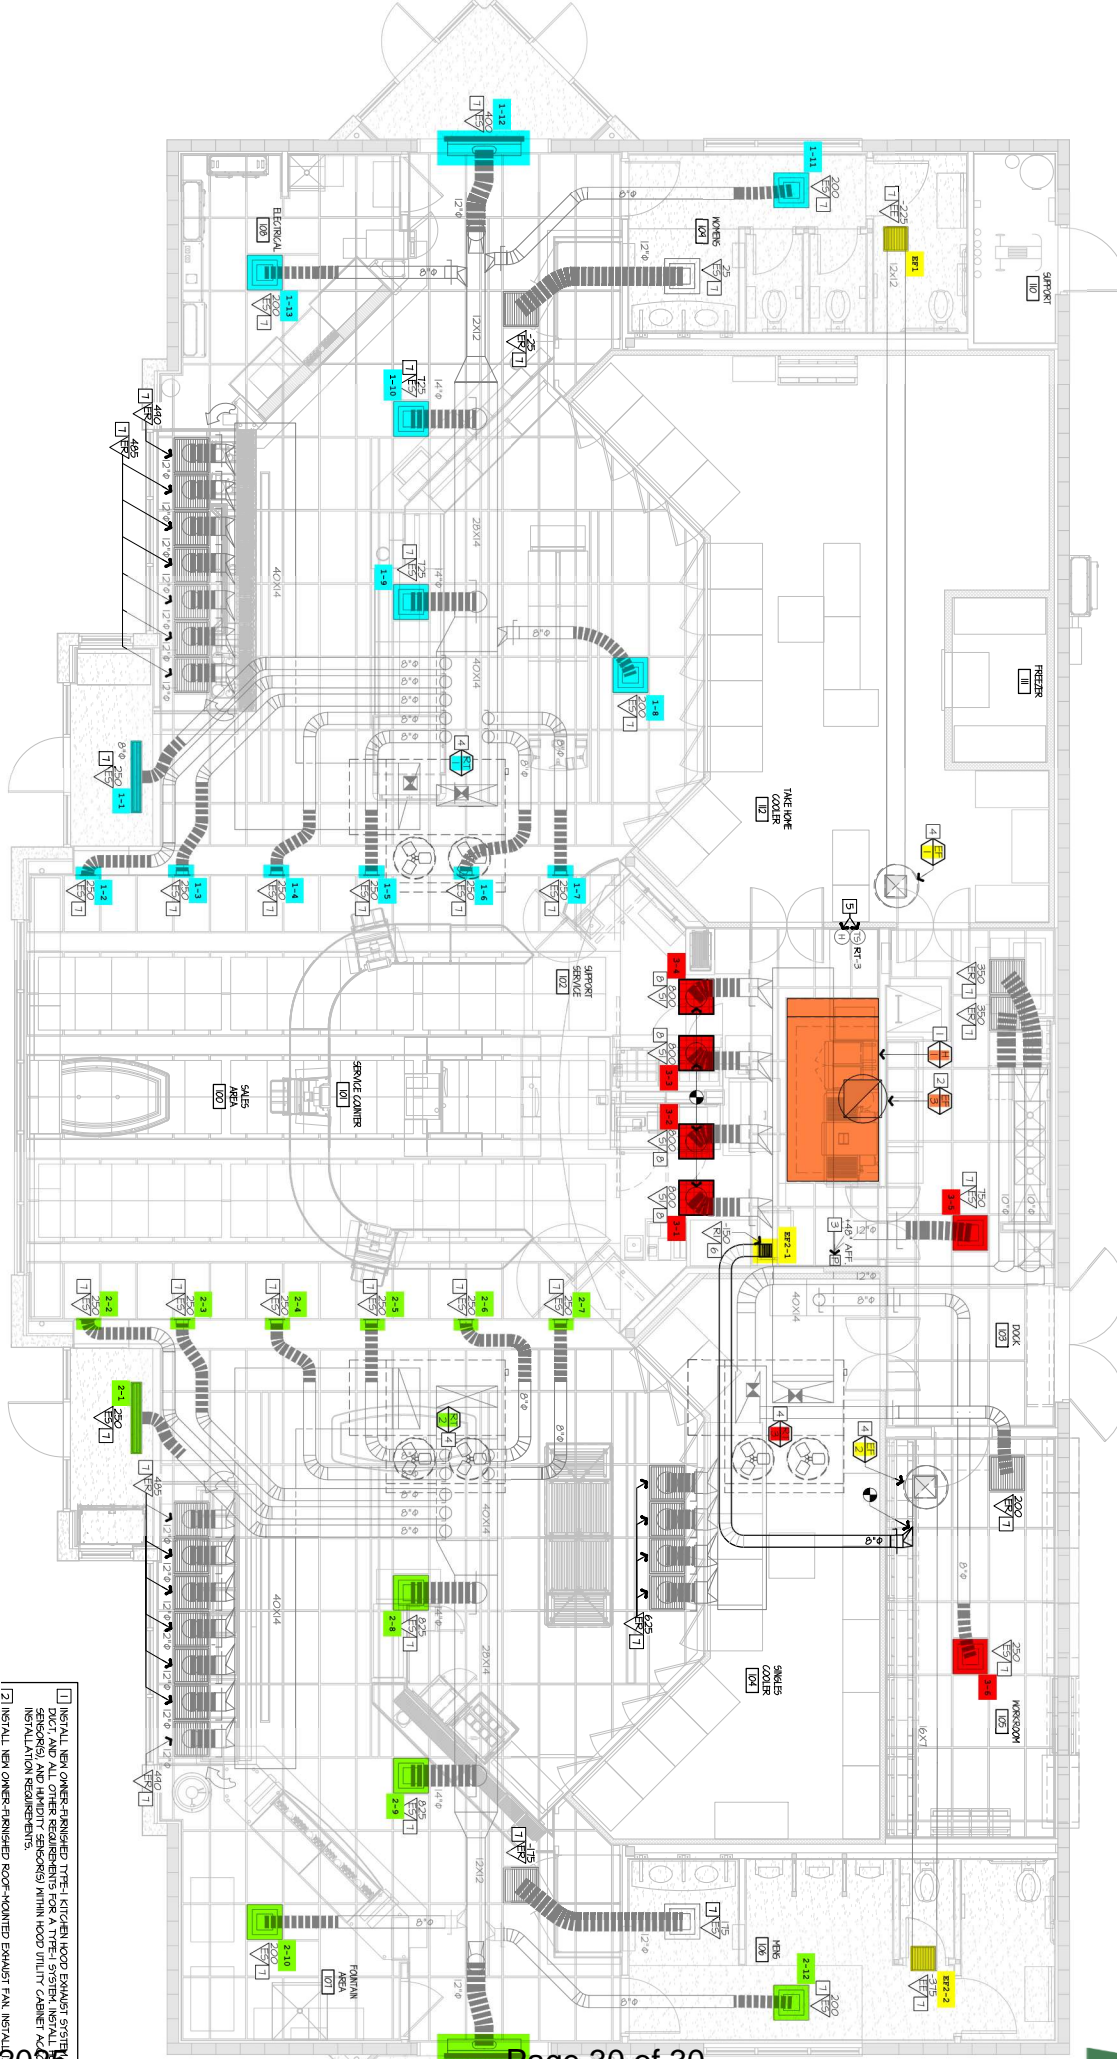
10/10/2025

[] INSTALL NEW OWNER-FINISHED TYPE-I TITANIUM HOOD EXHAUST SYSTEM...
 [] INSTALL NEW OWNER-FINISHED ROOF-MOUNTED EXHAUST FAN...
