Report: TAB REPORT
Function: Test, Adjust, & Balance
Date: 05/01/2025
Completed By: National TAB

PROJECT
04-28-25 WALGREENS #6937 AURORA, IL
(REACTIVE)

Project: 04-28-25 WALGREENS #6937 AURORA, IL (REACTIVE)

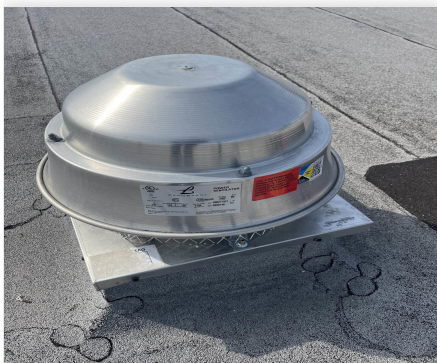
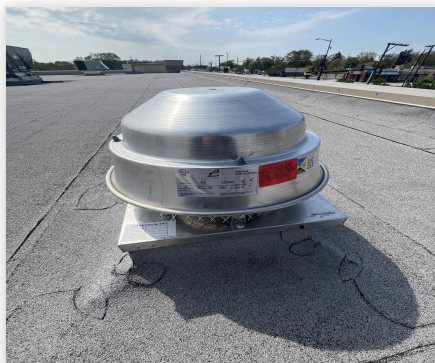
Issue Name : EF-2/EF-3 vibration
Description : EF-3/EF-2 have a significant vibration sound coming from them when turned down past a certain point on speed controller. When set at design CFM fans become louder. Recommend mechanical inspect for loose parts or fan misalignment. Increasing fan speed to lowest speed without vibration might be an option.
Created By : National TAB **Assigned To :** National TAB - Dylan Crisman
Status : Open
Priority : Low **Asset Tag :**
Originated Date : 04/30/2025 - Dylan Crisman - National TAB

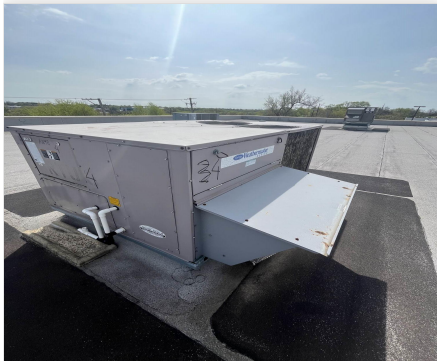
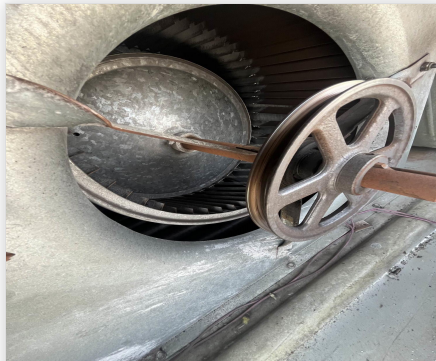
Issue Name : RTU-4 not operational
Description : RTU-4 is not operational, it appears the blower wheel has fallen out of alignment and the fan housing is dented and sunken along the back, appears someone has attempted to repair. Unable to determine current status of repairs with store managers.
Created By : National TAB **Assigned To :** National TAB - Dylan Crisman
Status : Open
Priority : Urgent **Asset Tag :**
Originated Date : 04/28/2025 - Dylan Crisman - National TAB

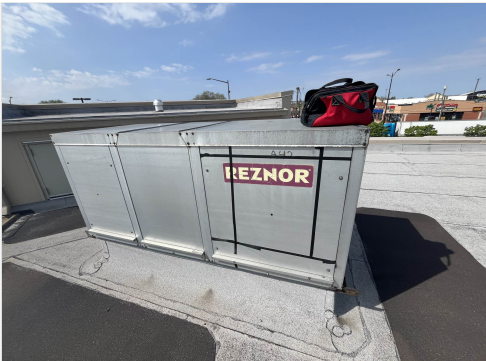
Unit Data - PHOTO LOG

Unit Data		
	Design	Actual
MFG	NA	REZNOR
Serial Num	-	NL
Model Num	NA	NL
Type	-	UNIT HEATER
Configuration	-	VERTICAL
Num Final Filter 1	-	1
Final Filter Size 1	-	32x25
Num Final Filter 2	-	1
Final Filter Size 2	-	32x20

Test Data		
	Design	Actual
SF CFM	2000	2093
SF RPM	-	1072
RA CFM	-	2093
OA CFM	0	0
RL Voltage	-	209/208/209
RL Amperage	-	1.9/2.0/2.0
SF Rotation	-	CW
SF System SetPt	-	2 TURNS OPEN

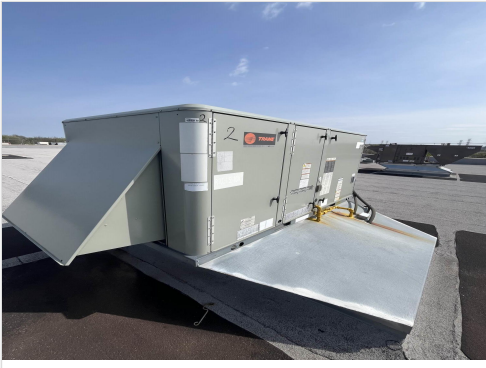
Unit Data - PHOTO LOG

Unit Data		Actual	Test Data																			
	Design		Design	Actual																		
MFG	TRANE	SF CRME	3150	3060																		
Serial Num	-	SF RPM225L	-	NA																		
Model Num	YHC092F3RHA0EF0A0A20600030000D000000000	RA CR092	2678	2576																		
Type	RTU	OA CRMU	472	484																		
Configuration	VERTICAL	RL Voltage	-	210/210/210																		
Num OA Filters 1	-	RL Amperage	-	3.8/3.4/3.9																		
OA Filter Size 1	-	SF Rotation	-	CW																		
Num Final Filter 1	-	SF System SetPt	-	4.6VDC																		
Final Filter Size 1	-	RA Damper Position	-	MECHANICAL LINKAGE

Notes:
Economizer not functional, OA damper manually set to achieve design airflow.

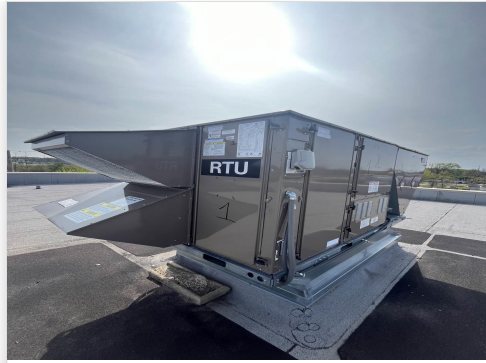
Unit Data - PHOTO LOG

Unit Data		
	Design	Actual
MFG	YORK	YORK
Serial Num	-	N2A3372345
Model Num	ZT078N18R2B5GCA2R2	ZT078
Type	RTU	RTU
Configuration	VERTICAL	VERTICAL
Num OA Filters 1	-	1
OA Filter Size 1	-	29X21
Num Final Filter 1	-	2
Final Filter Size 1	-	47X19.5

Test Data		
	Design	Actual
SF CFM	3125	3026
SF RPM	-	953
RA CFM	2656	2539
OA CFM	469	481
RL Voltage	-	210/209/210
RL Amperage	-	7.3/7.3/7.7
SF Rotation	-	CW
SF System SetPt	-	2 TURNS OPEN
RA Damper Position	-	MECHANICAL LINKAGE
Min OA Damper Position	-	1/2" OPEN
Min OA Damper Type	-	ECONOMIZER
OA Enthalpy Setpt	-	27B

Notes:
Economizer not functional, OA damper manually set to achieve design airflow.

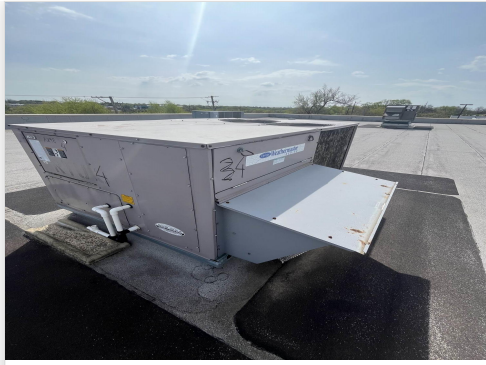
Unit Data - PHOTO LOG

Unit Data		
	Design	Actual
MFG	CARRIER	CARRIER
Serial Num	-	0203G30605
Model Num	48HJF008G	48HJF008G
Type	RTU	RTU
Configuration	VERTICAL	VERTICAL
Num OA Filters 1	-	1
OA Filter Size 1	-	35X20
Num Final Filter 1	-	2
Final Filter Size 1	-	42X16.5

Test Data		
	Design	Actual
SF CFM	3658	3390
SF RPM	-	867
RA CFM	3308	3018
OA CFM	350	372
RL Voltage	-	209/209/210
RL Amperage	-	7.9/8.2/8.0
SF Rotation	-	CW
SF System SetPt	-	1 TURN OPEN
RA Damper Position	-	MECHANICAL LINKAGE
Min OA Damper Position	-	1/4" OPEN
Min OA Damper Type	-	ECONOMIZER

Issue Name : RTU-3: Supply Diffusers 1 and 2 Low on Airflow
Description : Diffusers 1 and 2 on RTU-3 are low on airflow due to damper accessibility. We are unable to access the dampers on this system in order to push airflow to the low diffusers.
Created By : National TAB **Assigned To :** National TAB - Dylan Crisman
Status : Open
Priority : Medium **Asset Tag :**
Originated Date : 05/20/2025 - Michael McDonnell - National TAB
