**Report: TAB REPORT**  
**Function: Test, Adjust, & Balance**  
**Date: 05/01/2025**  
**Completed By: National TAB**

**PROJECT**  
**04-28-25 WALGREENS #6937 AURORA, IL**  
**(REACTIVE)**

Project: 04-28-25 WALGREENS #6937 AURORA, IL (REACTIVE)

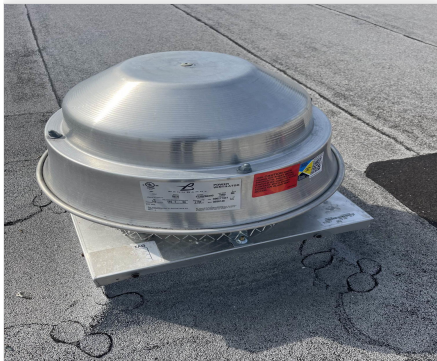
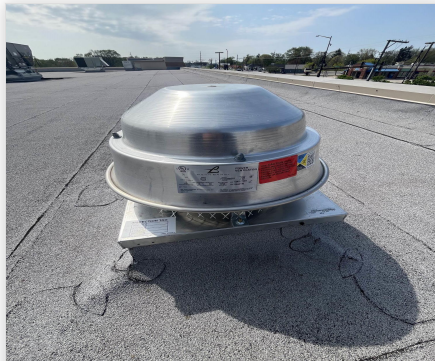
Project Issue File Details

**Issue Name :** EF-2/EF-3 vibration  
**Description :** EF-3/EF-2 have a significant vibration sound coming from them when turned down past a certain point on speed controller. When set at design CFM fans become louder. Recommend mechanical inspect for loose parts or fan misalignment.  
**Created By :** National TAB                      **Assigned To :** National TAB - Dylan Crisman  
**Status :** Open  
**Priority :** Low    **Asset Tag :**  
**Originated Date :** 04/30/2025 - Dylan Crisman - National TAB

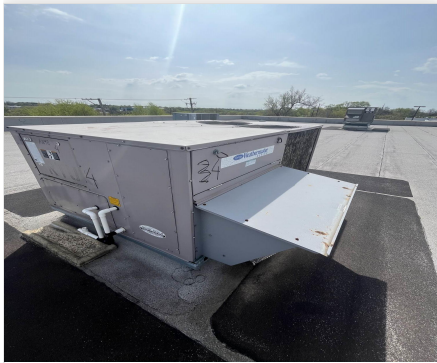
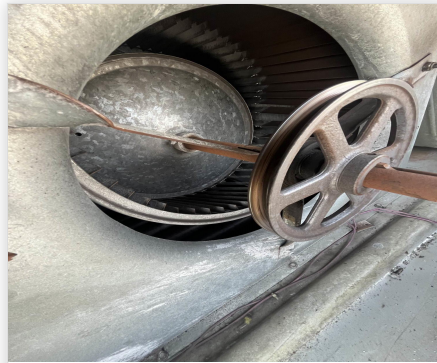
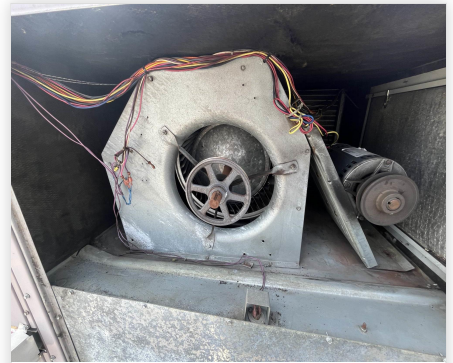
Project Issue File Details

**Issue Name :** RTU-4 not operational  
**Description :** RTU-4 is not operational, it appears the blower wheel has fallen out of alignment and the fan housing is dented and sunken along the back, appears someone has attempted to repair. Unable to determine current status of repairs with store managers.  
**Created By :** National TAB                      **Assigned To :** National TAB - Dylan Crisman  
**Status :** Open  
**Priority :** Urgent                                      **Asset Tag :**  
**Originated Date :** 04/28/2025 - Dylan Crisman - National TAB

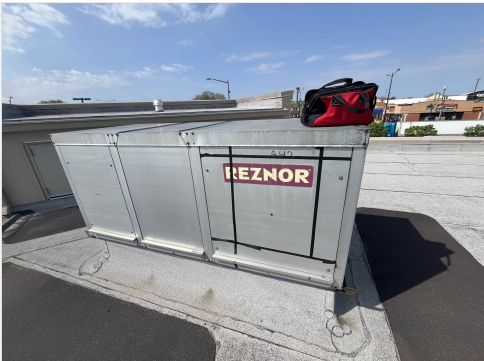
### Unit Data - PHOTO LOG

Unit Data		
	Design	Actual
MFG	NA	REZNOR
Serial Num	-	NL
Model Num	NA	NL
Type	-	UNIT HEATER
Configuration	-	VERTICAL
Num Final Filter 1	-	1
Final Filter Size 1	-	32x25
Num Final Filter 2	-	1
Final Filter Size 2	-	32x20

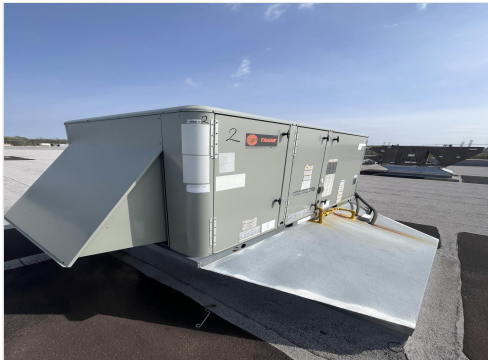
### Unit Data - PHOTO LOG

Unit Data		Actual	Test Data																			
	Design		Design	Actual																		
MFG	TRANE	SF CFM TRANE	3150	3060																		
Serial Num	-	SF RPM 15401225L	-	NA																		
Model Num	YHC092F3RHA0EF0A0A20600030000D000000000	YHC092F3RHA04EFU	2678	2576																		
Type	RTU	OA CFM RTU	472	484																		
Configuration	VERTICAL	RL Voltage	-	210/210/210																		
Num OA Filters 1	-	RL Amperage	-	3.8/3.4/3.9																		
OA Filter Size 1	-	SF Rotation	-	CW																		
Num Final Filter 1	-	SF System SetPt	-	4.6VDC																		
Final Filter Size 1	-	RA Damper Position	-	MECHANICAL LINKAGE
