**Report: TAB REPORT**  
**Function: Test, Adjust, & Balance**  
**Date: 05/01/2025**  
**Completed By: National TAB**

**PROJECT**  
**04-28-25 WALGREENS #6937 AURORA, IL**  
**(REACTIVE)**

Project: 04-28-25 WALGREENS #6937 AURORA, IL (REACTIVE)

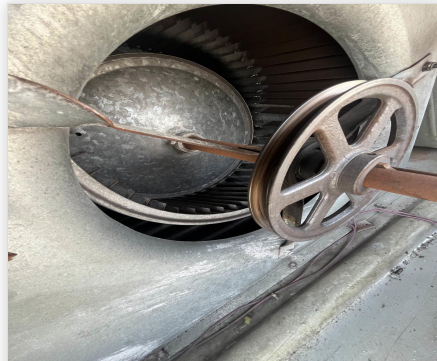
**Issue Name :** RTU-4 not operational  
**Description :** RTU-4 is not operational, it appears the blower wheel has fallen out of alignment and the fan housing is dented and sunken along the back, appears someone has attempted to repair. Unable to determine current status of repairs with store managers.  
**Created By :** National TAB                      **Assigned To :** National TAB - Dylan Crisman  
**Status :** Open  
**Priority :** Urgent                                      **Asset Tag :**  
**Originated Date :** 04/28/2025 - Dylan Crisman - National TAB

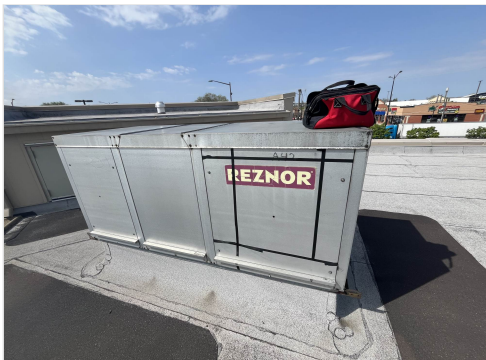
Asset: EH1

Unit Data		
	Design	Actual
MFG	NA	REZNOR
Serial Num	-	NL
Model Num	NA	NL
Type	-	UNIT HEATER
Configuration	-	VERTICAL
Num Final Filter 1	-	1
Final Filter Size 1	-	32x25
Num Final Filter 2	-	1
Final Filter Size 2	-	32x20

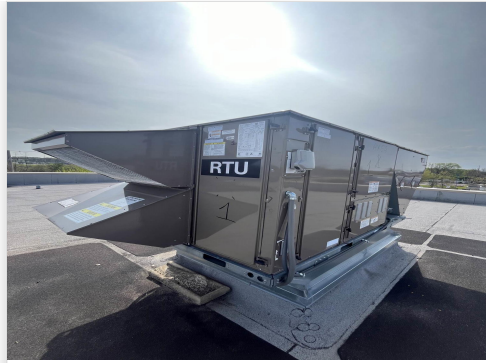
Asset: RTU2

Unit Data			Test Data		
	Design	Actual		Design	Actual
MFG	YORK	YORK	SF CFM	3125	3026
Serial Num	-	N2A3372345	SF RPM	-	953
Model Num	ZT078N18R2B5GCA2R2	ZT078N18R2B5GCA2R2	RA CFM	2656	2539
Type	RTU	RTU	OA CFM	469	481
Configuration	VERTICAL	VERTICAL	RL Voltage	-	210/209/210
Num OA Filters 1	-	1	RL Amperage	-	7.3/7.3/7.7
OA Filter Size 1	-	29X21	SF Rotation	-	CW
Num Final Filter 1	-	2	SF System SetPt	-	2 TURNS OPEN
Final Filter Size 1	-	47X19.5	RA Damper Position	-	MECHANICAL LINKAGE

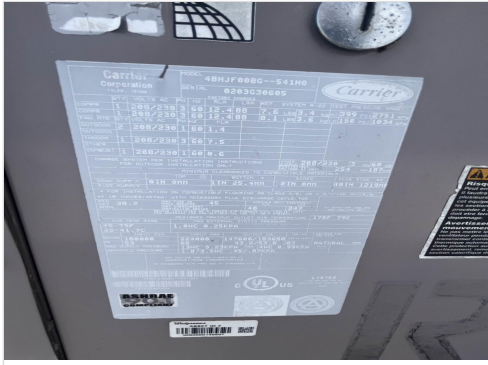
Asset: RTU3

**Issue Name :** RTU-3 low on flow  
**Description :** RTU-3 is low on flow at 92% of design at 1 turn open. Unit is at FLA, could not increase speed further without motor overramping.  
**Created By :** National TAB                      **Assigned To :** National TAB - Dylan Crisman  
**Status :** Open  
**Priority :** High                                      **Asset Tag :**  
**Originated Date :** 04/30/2025 - Dylan Crisman - National TAB
