Report: TAB REPORT
Function: Test, Adjust, & Balance
Date: 05/01/2025
Completed By: National TAB

PROJECT
04-28-25 WALGREENS #6937 AURORA, IL
(REACTIVE)

Project: 04-28-25 WALGREENS #6937 AURORA, IL (REACTIVE)

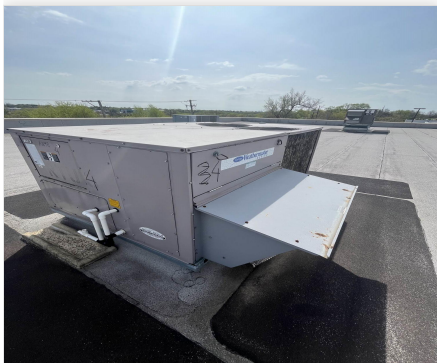
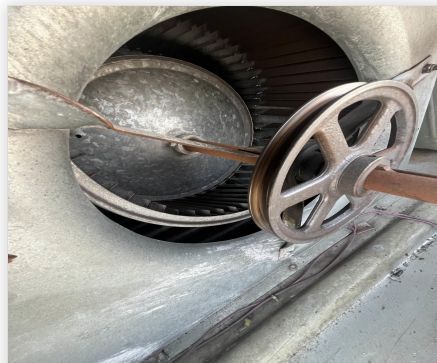
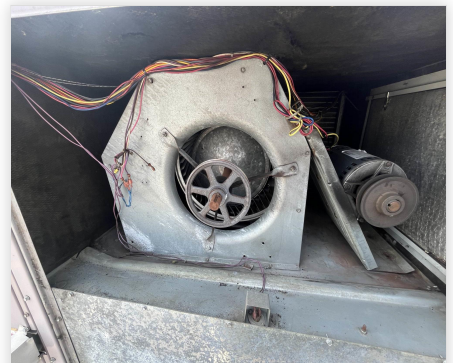
Issue Name : RTU-4 not operational
Description : RTU-4 is not operational, it appears the blower wheel has fallen out of alignment and the fan housing is dented and sunken along the back, appears someone has attempted to repair. Unable to determine current status of repairs with store managers.
Created By : National TAB **Assigned To :** National TAB - Dylan Crisman
Status : Open
Priority : Urgent **Asset Tag :**
Originated Date : 04/28/2025 - Dylan Crisman - National TAB
