Report: Renew
Date: 4/18/2022

FREDDY'S HCI - FAYETTEVILLE, NC (3205) - RENEW 2FCB (3)

4825 Ramsey Street (US401N)
Fayetteville, NC 28311

The purpose of the visit is to perform preventative maintenance for the store. We change belts and filters, clean evaporators and condenser, and check refrigeration and heating cycle where possible. We also, check and set exhaust, outside air, and make up air coming in out of the build to the engineer's design and/or to make the space as comfortable and healthy as possible. All of this ensures a healthy and comfortable space, extends service life of units, and reduces the number of future repairs by prevention.

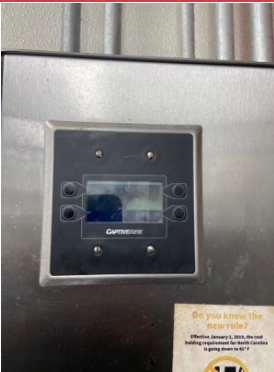
HMI BLACK OUT

(1) HMI IS BLACKENING

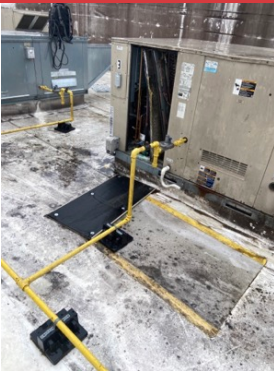
RTU-3 DOOR OFF UNIT

INFO	Extreme weather while on site. Testing was limited. Due to low temperature outside cooling could not be properly tested. Will retest next visit.
RECOMMENDATION (CLEAN/REPAIR/REPLACE/INFO)	
INFO	RTU-3 (Kitchen) door came of the unit in a storm and stripped the screw holes. New holes and screws were put into the door to secure it.
REPAIR	The Walk-In freezer has frost building up on the refrigeration lines. Service providers have tried to resolve the issues, but with no success.
REPAIR	HMI screen has a black spot. Possible drink was spilled on it someone hitting the buttons to hard.
REPAIR	Both restroom exhaust fans are not operational.

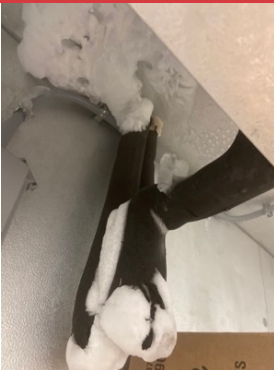
FROZEN LIN ON WALK IN COOLER

Notes: ICE ON PEN PIPE///ICE ON CEILING///
IN SITE PICTURES THERE IS SLIGHT FROST ON EVAP COILS, THEY HAD THE BOTH DOORS OPEN DUE A SPILL INSIDE THE WALKIN COOLER THAT SPREAD TO THE WALK IN FREEZER AND WHERE TRYING TO CONTAIN THE MESS.

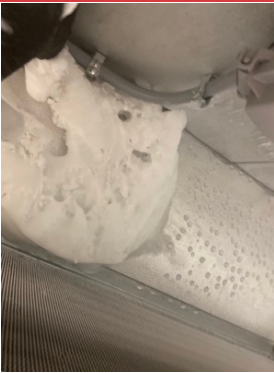
ICE BUILDUP ON CEILING

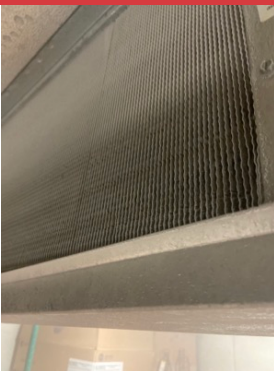
WALK IN FREEZER CLEAN

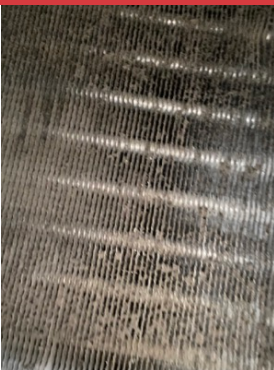
WALK IN COOLER DIRTY

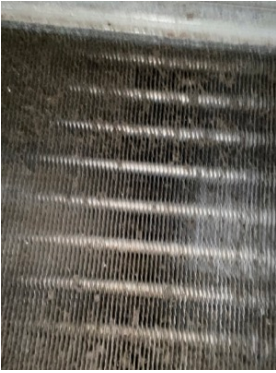
WALK-IN COOLER CLEANED

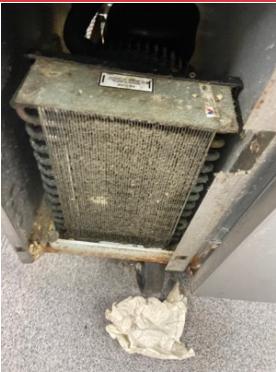
MEAT COOLER DIRTY

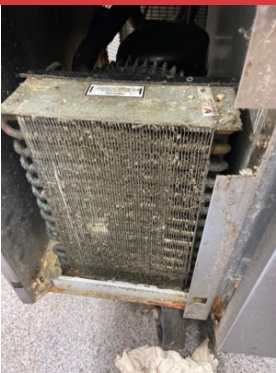
MEAT COOLER CLEAN

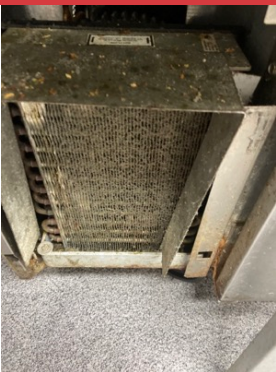
PREP STATION DIRTY

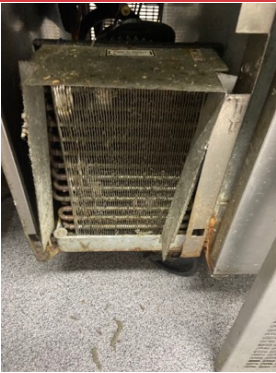
PREP STATION CLEAN

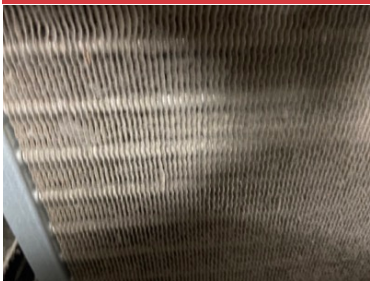
FREYR DIRTY

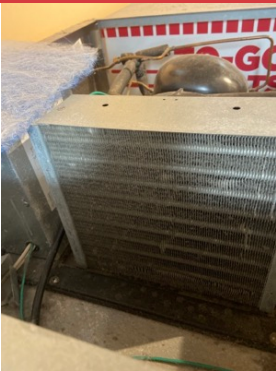
SUNDAY STATION DIRTY

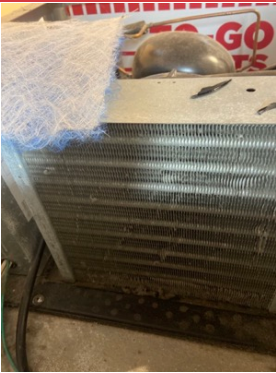
SUNDAY STATION CLEAN

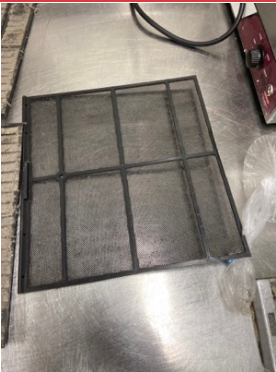
ICE MACHINE DIRTY

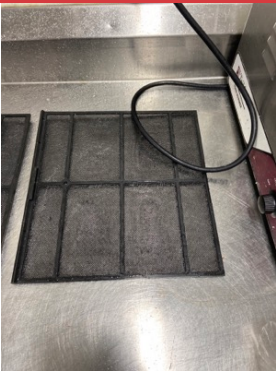
ICE MACHINE CLEAN

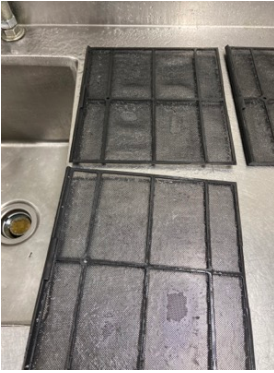
SODA MACHINE CLEAN

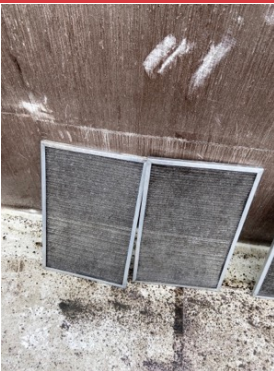
RTU-1 OA DIRTY

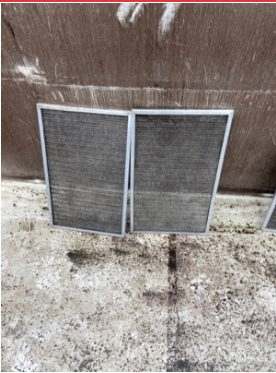
RTU-1 OA CLEAN

RTUs: There evaporator coil was rinsed off and cleaned. During warmer months a self-cleaning chemical is sprayed on the evaporator. The outside air filters were rinsed off to remove any dirty, so the unit stays at the designated outside air set point. Based on static pressures, amps, and fan rpm it shows that the total supply has not changed since the last test and balance.

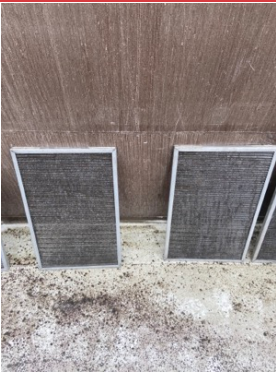
RTU-2 OA DIRTY

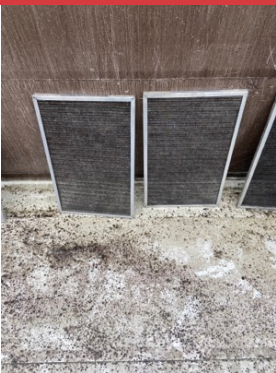
RTU-2 OA CLEAN

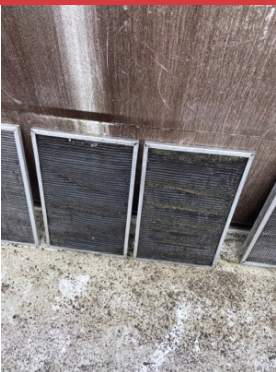
RTU-3 OA DIRTY

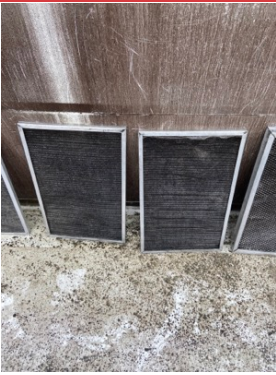
RTU-3 OA CLEAN

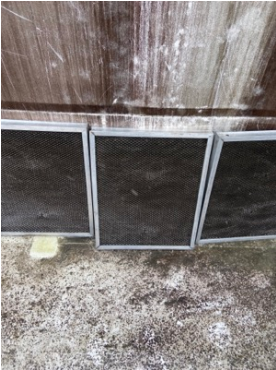
MUA OA DIRTY

MAU: The intake filters had slight dirt accumulation. They were washed.

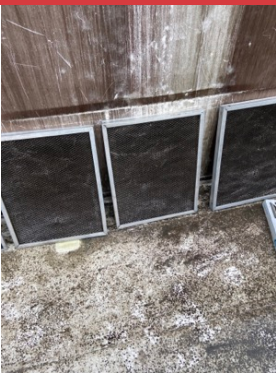
MAU OA CLEAN

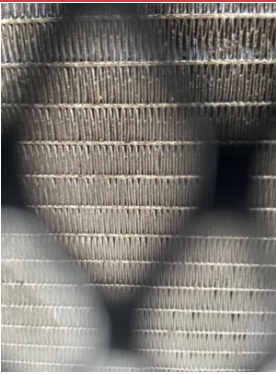
RTU-1 CONDENSER CLEAN

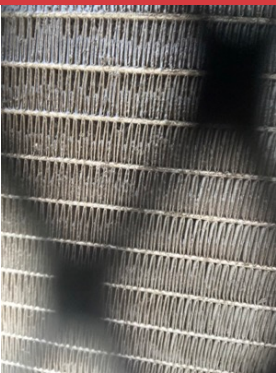
RTU-2 CONDENSER CLEAN

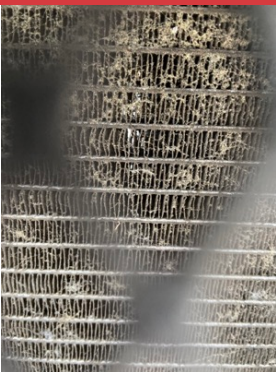
RTU-3 CONDENSER DIRTY

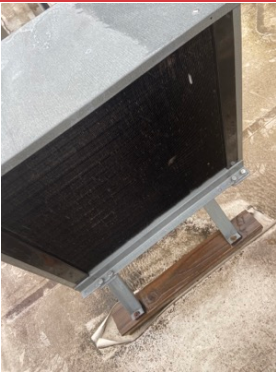
ICE MACHINE CONDENSER DIRTY

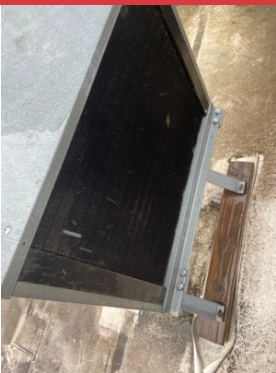
ICE MACHINE CONDENSER CLEAN

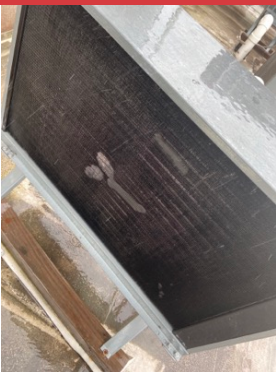
SODA MACHINE CONDENSER DIRTY

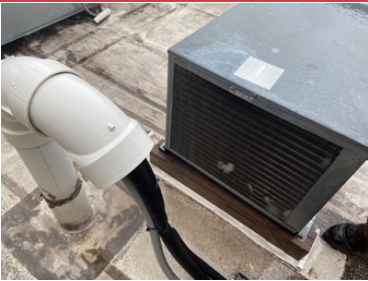
WALK-IN COOLER CONDENSER DIRTY

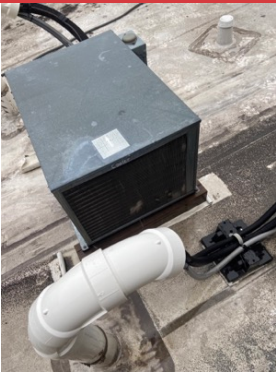
WALK-IN COOLER CONDENSER CLEAN

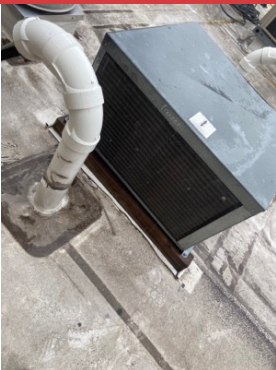
WALK IN FREEZER CONDENSER DIRTY

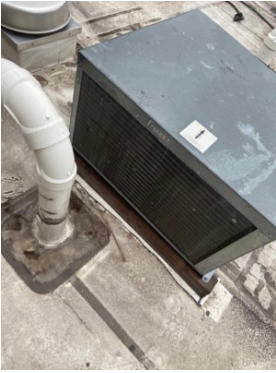
WALK IN FREEZER CONDENSER DIRTY

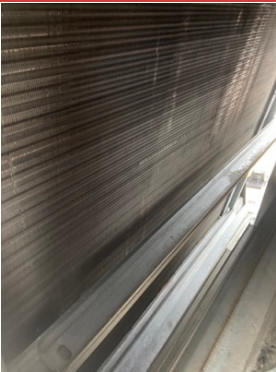
RTU-1 EVAP COIL DIRTY

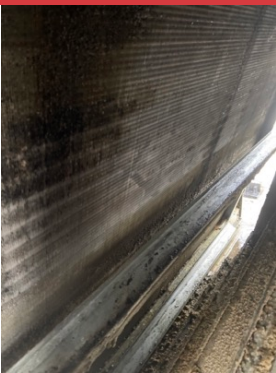
RTU-3 EVAP COIL CLEAN

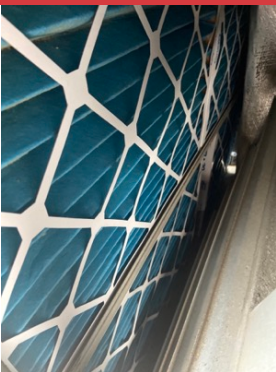
RTU-1 EVAP FILTER DIRTY

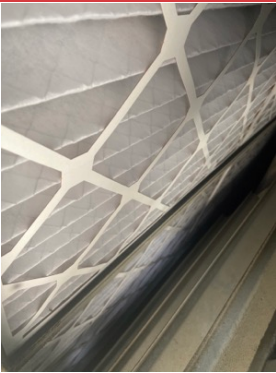
RTU-1 EVAP FILTER CLEAN

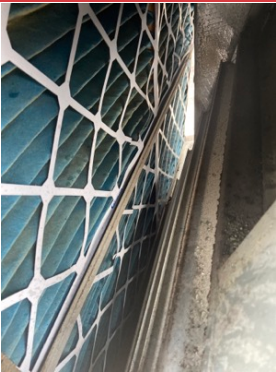
RTU-2 EVAP FILTER DIRTY

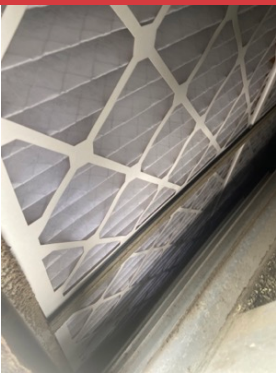
RTU-1 EVAP FILTER CLEAN

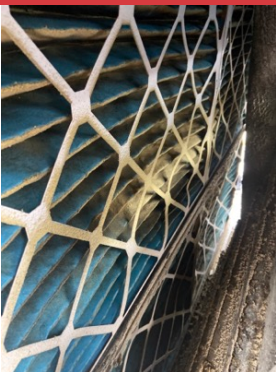
RTU-3 EVAP FILTER DIRTY

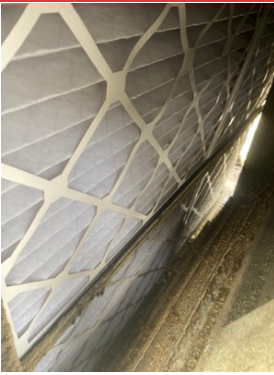
RTU-3 EVAP FILTER CLEAN

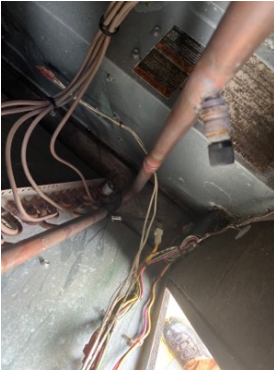
RTU-1 CONDENSATION TRAY CLEAN

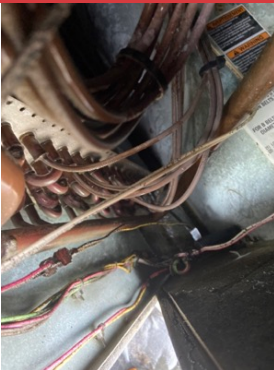
RTU-3 CONDENSATION TRAY CLEAN

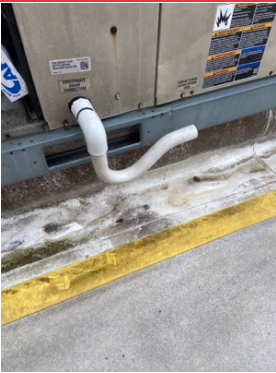
RTU-1 CONDENSATION DRAIN CLEAN

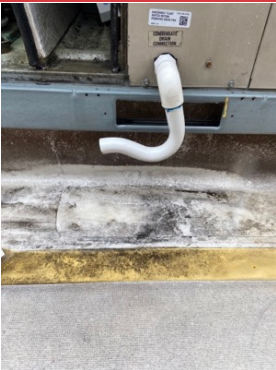
RTU-2 CONDENSATION DRAIN CLEAN

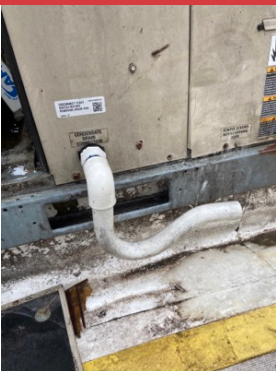
RTU-3 CONDENSATION DRAIN CLEAN
