Report: TAB Report
Function: Test, Adjust, & Balance
Date: 10/14/2025
Completed By: National TAB

11-03-25 WAWA #8216 SOUTHAMPTON, PA

25 Second Street Pike

HUNTINGTON VALLEY, PA 19006

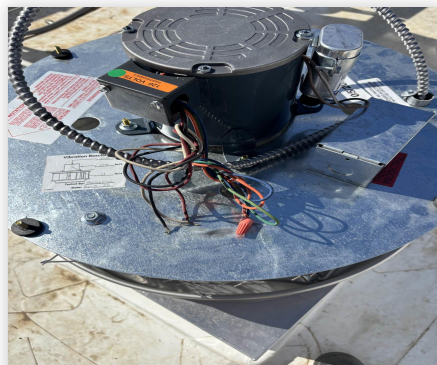
Issue Name : EF1, EF2: Exhaust Fan Speed switch wiring
Description : During original TAB trip Speed switches were not wired. During second tab trip the speed switches are not securely installed. wires are going to vibrate rub and short out over time. speed switch should be secured in an electrical enclosure
Created By : National TAB **Assigned To :** National TAB - Brianna Biggs
Status : Open
Priority : **Urgent** **Asset Tag :**
Originated Date : 10/06/2025 - Ryan Smith - National TAB

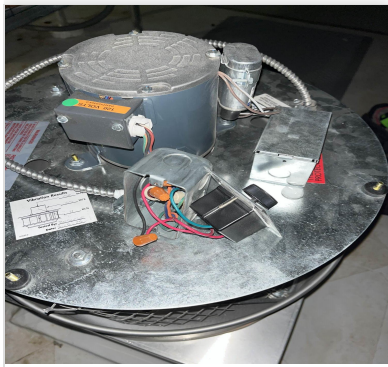
- **11/07/2025 National TAB - Tyler Youells**
 - Exhaust is powered, speed switches are not safely/securely installed

Speed controller is not safely and securely installed

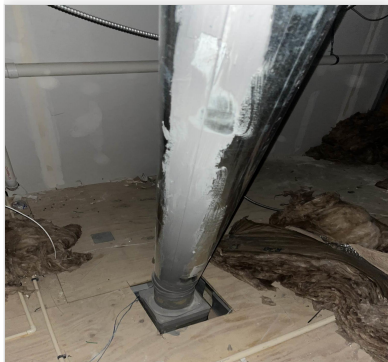
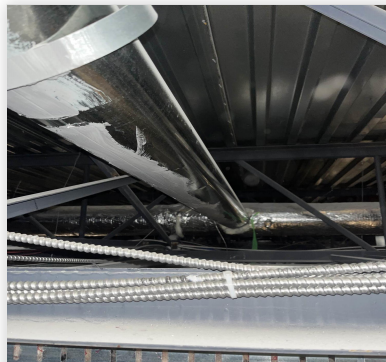
- **11/07/2025 National TAB - Tyler Youells**
 - 3-10 runout does not have insulation

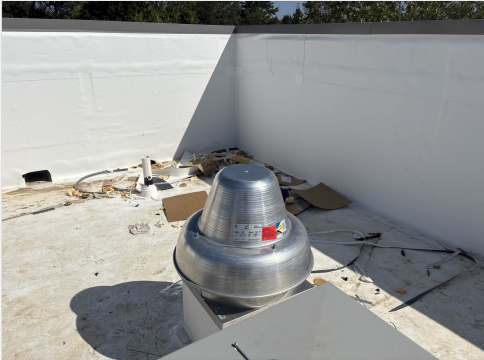
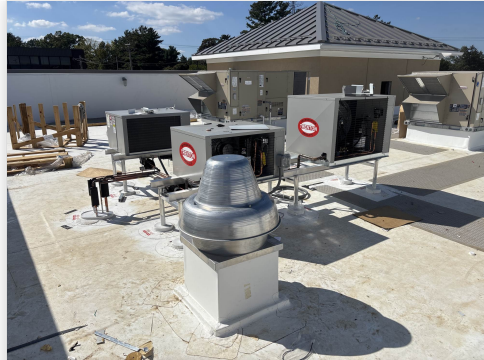
[1] AMP DRAW REMAINS UNCHANGED REGARDLESS OF SPEED DIAL POSITION. AMP DRAW IS 5.7/4.6
