**Report: TAB Report**  
**Function: Test, Adjust, & Balance**  
**Date: 10/14/2025**  
**Completed By: National TAB**

## 11-03-25 WAWA #8216 SOUTHAMPTON, PA

25 Second Street Pike

Project: 11-03-25 WAWA #8216 SOUTHAMPTON, PA

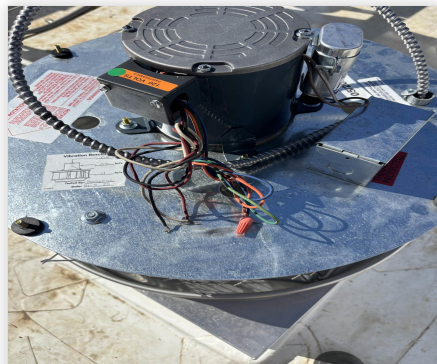
**Issue Name :** EF1, EF2: Exhaust Fans Not Powered  
**Description :** Exhaust fans have not been wired to power. Ask electricians to wire up fans and install speed controllers.  
**Created By :** National TAB                      **Assigned To :** National TAB - Brianna Biggs  
**Status :** Open  
**Priority :** Urgent                                      **Asset Tag :**  
**Originated Date :** 10/06/2025 - Ryan Smith - National TAB

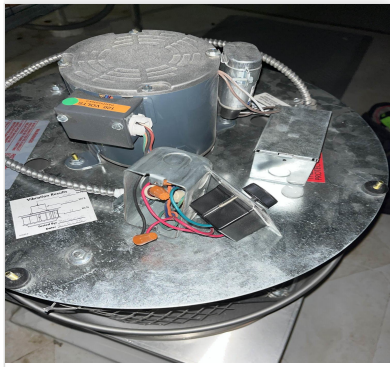
11/07/2025

- **11/07/2025 National TAB - Tyler Youells**
  - Exhaust is powered, speed switches are not safely/securely installed

Speed controller is not safely and securely installed

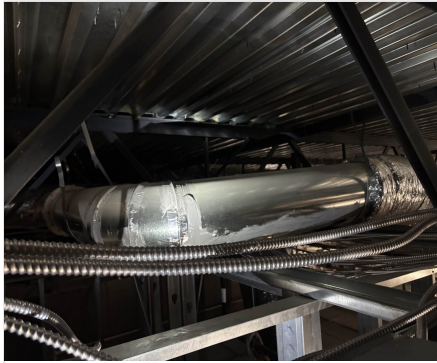
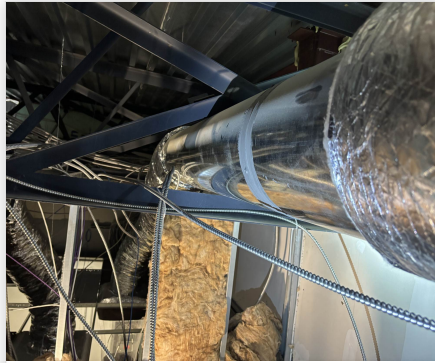
**Issue Name :** Insulation Not Installed  
**Description :** Insulation is missing from ductwork to diffuser 1-1 and 2-7.  
**Created By :** National TAB                      **Assigned To :** National TAB - Brianna Biggs  
**Status :** Open  
**Priority :** Low                                      **Asset Tag :**  
**Originated Date :** 10/07/2025 - Ryan Smith - National TAB

- **11/07/2025 National TAB - Tyler Youells**
  - 3-10 runout does not have insulation

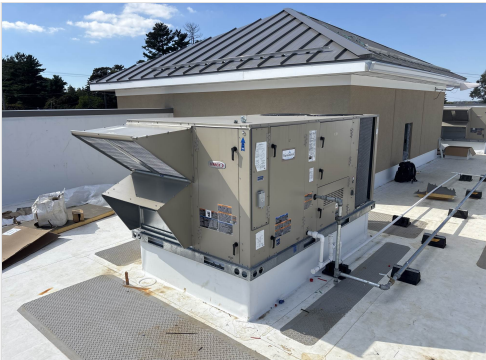
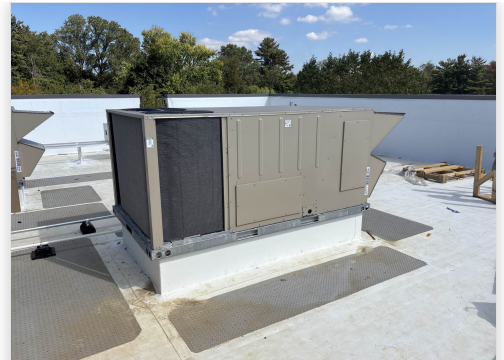
Asset: RTU1

Unit Data		
	Design	Actual
MFG	LENNOX	LENNOX
Serial Num	-	5625F01194
Model Num	LGT092H4E	LGT092H5ES2Y
Type	RTU	RTU
Configuration	VERTICAL	VERTICAL
Num OA Filters 1	-	2
OA Filter Size 1	-	15.5X25
Num Final Filter 1	-	4
Final Filter Size 1	-	20X25X2

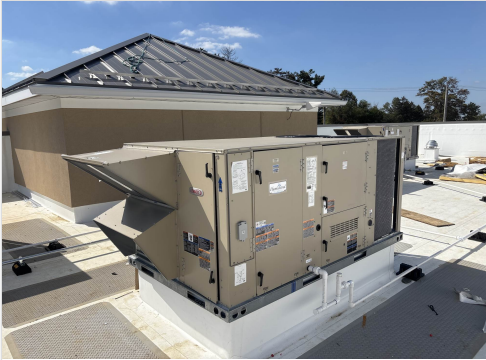
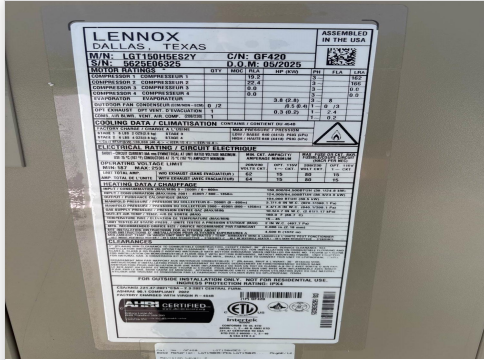
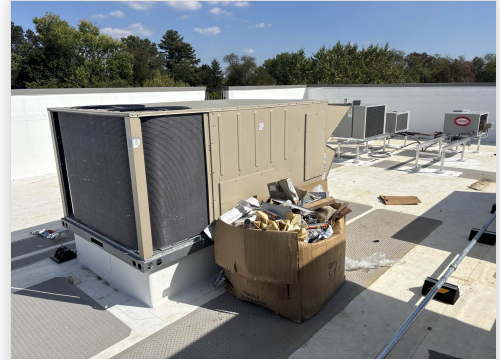
Asset: RTU2

Unit Data		
	Design	Actual
MFG	LENNOX	LENNOX
Serial Num	-	5625E06325
Model Num	LCT150H4E	LGT150H5ES2Y
Type	RTU	RTU
Configuration	VERTICAL	VERTICAL
Num OA Filters 1	-	2
OA Filter Size 1	-	15.5X25
Num Final Filter 1	-	4
Final Filter Size 1	-	20X25X2

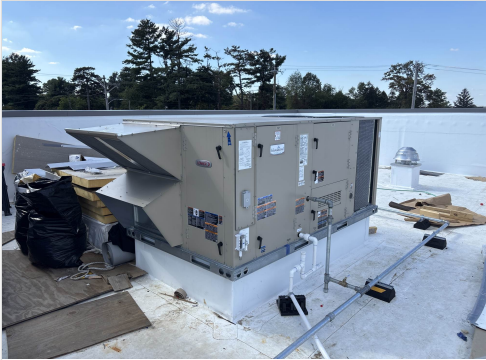
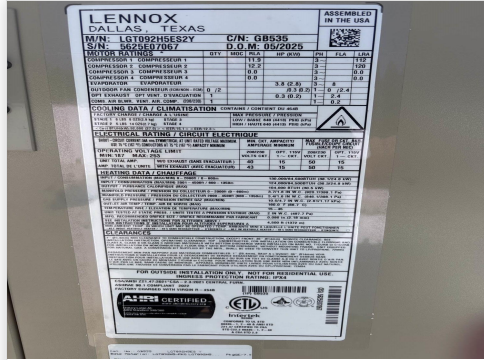
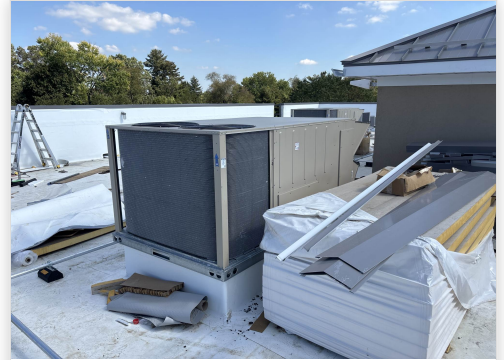
Asset: RTU3

Unit Data		
	Design	Actual
MFG	LENNOX	LENNOX
Serial Num	-	5625E07067
Model Num	LGT092H4E	LGT092H5ES2Y
Type	RTU	RTU
Configuration	VERTICAL	VERTICAL
Num OA Filters 1	-	2
OA Filter Size 1	-	15.5X25
Num Final Filter 1	-	4
Final Filter Size 1	-	20X25X2

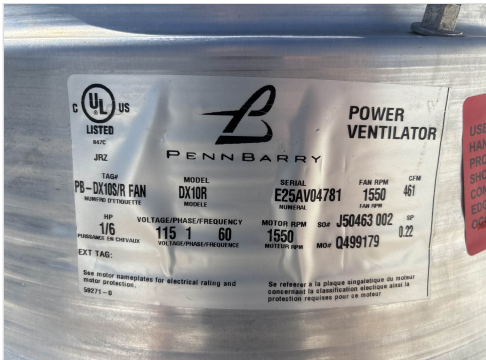
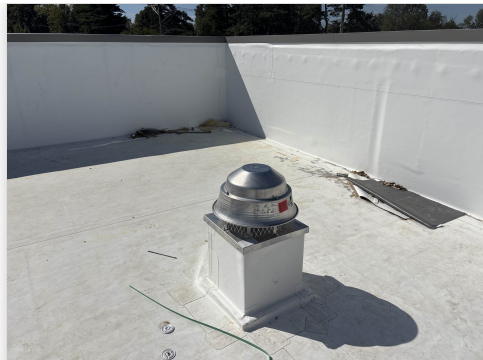
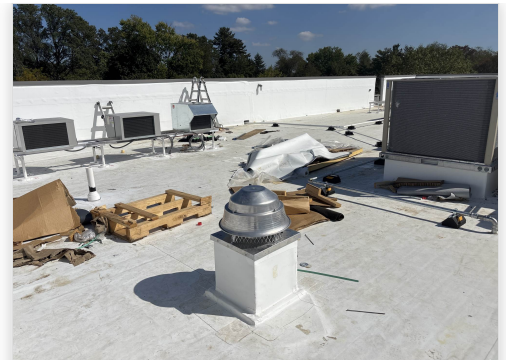
Asset: EF1

Unit Data		
	Design	Actual
MFG	PENNBARRY	PENNBARRY
Model Num	DX10R	DX10R
Serial Num	-	E25AV04781
Type	DOWNBLAST	DOWNBLAST
Configuration	VERTICAL	VERTICAL

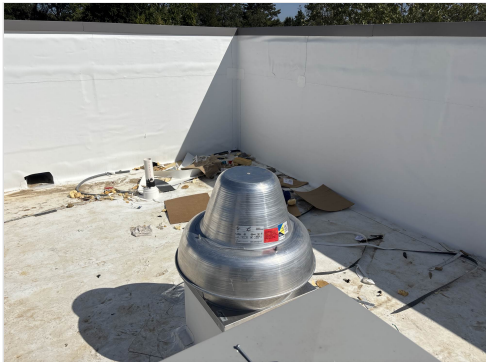
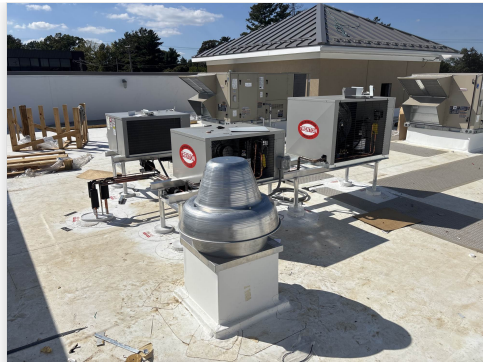
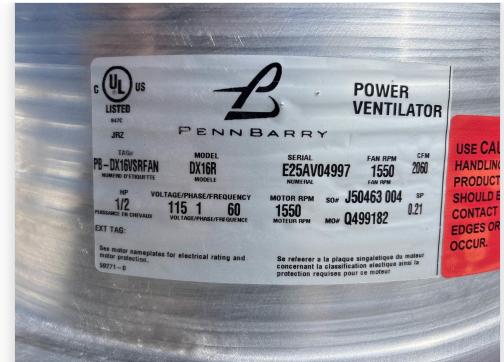
Asset: EF2

Unit Data		
	Design	Actual
MFG	PENNBARRY	PENNBARRY
Model Num	DX16S	DX16R
Serial Num	-	E25AV04997
Type	DOWNBLAST	DOWNBLAST
Configuration	VERTICAL	VERTICAL

[1] AMP DRAW REMAINS UNCHANGED REGARDLESS OF SPEED DIAL POSITION. AMP DRAW IS 5.7/4.6
