Report: TAB REPORT
Function: Test, Adjust, & Balance
Date: 02/03/2026
Completed By: National TAB

PROJECT
02-02-26 WHATABURGER #1641 COLUMBIA,
TN

Project: 02-02-26 WHATABURGER #1641 COLUMBIA, TN

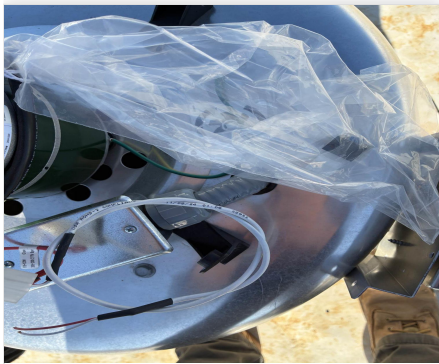
Issue Name : EXHAUST FANS SPEED CONTROL
Description : Exhaust fan speed controls are not wired. This may inhibit TAB.
Created By : National TAB **Assigned To :** National TAB - Noah Stafford
Status : Closed
Priority : Medium **Asset Tag :**
Originated Date : 02/02/2026 - Noah Stafford - National TAB

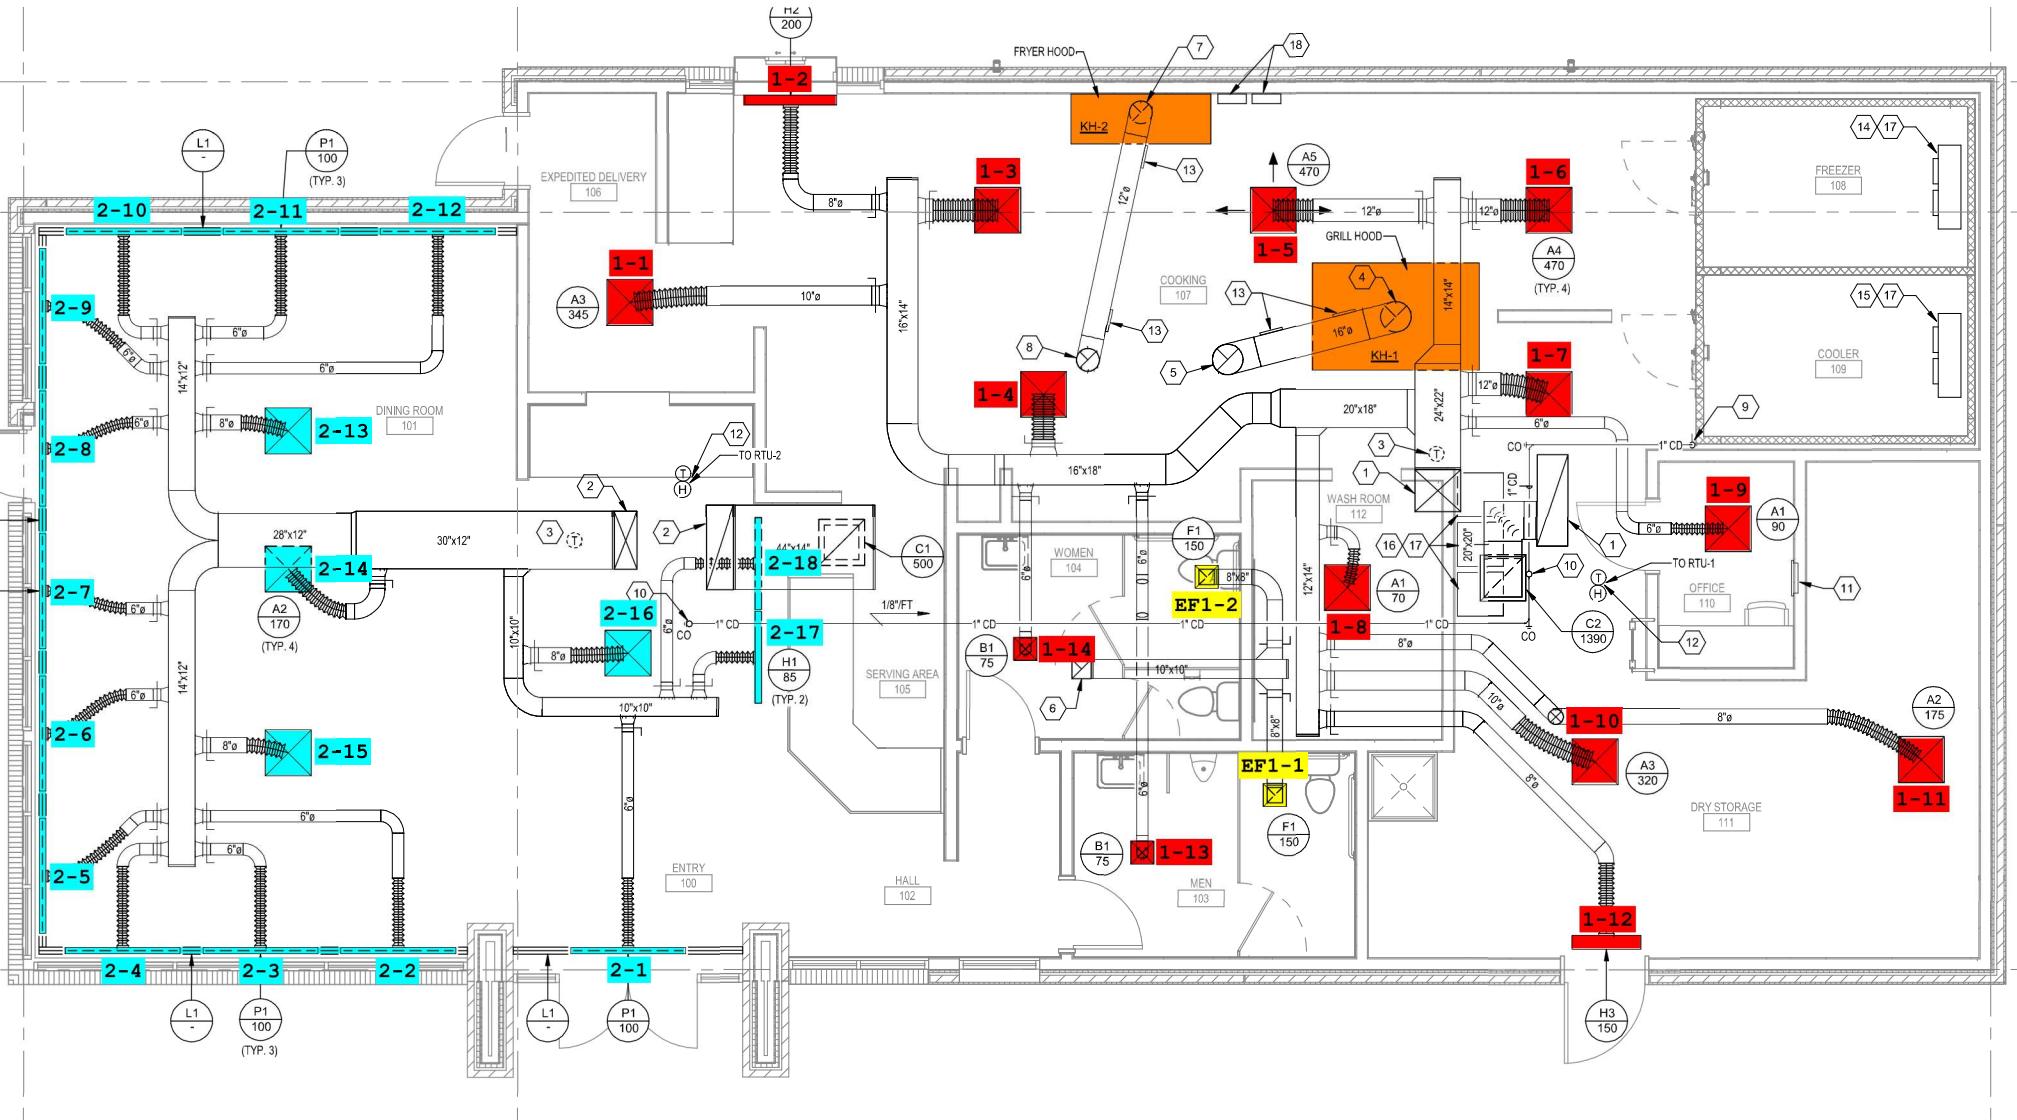
Test Data Exhaust		
	Design	Actual
Filter Type	FLAMEGUARD	FLAMEGUARD
Filter Size 1	12X20	12X20"
Filter Size 2	12X16	12X16"
Filter Qty 1	2	1
Filter Qty 2	2	3
Filter AK factor size 1	1.50	1.50
Filters AK factor size 2	1.16	1.16
Filter Total AK Area	5.32	4.98
Filter1 FPM	-	
Filter2 FPM	-	
Filter3 FPM	-	
Filter4 FPM	-	
Filter Ave FPM(corr)	-	
CFM	1216

Cooking Equipment	
	Actual
Item 1	FRYER
Item 2	FRYER
