Report: TAB REPORT
Function: Test, Adjust, & Balance
Date: 02/16/2024

PROJECT
02-05-24 PERRY'S - VERNON HILLS, IL

Project Summary

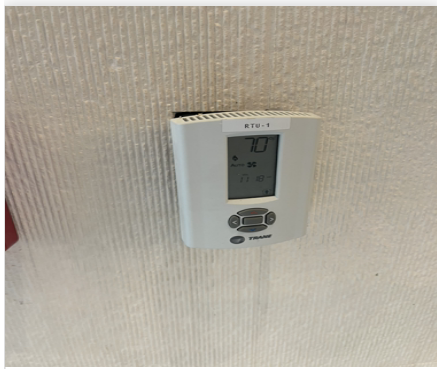
RTU-1(1)
02/16/2024

Issue Name : 04. RTU-1 Thermostat: Down Button Broken
Description : The down arrow on the thermostat does not appear functional. Could not program thermostat as a result.
Created By : National TAB **Assigned To :** National TAB - Michael McDonnell
Status : Open
Priority : Medium **Asset Tag :**
Originated Date : 02/16/2024 - Michael McDonnell - National TAB

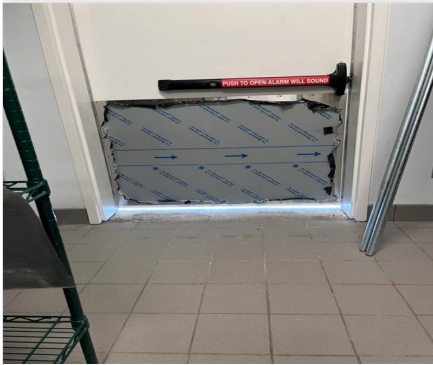
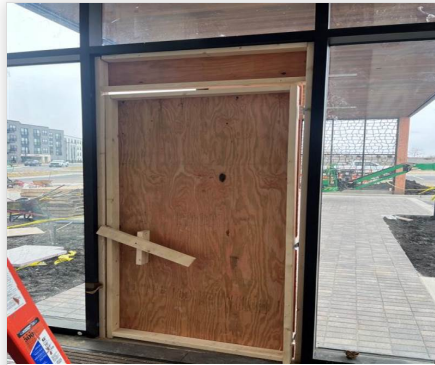
Issue Name : 05. Building Pressure: Building Not Sealed
Description : Building pressure could not be accurately measured as building is not yet sealed. Front door is not yet installed and several doors are not fully installed. Net airflow is positive.
Created By : National TAB **Assigned To :** National TAB - Michael McDonnell
Status : Open
Priority : InfoOnly **Asset Tag :**
Originated Date : 02/16/2024 - Michael McDonnell - National TAB

[1] Unable to accurately measure Building Pressure as building is not completely sealed. [2] EF-2 (Dishwasher) and EF-5 (Smoker) run Intermittently; Removed from balance Schedule.

Unable to accurately measure building pressure; front door not installed, not all doors sealed. Do not anticipate any issues, total building airflow is net positive.
