Report: TAB REPORT
Function: Test, Adjust, & Balance
Date: 02/16/2024

PROJECT
02-05-24 PERRY'S - VERNON HILLS, IL

Project Summary

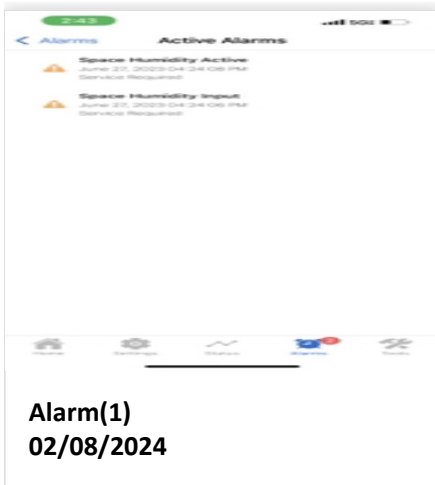
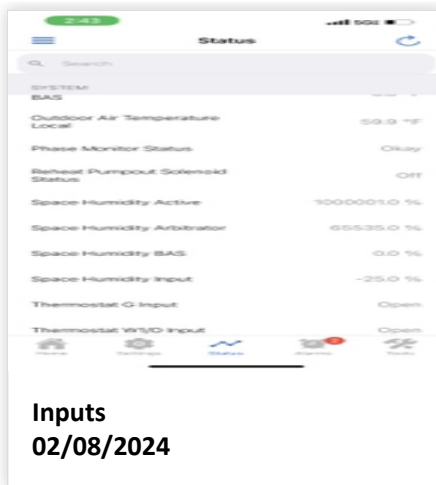
Issue Name : 01. Symbio RTUs: Humidity Alarm
Description : All Symbio RTUs have an alarm regarding space humidity input. Space humidity is being displayed as 1000001.0% at the RTUs. Space humidity arbitrator displays 65535.0%. Space humidity input displays -25.0%. Unsure how or if RTUs are reading space humidity. No sensors installed. Recommend Trane / EOR is contacted for clarification.
Created By : National TAB **Assigned To :** National TAB - Michael McDonnell
Status : Open
Priority : Urgent **Asset Tag :**
Originated Date : 02/08/2024 - Michael McDonnell - National TAB

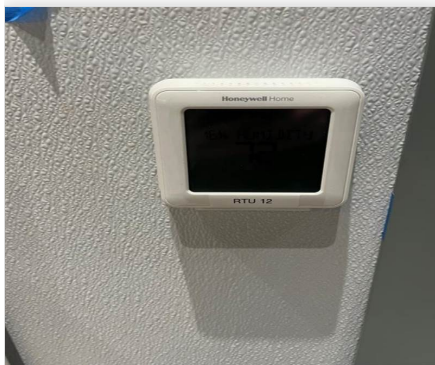
Honeywell_Home
02/16/2024

Issue Name : 03. Thermostats Not Programmable
Description : Thermostats for majority of RTUs are Honeywell Home thermostats. Thermostat is not capable of scheduling with Fan operation and not intended for commercial use. Recommend fully programmable thermostats are installed. Per MC, Trane indicated proper thermostats are on back order.
Created By : National TAB **Assigned To :** National TAB - Michael McDonnell
Status : Open
Priority : Medium **Asset Tag :**
Originated Date : 02/16/2024 - Michael McDonnell - National TAB

Honeywell Home thermostats are not programmable for this application. Recommend different thermostats. RTU-1 thermostat down button broken.

Thermostats are Honeywell Home thermostats. Unable to be programmed for this application.

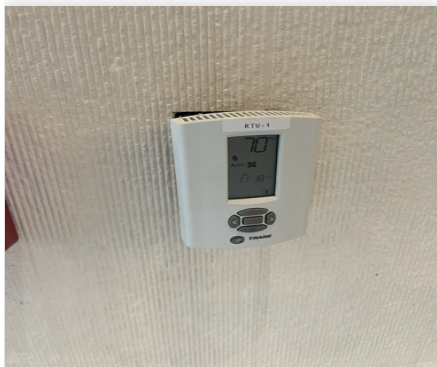
RTU-1(1)
02/16/2024

Issue Name : 04. RTU-1 Thermostat: Down Button Broken
Description : The down arrow on the thermostat does not appear functional. Could not program thermostat as a result.
Created By : National TAB **Assigned To :** National TAB - Michael McDonnell
Status : Open
Priority : Urgent **Asset Tag :**
Originated Date : 02/16/2024 - Michael McDonnell - National TAB

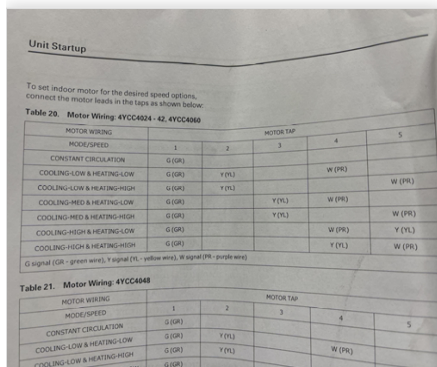
Speedtaps
02/08/2024

Issue Name : 06. RTU-4: High on airflow
Description : RTU-4 is multispeed unit scheduled for 600cfm with speed taps. Plans call for constant volume. Unit is within design at Speed tap 1, where G is landed. Manual indicates placing W(heat) at 4 and Y (cool) at tap 2, puts heating and cooling to low speed, this is 940cfm. Not possible to wire all stages to same speed. No indication if jumpers are allowed.

Test Data		
	Design	Actual
SF CFM	600	940
SF RPM	-	DD
RA CFM	450	786
OA CFM	150	154
RL Voltage	-	208
RL Amperage	-	1.5
SF Rotation	-	CORRECT
Min OA Damper Position	-	HIGH: 1/4" LOW: 1/2"
Min OA Damper Type	-	ECONOMIZER
OA Enthalpy Setpt	-	E
