Report: TAB Report
Function: Test, Adjust, & Balance
Date: 08/13/2025
Completed By: National TAB

08-11-25 WHATABURGER #1419 GILBERT, AZ

Project: 08-11-25 WHATABURGER #1419 GILBERT, AZ

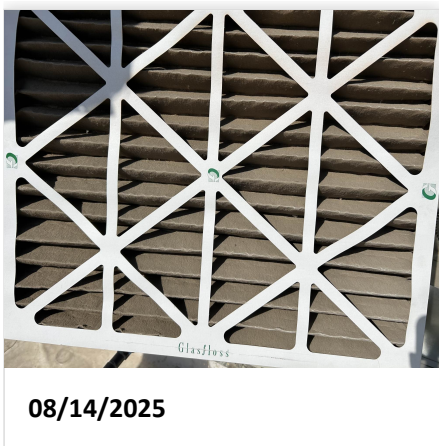
Issue Name : RTU-1 FILTER REPLACEMENT REQUIRED
Description : RTU-1 filters are extremely dirty. Filter change recommended.
Created By : National TAB **Assigned To :** National TAB - Will Turnbough
Status : Open
Priority : Low **Asset Tag :**
Originated Date : 08/14/2025 - Vaughn Paape - National TAB

General	
	Actual
Unit free of Damage	YES
Fan Rotation Correct	YES
Unit Filters Clean	NO
Condensate Drain Installed	YES
