Report: TAB Report
Function: Test, Adjust, & Balance
Date: 08/13/2025
Completed By: National TAB

08-11-25 WHATABURGER #1419 GILBERT, AZ

905 S Gilbert Rd

Whataburger Restaurants
300 Concord Plaza Dr
San Antonio, TX 78216

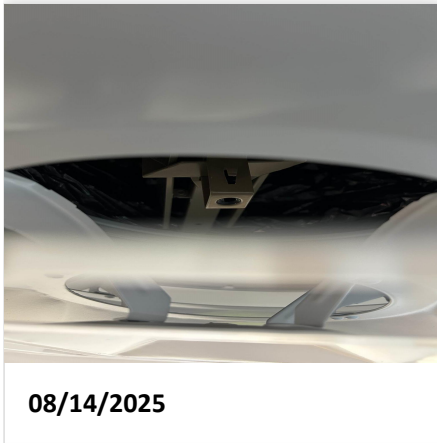
Issue Name : DIFFUSER 2-1 LOW AIRFLOW
Description : Damper has been adjusted to max open position. Unable to redirect airflow from other diffuser without increasing static pressures.
Created By : National TAB **Assigned To :** National TAB - Will Turnbough
Status : Open
Priority : Low **Asset Tag :**
Originated Date : 08/14/2025 - Vaughn Paape - National TAB

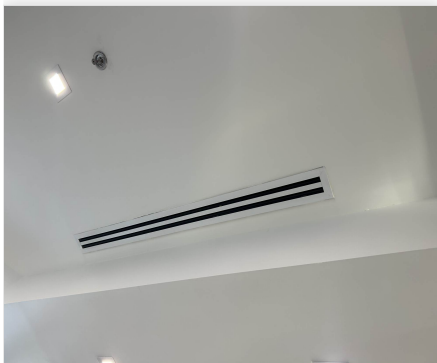
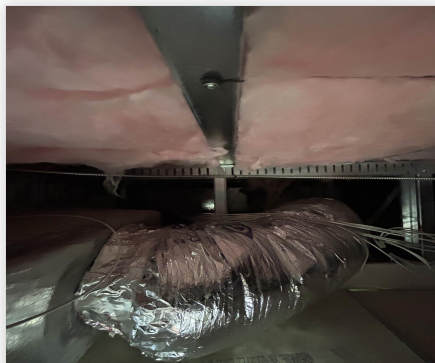
Issue Name : LINEAR DIFFUSER 1-4 HIGH AIRFLOW
Description : Unable to locate dampers for linear diffuser. High airflow and unable to lower to design cfm. Recommend installing damper to achieve design airflow.
Created By : National TAB **Assigned To :** National TAB - Will Turnbough
Status : Open
Priority : Low **Asset Tag :**
Originated Date : 08/14/2025 - Vaughn Paape - National TAB

Linear diffuser 1-4 duct rerouted to dining RTU. Extra diffuser installed for dining RTU.

Notes:
 LINEAR DIFFUSER 1-4 WAS REROUTED TO RTU-2. EXTRA DIFFUSER INSTALLED. TOTAL SUPPLY AIRFLOW FOR RTU-2 HAS BEEN ADJUSTED TO ACCOMIDATE FOR EXTRA DIFFUSERS ADDED.

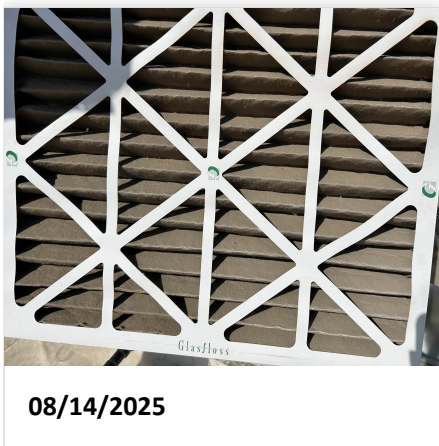
Issue Name : RTU-1 FILTER REPLACEMENT REQUIRED
Description : RTU-1 filters are extremely dirty. Filter change recommended.
Created By : National TAB **Assigned To :** National TAB - Will Turnbough
Status : Open
Priority : Low **Asset Tag :**
Originated Date : 08/14/2025 - Vaughn Paape - National TAB

General	
	Actual
Unit free of Damage	YES
Fan Rotation Correct	YES
Unit Filters Clean	NO
Condensate Drain Installed	YES

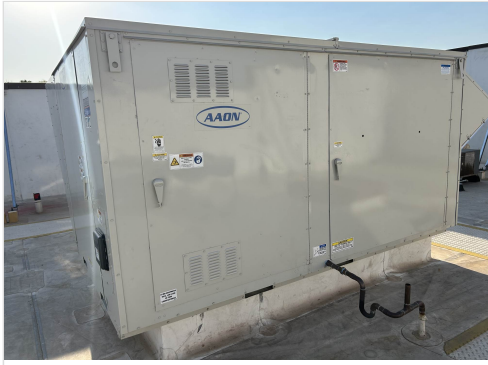
Unit Data - PHOTO LOG

Unit Data		
	Design	Actual
MFG	NA	AAON
Serial Num	-	202408-BNEM31748
Model Num	NA	RN-016-3-H-BABY-S0-21-000-A
Num OA Filters 1	-	3
OA Filter Size 1	-	19.625X25"
Num Final Filter 1	-	6
Final Filter Size 1	-	20X25X2

Notes:
UNIT PROPORTIONALLY BALANCED TO ACCOUNT FOR REROUTED DIFFUSER.

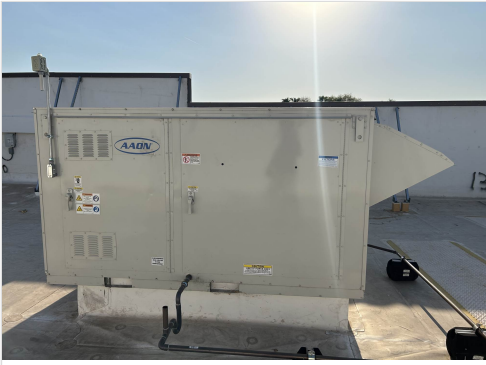
Unit Data - PHOTO LOG

Unit Data		
	Design	Actual
MFG	NA	AAON
Serial Num	-	202408-ANEL31741
Model Num	NA	RN-015-2,3,4,8-!GB!!-!!!:!!
Num OA Filters 1	-	N/A
OA Filter Size 1	-	N/A
Num Final Filter 1	-	4
Final Filter Size 1	-	20X25X2

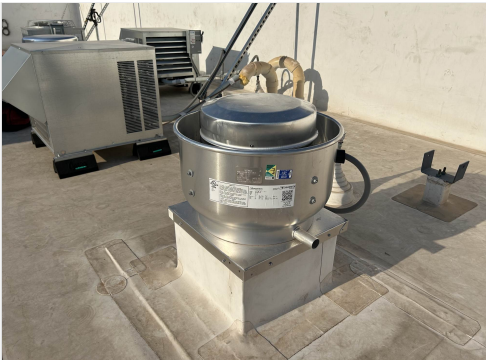
Unit Data - PHOTO LOG

Unit Data		
	Design	Actual
MFG	MARS	GREENHECK
Model Num	STD242-1U	CUE-080-VG-1-19-X
Serial Num	-	26510047 25C
Type	CEILING	UPBLAST
Configuration	VERTICAL	VERTICAL

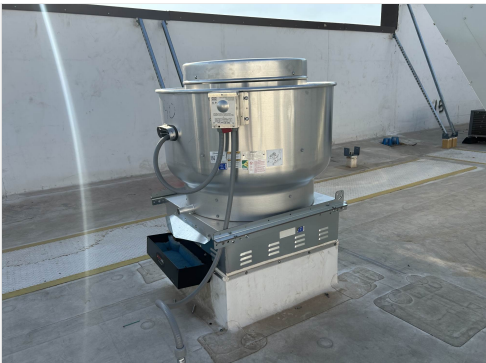
Unit Data - PHOTO LOG

Unit Data		
	Design	Actual
MFG	GREENHECK	GREENHECK
Model Num	CUBE-180HP-10-1-30-6	CUBE-180HP-10-1-30-6
Serial Num	-	26510026
Type	UPBLAST	UPBLAST
Configuration	VERTICAL	VERTICAL

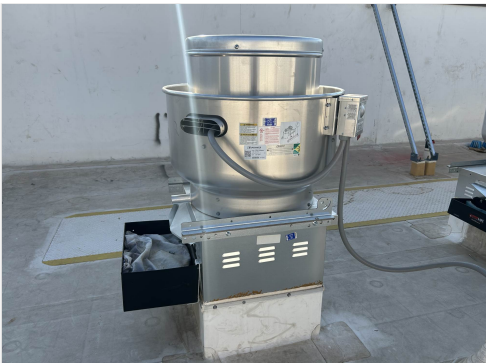
Unit Data - PHOTO LOG

Unit Data		
	Design	Actual
MFG	GREENHECK	GREENHECK
Model Num	CUBE-180HP-10-1-30-6	CUBE-140-5-1-22-6
Serial Num	-	26510037
Type	UPBLAST	UPBLAST
Configuration	VERTICAL	VERTICAL
