Report: TAB Report
Function: Test, Adjust, & Balance
Date: 08/20/2025
Completed By: National TAB

08-18-25 WHATABURGER #1449 TUCSON, AZ

Project: 08-18-25 WHATABURGER #1449 TUCSON, AZ

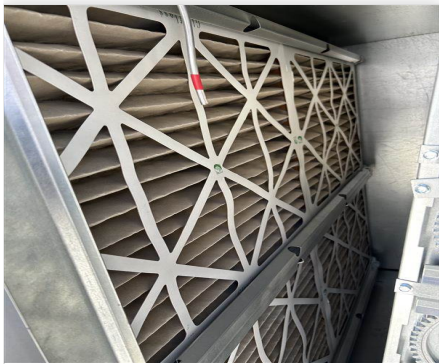
Project Issue File Details

Issue Name : DIRTY FINAL FILTERS
Description : RTU-1 and RTU-2 final filters are dirty. Recommend replacement.
Created By : National TAB **Assigned To :** National TAB - Dan Hertenstein
Status : Open
Priority : Low **Asset Tag :** RTU1
Originated Date : 08/20/2025 - Christine Weale - National TAB

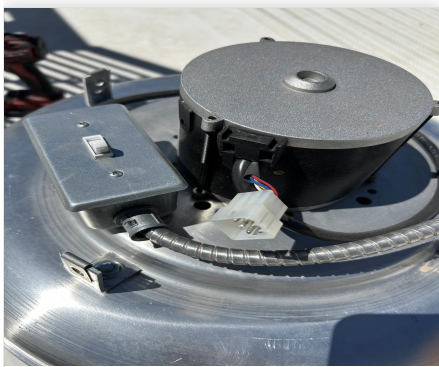
Project Issue File Details

Issue Name : NO SPEED CTRL ON EF1
Description : There is no way to decrease the speed for the EF1 exhaust fan.
Recommend adding a speed controller.
Created By : National TAB **Assigned To :** National TAB - Dan Hertenstein
Status : Open
Priority : Low **Asset Tag :** EF1
Originated Date : 08/20/2025 - Christine Weale - National TAB

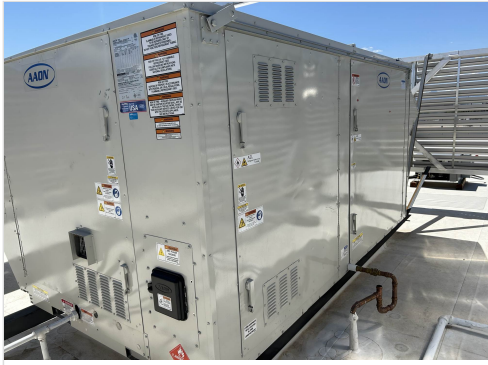
Unit Data - PHOTO LOG

Unit Data		
	Design	Actual
MFG	AAON	AAON
Serial Num	-	202506-BNGP123067
Model Num	RN-020-8-0-GB04-349	RNA-020-C-A-8-FAB04-CD1K0
Num OA Filters 1	-	3
OA Filter Size 1	-	19.5X25.75
Num Final Filter 1	-	6
Final Filter Size 1	-	20X25X2

General	
	Actual
Unit free of Damage	YES
Fan Rotation Correct	YES
Unit Filters Clean	NO
Condensate Drain Installed	YES

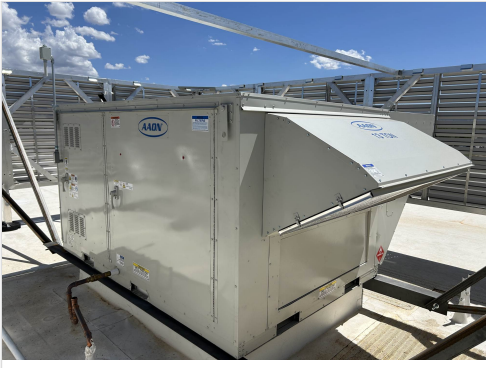
Unit Data - PHOTO LOG

Unit Data		
	Design	Actual
MFG	AAON	AAON
Serial Num	-	202506-ANGK123034
Model Num	RN-013-8-0-GB04-3F9	RN-013-8-0-GB04-3F9
Num OA Filters 1	-	2
OA Filter Size 1	-	24.68X19.75
Num Final Filter 1	-	4
Final Filter Size 1	-	20X25X2

General	
	Actual
Unit free of Damage	YES
Fan Rotation Correct	YES
Unit Filters Clean	No
Condensate Drain Installed	YES

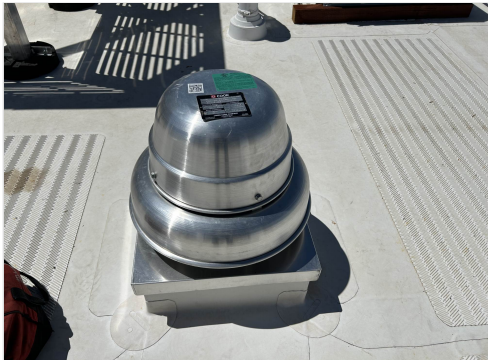
Unit Data - PHOTO LOG

Unit Data		
	Design	Actual
MFG	GREENHECK	GREENHECK
Model Num	G-080-VG	90C17DEC90ACEH
Serial Num	-	347PL64236-01/0000701
Type	DOWNBLAST	DOWNBLAST
Configuration	VERTICAL	VERTICAL

Test Data		
	Design	Actual
CFM	300	436
Fan RPM	1680	DD
Fan Rotation	-	CCW
Motor RPM	-	DD
System SetPt	-	SINGLE SPEED
RL Voltage	-	NA
RL Amperage	-	NA
Total ESP	0.50"	0.22"
Fan Inlet SP	-	-0.22"
Fan Discharge SP	-	ATMS

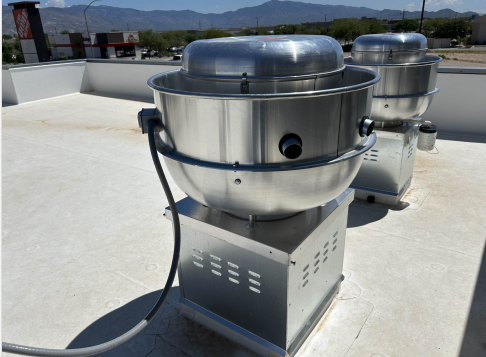
Unit Data - PHOTO LOG

Unit Data		
	Design	Actual
MFG	GREENHECK	COOK
Model Num	CUE-140-VG	164VH16DEC165CRH
Serial Num	-	3475L64236-00/000070
Type	UPBLAST	UPBLAST
Configuration	VERTICAL	VERTICAL

Test Data		
	Design	Actual
CFM	2110	2134
Fan RPM	1517	1372
Fan Rotation	-	CCW
Motor RPM	-	1372
System SetPt	-	81
RL Voltage	-	NA
RL Amperage	-	NA
Total ESP	1.00"	0.98"
Fan Inlet SP	-	-0.98"
Fan Discharge SP	-	ATMS

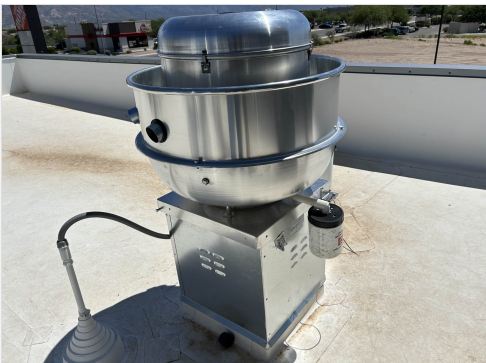
Unit Data - PHOTO LOG

Unit Data		
	Design	Actual
MFG	GREENHECK	COOK
Model Num	CUE-120-VG	120V17DEC120VCR
Serial Num	-	347SL64236-00/000230
Type	UPBLAST	UPBLAST
Configuration	VERTICAL	VERTICAL

Test Data		
	Design	Actual
CFM	1215	1250
Fan RPM	1415	1472
Fan Rotation	-	CCW
Motor RPM	-	1472
System SetPt	-	83
RL Voltage	-	NA
RL Amperage	-	NA
Total ESP	0.75"	0.40"
Fan Inlet SP	-	-0.40"
Fan Discharge SP	-	ATMS
