**Report: TAB Report**  
**Function: Test, Adjust, & Balance**  
**Date: 09/04/2025**  
**Completed By: National TAB**

**PROJECT**  
**08-25-25 CAVA DANBURY, CT**

44 BACKUS AVENUE

DANBURY, CT 06810

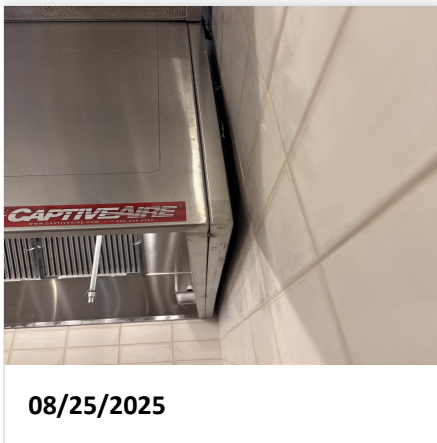
**Issue Name :** HD1: Gap Next to Wall  
**Description :** Small gap between hood and well. Recommend filling.  
**Created By :** National TAB                      **Assigned To :** National TAB - Dan Hertenstein  
**Status :** Open  
**Priority :** Low                                      **Asset Tag :**  
**Originated Date :** 08/25/2025 - Ryan Smith - National TAB

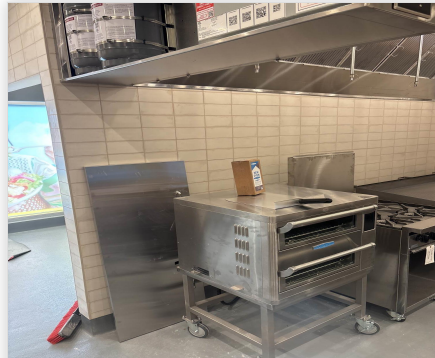
**Issue Name :** HD1: Left End Panel Not Installed  
**Description :** Hood is designed to have left end panel. Recommend installing according to drawings.  
**Created By :** National TAB                      **Assigned To :** National TAB - Dan Hertenstein  
**Status :** Open  
**Priority :** Medium                                      **Asset Tag :**  
**Originated Date :** 08/25/2025 - Ryan Smith - National TAB

Left end panel not installed.

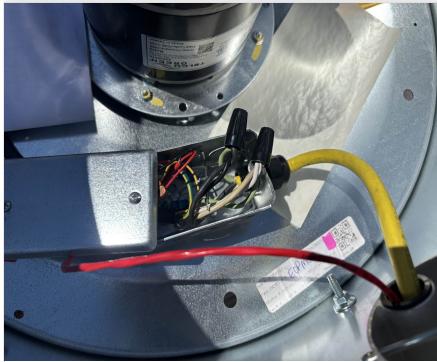
**Issue Name :** KEF1: Electrical Boxes Left Open  
**Description :** Electrical boxes are open, potentially exposing wiring to elements. Recommend closing.  
**Created By :** National TAB                      **Assigned To :** National TAB - Dan Hertenstein  
**Status :** Open  
**Priority :** Low                                              **Asset Tag :**  
**Originated Date :** 08/25/2025 - Ryan Smith - National TAB

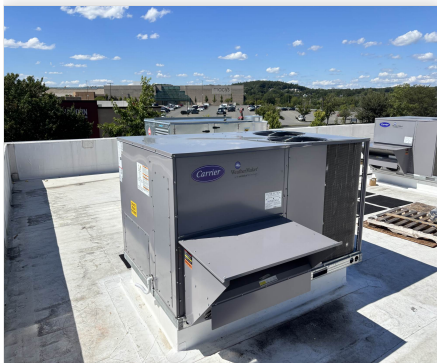
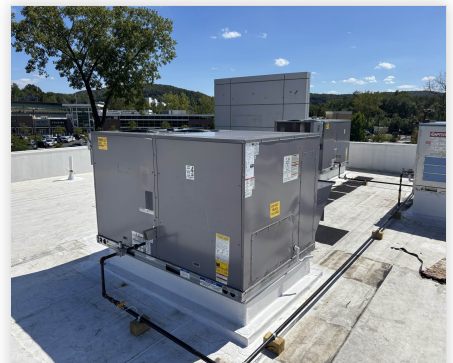
**Issue Name :** Rooftop Assets & Thermostats: No Identification Tags  
**Description :** No permanent tags or labels to identify rooftop units as RTU1, RTU2, MAU, KEF1. Also no permanent tags or labels to identify which thermostat serves which area.  
**Created By :** National TAB                      **Assigned To :** National TAB - Dan Hertenstein  
**Status :** Open  
**Priority :** Low                                      **Asset Tag :**  
**Originated Date :** 08/25/2025 - Ryan Smith - National TAB

- **08/27/2025 National TAB - Ryan Smith**
  - Tags have been applied to rooftop assets, but not thermostats.

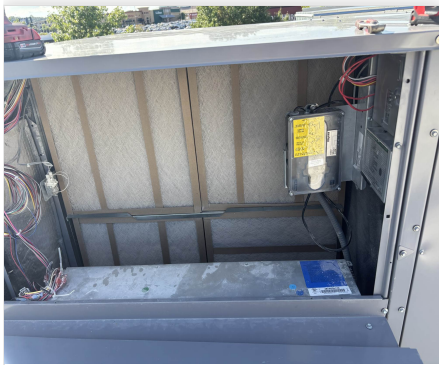
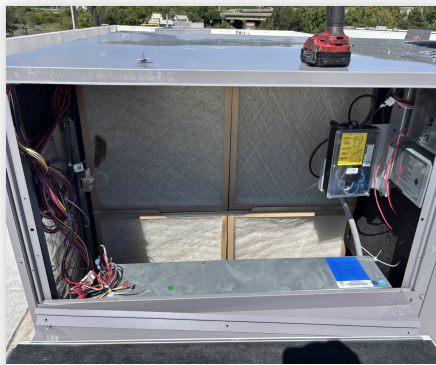
**Issue Name :** RTU1, RTU2: Construction Filters Still Installed  
**Description :** Construction filters still installed in both RTUs. Recommend replacing with MERV8 filters.  
**Created By :** National TAB                      **Assigned To :** National TAB - Dan Hertenstein  
**Status :** Open  
**Priority :** Medium                                      **Asset Tag :**  
**Originated Date :** 08/25/2025 - Ryan Smith - National TAB

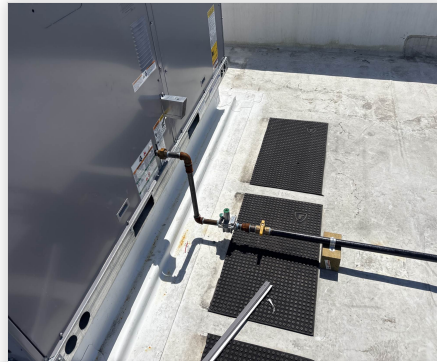
**Issue Name :** RTU1, RTU2: Gas Valves Closed  
**Description :** Gas valves for both RTUs are closed. Open valves and perform burner startup.  
**Created By :** National TAB                      **Assigned To :** National TAB - Dan Hertenstein  
**Status :** Open  
**Priority :** Low                                      **Asset Tag :**  
**Originated Date :** 08/25/2025 - Ryan Smith - National TAB

Gas valves closed and burners not started up. See OA temperature.

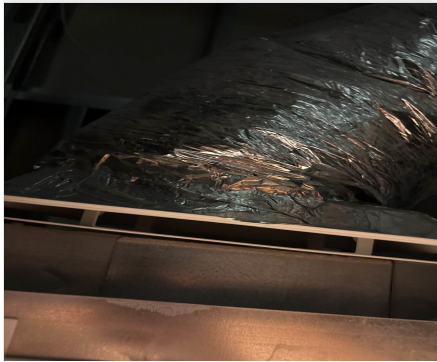
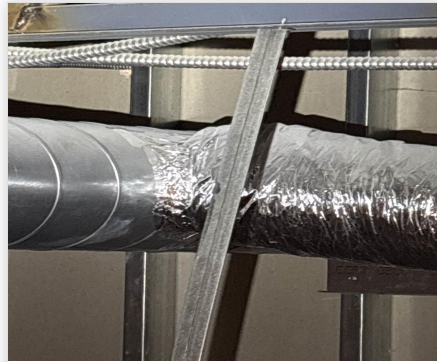
**Issue Name :** RTU2-10,12: No Dampers in Bathroom Supply Diffusers  
**Description :** Bathroom supply diffusers do not have dampers. Unable to adjust.  
**Created By :** National TAB                      **Assigned To :** National TAB - Dan Hertenstein  
**Status :** Open  
**Priority :** Low                                      **Asset Tag :**  
**Originated Date :** 08/27/2025 - Ryan Smith - National TAB
