Report: TAB Report
Function: Test, Adjust, & Balance
Date: 09/04/2025
Completed By: National TAB

PROJECT
08-25-25 CAVA DANBURY, CT

Project: 08-25-25 CAVA DANBURY, CT

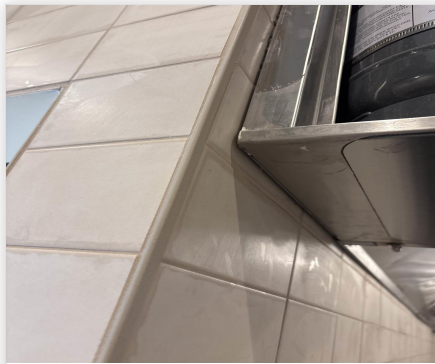
Issue Name : HD1: Not Caulked Along Wall
Description : Hood not caulked where it meets wall. Recommend caulking.
Created By : National TAB **Assigned To :** National TAB - Dan Hertenstein
Status : Open
Priority : **Medium** **Asset Tag :**
Originated Date : 08/25/2025 - Ryan Smith - National TAB

Caulk not applied

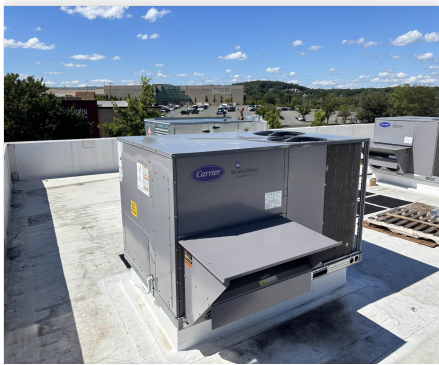
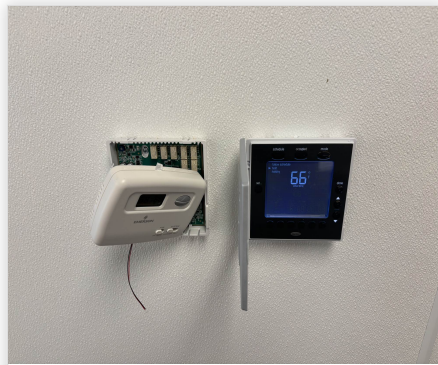
Issue Name : Rooftop Assets & Thermostats: No Identification Tags
Description : No permanent tags or labels to identify rooftop units as RTU1, RTU2, MAU, KEF1. Also no permanent tags or labels to identify which thermostat serves which area.
Created By : National TAB **Assigned To :** National TAB - Dan Hertenstein
Status : Open
Priority : Low **Asset Tag :**
Originated Date : 08/25/2025 - Ryan Smith - National TAB

- **08/27/2025 National TAB - Ryan Smith**
 - Tags have been applied to rooftop assets, but not thermostats.

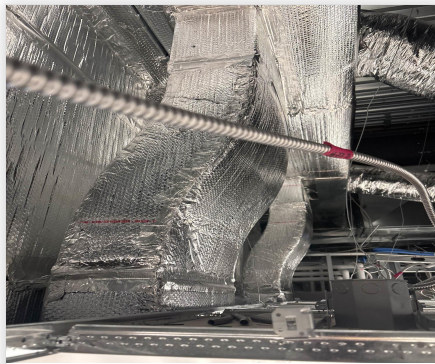
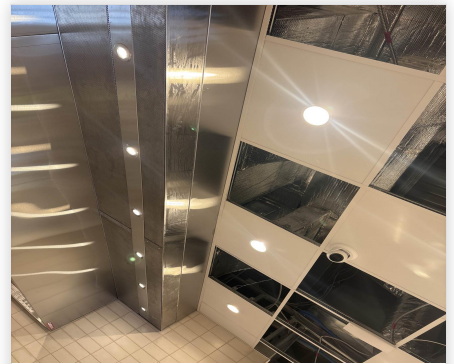
Issue Name : RTU1-1: No Dampers in ACPSP
Description : No dampers in ACPSP. Unable to adjust kitchen diffusers.
Created By : National TAB **Assigned To :** National TAB - Dan Hertenstein
Status : Open
Priority : High **Asset Tag :**
Originated Date : 08/27/2025 - Ryan Smith - National TAB

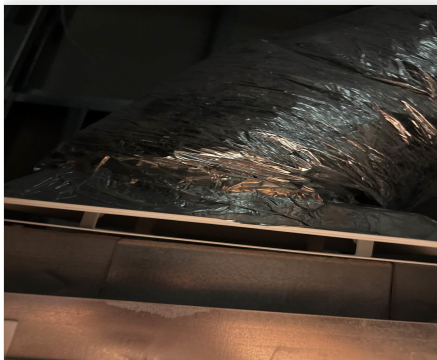
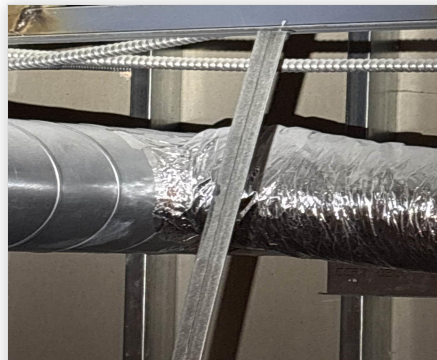
Issue Name : RTU2-10,12: No Dampers in Bathroom Supply Diffusers
Description : Bathroom supply diffusers do not have dampers. Unable to adjust.
Created By : National TAB **Assigned To :** National TAB - Dan Hertenstein
Status : Open
Priority : Low **Asset Tag :**
Originated Date : 08/27/2025 - Ryan Smith - National TAB
