**Report: TAB Report**  
**Function: Test, Adjust, & Balance**  
**Date: 05/02/2025**  
**Completed By: National TAB**

**PROJECT**  
**04-21-25 SAFEWAY #1535 TEMPE, AZ**

1515 E. ELLIOT RD

Project: 04-21-25 SAFEWAY #1535 TEMPE, AZ

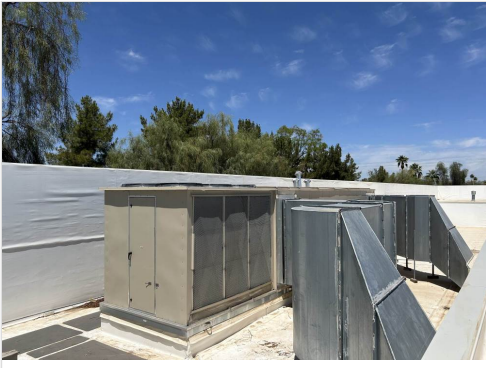
## Unit Data - PHOTO LOG

Asset: AC-1

Test Data		
	Design	Actual
SF CFM	20980	20539
SF RPM	-	786
RA CFM	16830	16561
OA CFM	4150	3978
RL Voltage	-	419/419/420
RL Amperage	-	16.57@VFD
SF Rotation	-	CCW
SF System SetPt	-	40HZ
RA Damper Position	-	45%
Min OA Damper Position	-	55%
Min OA Damper Type	-	POTENTIOMETER
OA Enthalpy Setpt	-	N/A

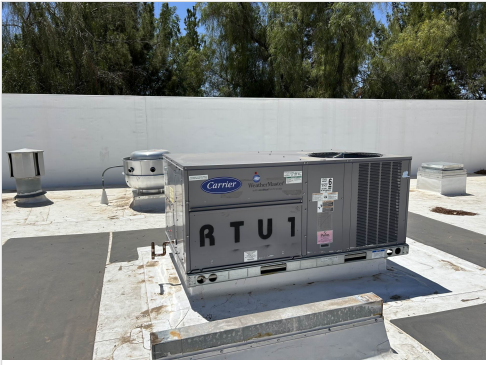
## Unit Data - PHOTO LOG

Asset: AC-2

Test Data		
	Design	Actual
SF CFM	1000	1082
SF RPM	-	1469
RA CFM	-	1082
OA CFM	-	0
RL Voltage	-	207
RL Amperage	-	2.46
SF Rotation	-	CCW
SF System SetPt	-	C
RA Damper Position	-	N/A
Min OA Damper Position	-	N/A
Min OA Damper Type	-	N/A
OA Enthalpy Setpt	-	N/A

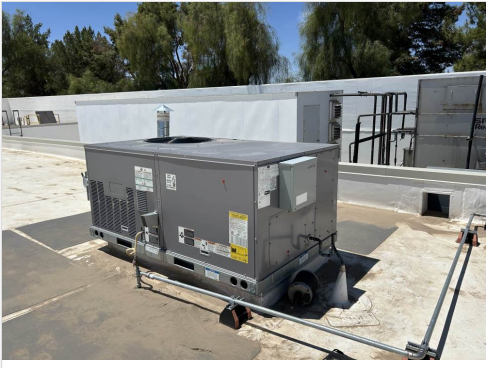
## Unit Data - PHOTO LOG

Asset: AC-3

Test Data		
	Design	Actual
SF CFM	1000	1029
SF RPM	-	1921
RA CFM	750	1029
OA CFM	250	0
RL Voltage	-	478/477/480
RL Amperage	-	0.93/0.95/0.98
SF Rotation	-	CCW
SF System SetPt	-	C
RA Damper Position	-	N/A
Min OA Damper Position	-	N/A
Min OA Damper Type	-	N/A
OA Enthalpy Setpt	-	N/A

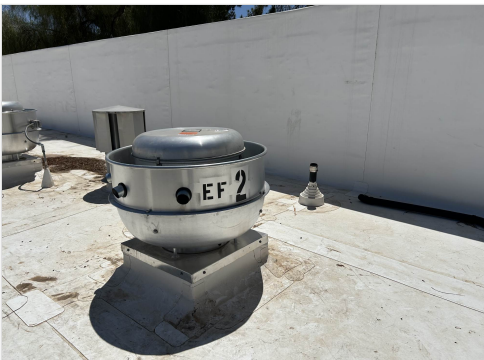
## Unit Data - PHOTO LOG

Asset: EF7

Test Data		
	Design	Actual
CFM	1000	986
Fan RPM	-	1346
Fan Rotation	-	CCW
Motor RPM	-	1346
RL Voltage	-	119
RL Amperage	-	NA
Suction ESP	-	0.56"
Discharge ESP	-	ATMS
Total ESP	0.625"	-0.56"

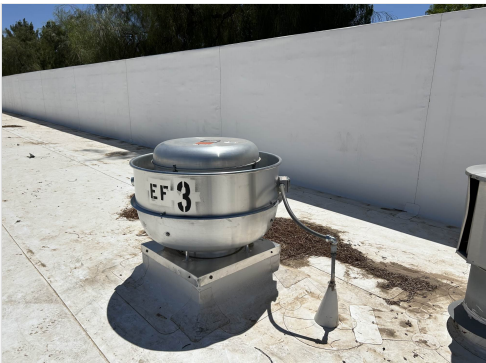
## Unit Data - PHOTO LOG

Asset: EF8

Test Data		
	Design	Actual
CFM	1000	1037
Fan RPM	-	1211
Fan Rotation	-	CCW
Motor RPM	-	1211
RL Voltage	-	119
RL Amperage	-	NA
Suction ESP	-	0.52"
Discharge ESP	-	ATMS
Total ESP	0.625"	0.52"
