Report: TAB Report
Function: Test, Adjust, & Balance
Date: 05/02/2025
Completed By: National TAB

PROJECT
04-21-25 SAFEWAY #1535 TEMPE, AZ

1515 E. ELLIOT RD

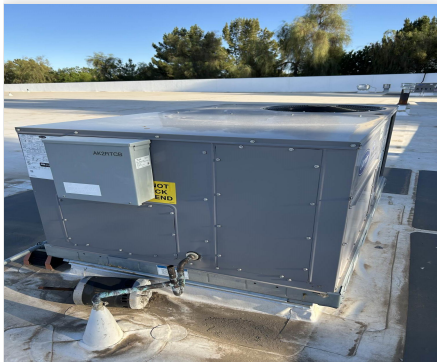
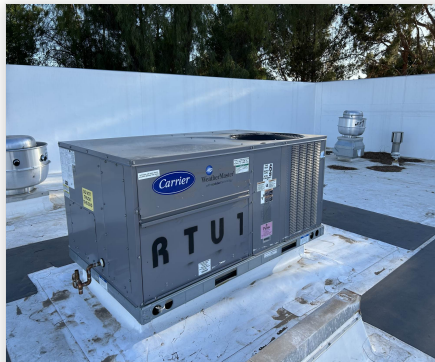
Issue Name : AC-1 & AC-2 NO OUTSIDE AIR VENTS INSTALLED
Description : Unable to set outside air for units AC-1 & AC-2. Both units do not have OA vents installed preventing from outside air from being set. Recommend installing outside air vents and dampers so outside air can be balanced.
Created By : National TAB **Assigned To :** National TAB - Dan Hertenstein
Status : Open
Priority : Medium **Asset Tag :**
Originated Date : 05/02/2025 - David Nicolas Sanchez - National TAB

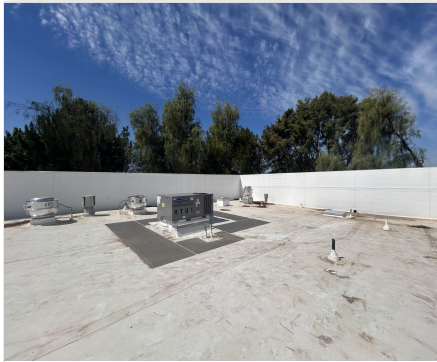
Issue Name : MUA DOES NOT EXIST
Description : MUA does not exist on rooftop as mentioned on plans. Unable to balance unit.
Created By : National TAB **Assigned To :** National TAB - Dan Hertenstein
Status : Open
Priority : InfoOnly **Asset Tag :**
Originated Date : 05/02/2025 - David Nicolas Sanchez - National TAB

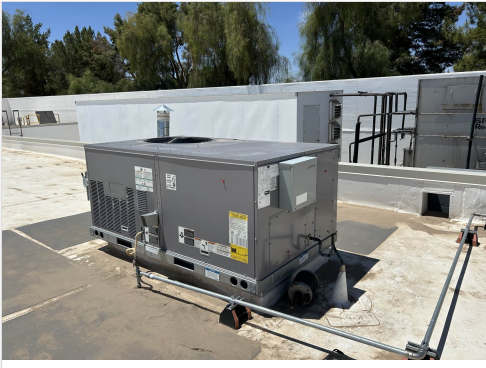
Unit Data - PHOTO LOG

Asset: AC-1

Unit Data		
	Design	Actual
MFG	NA	NL
Serial Num	-	A E442 -0124 -01
Model Num	NA	LA045
Type	AC	AC
Configuration	VERTICAL	VERTICAL
Num OA Filters 1	-	N/A
OA Filter Size 1	-	N/A
Num Final Filter 1	-	24
Final Filter Size 1	-	16X20X2

Test Data		
	Design	Actual
SF CFM	20980	20539
SF RPM	-	786
RA CFM	16830	16561
OA CFM	4150	3978
RL Voltage	-	419/419/420
RL Amperage	-	16.57@VFD
SF Rotation	-	CCW
SF System SetPt	-	40HZ
RA Damper Position	-	45%
Min OA Damper Position	-	55%
Min OA Damper Type	-	POTENTIOMETER
OA Enthalpy Setpt	-	N/A

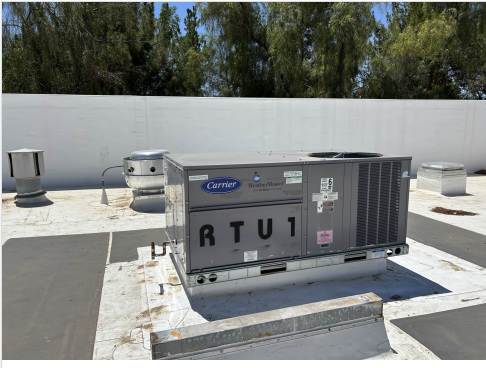
Unit Data - PHOTO LOG

Asset: AC-2

Unit Data		
	Design	Actual
MFG	NA	CARRIER
Serial Num	-	1524C09547
Model Num	NA	50GCJ04A2M5A6U1F0
Type	-	RTU
Configuration	-	VERTICAL
Num OA Filters 1	-	N/A
OA Filter Size 1	-	N/A
Num Final Filter 1	-	2
Final Filter Size 1	-	16X25X2
Num Final Filter 2	-	
Final Filter Size 2	-

Test Data		
	Design	Actual
SF CFM	1000	1082
SF RPM	-	1469
RA CFM	-	1082
OA CFM	-	0
RL Voltage	-	207
RL Amperage	-	2.46
SF Rotation	-	CCW
SF System SetPt	-	C
RA Damper Position	-	N/A
Min OA Damper Position	-	N/A
Min OA Damper Type	-	N/A
OA Enthalpy Setpt	-	N/A

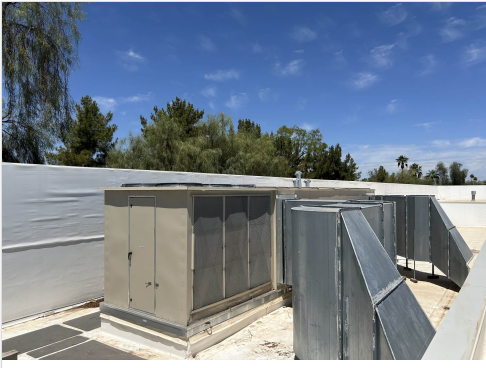
Unit Data - PHOTO LOG

Asset: AC-3

Unit Data		
	Design	Actual
MFG	CARRIER	CARRIER
Serial Num	-	4222C04700
Model Num	48HJEDD4	48FCDA04A2A6A
Type	AC	AC
Configuration	VERTICAL	VERTICAL
Num OA Filters 1	-	N/A
OA Filter Size 1	-	N/A
Num Final Filter 1	-	2
Final Filter Size 1	-	16X25X2

Test Data		
	Design	Actual
SF CFM	1000	1029
SF RPM	-	1921
RA CFM	750	1029
OA CFM	250	0
RL Voltage	-	478/477/480
RL Amperage	-	0.93/0.95/0.98
SF Rotation	-	CCW
SF System SetPt	-	C
RA Damper Position	-	N/A
Min OA Damper Position	-	N/A
Min OA Damper Type	-	N/A
OA Enthalpy Setpt	-	N/A

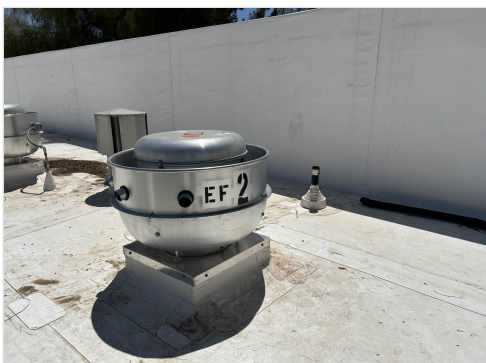
Unit Data - PHOTO LOG

Asset: EF7

Unit Data		
	Design	Actual
MFG	COOK	COOK
Model Num	135R4B	150VH17D VF 150 VCRH
Serial Num	-	296SK85095
Type	UPBLAST	UPBLAST
Configuration	VERTICAL	VERTICAL

Test Data		
	Design	Actual
CFM	1000	986
Fan RPM	-	1346
Fan Rotation	-	CCW
Motor RPM	-	1346
RL Voltage	-	119
RL Amperage	-	NA
Suction ESP	-	0.56"
Discharge ESP	-	ATMS
Total ESP	0.625"	-0.56"

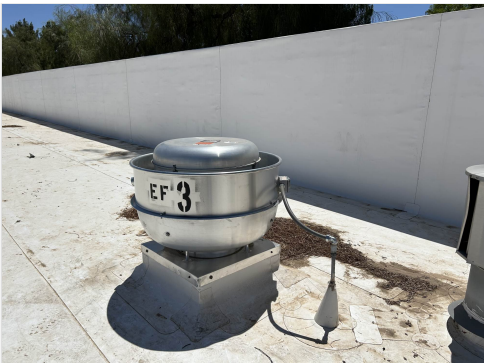
Unit Data - PHOTO LOG

Asset: EF8

Unit Data		
	Design	Actual
MFG	COOK	COOK
Model Num	135R4B	150VH17D VF 150 VCRH
Serial Num	-	296SK85095
Type	UPBLAST	UPBLAST
Configuration	VERTICAL	VERTICAL

Test Data		
	Design	Actual
CFM	1000	1037
Fan RPM	-	1211
Fan Rotation	-	CCW
Motor RPM	-	1211
RL Voltage	-	119
RL Amperage	-	NA
Suction ESP	-	0.52"
Discharge ESP	-	ATMS
Total ESP	0.625"	0.52"

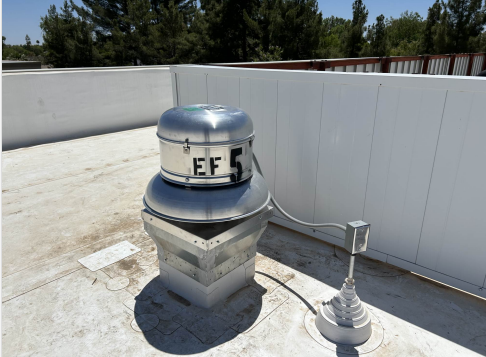
Unit Data - PHOTO LOG

Issue Name : EF-9 NOT FUNCTIONAL
Description : EF-9 not functional. Unit has 119 Volts connected to motor. Unit unable to start and be adjusted.
Created By : National TAB **Assigned To :** National TAB - Dan Hertenstein
Status : Open
Priority : Urgent **Asset Tag :**
Originated Date : 05/01/2025 - David Nicolas Sanchez - National TAB

Asset: EF9

Test Data		
	Design	Actual
CFM	100	0
Fan RPM	-	0
Fan Rotation	-	CCW
Motor RPM	-	0
System SetPt	-	0
RL Voltage	-	119
RL Amperage	-	0
Total ESP	0.125"	0
Fan Inlet SP	-	0
Fan Discharge SP	-	0
