**Report: FINAL TAB REPORT**  
**Function: Test, Adjust, & Balance**  
**Date: 08/24/2022**

**PROJECT**  
**08-15 CULVERS - WHEATON, IL**

908 E ROOSEVELT RD

WHEATON, IL

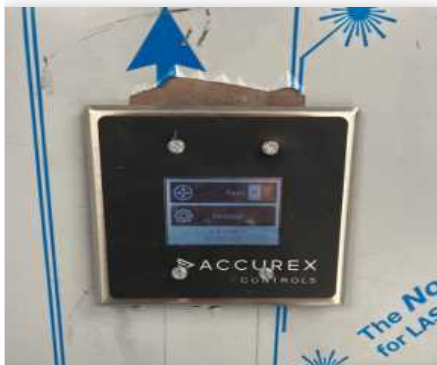
Screenshot\_2022\_09\_12...

**Issue Name :** Accurex hood control screwed through.

**Description :** Typically the hood control screen clips into the wall box. In this instance the incorrect box was installed in the wall.

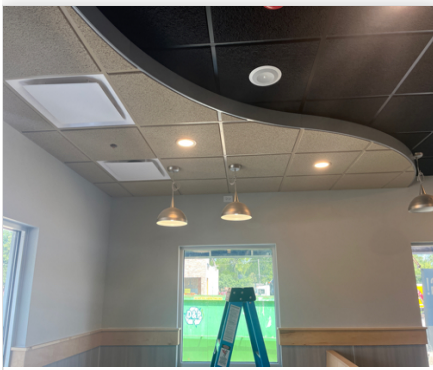
FuselTa2c618b017cc4ae...

**Issue Name :** Diffuser 1-11 in wrong location.  
**Description :** Lighting installed in ceiling tile for diffuser. Not anticipated to cause any issues.  
**Created By :** National TAB **Assigned To :** National TAB - Will Turnbough  
**Status :** Open  
**Originated Date :** 08/18/2022 - Michael McDonnell - National TAB

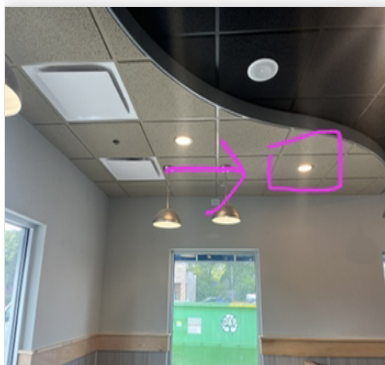
FuselTe74dfb8f877e451585d  
299e2f419c779.jpeg

- **08/19/2022**    **National TAB - Michael McDonnell**
  - Correct location.

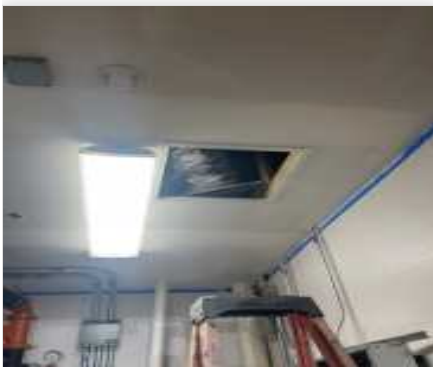
Screenshot\_2022\_09\_12...

**Issue Name :** Diffuser 2-14 has 10" neck. Plans call for 12".  
**Description :** 10"neck diffuser installed. Diffuser scheduled for 600cfm. MC installing 12-10" reducer.  
**Created By :** National TAB **Assigned To :** National TAB - Will Turnbough  
**Status :** Open  
**Originated Date :** 08/18/2022 - Michael McDonnell - National TAB

- **08/19/2022 National TAB - Michael McDonnell**
  - Diffuser is low on airflow (480/600cfm-80%) with all other diffusers within design and unit at FLA. Cannot push more air to diffuser. In mechanical room. Not anticipated to cause any issue.

Notes: [1] DIFFUSER 2-14 LOW ON AIRFLOW (480/600CFM-80%) DUE TO INCORRECT NECK SIZE. 10" INSTALLED, PLANS CALL FOR 12". REDUCER INSTALLED BEFORE NECK, CANNOT PUSH ANY MORE AIR TO DIFFUSER WITH ALL OTHER DIFFUSERS ACHIEVING DESIGN. [2] INFORMATION TAKEN FROM VFD. RECIEVED PERMISSION FROM CAPTIVE AIRE TO PUSH UNIT TO UNIT STICKER FLA (27.0A) BASED ON UNIT VOLTAGE OF 204V. [3] SERVED BY RIGHT HMI (THERMOSTAT) IN OFFICE.

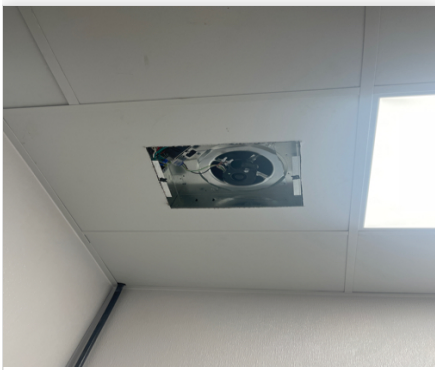
FuselT819875a6ee824c1...

**Issue Name :** EF-1A (mop room) cover not yet installed.

**Description :** EF-1A fan cover not yet in place.

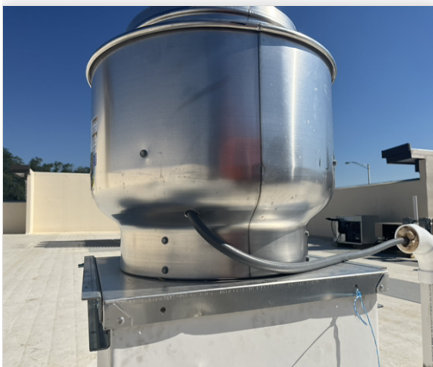
FuselT003a6a8053c74d1...

**Issue Name :** PRV-2 and PRV-3 conduit drilled through fan housing.  
**Description :** Conduit was routed/drilled through fan housing. Typically is routed through motor housing exhaust vent.  
**Created By :** National TAB **Assigned To :** National TAB - Will Turnbough  
**Status :** Closed  
**Originated Date :** 08/18/2022 - Michael McDonnell - National TAB

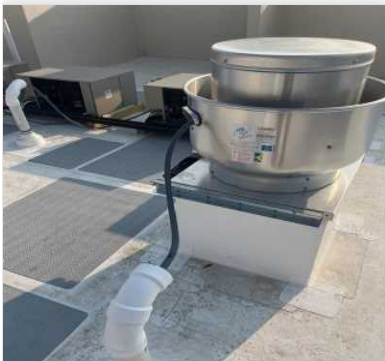
08b22576\_cb33\_4e5d\_91c3  
\_ae3b3310f44c.jpg

- **09/15/2022**    **National TAB - Michael McDonnell**
  - PROPERLY INSTALLED

- **09/15/2022**    **National TAB - Michael McDonnell**
  - ROUTED PROPERLY THROUGH MOTOR VENT

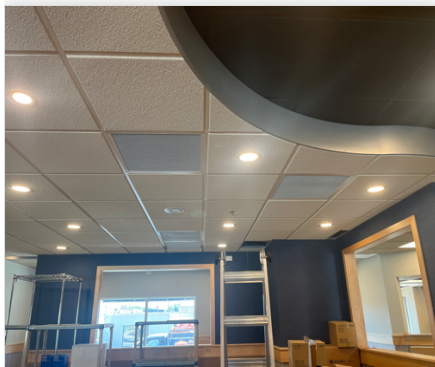
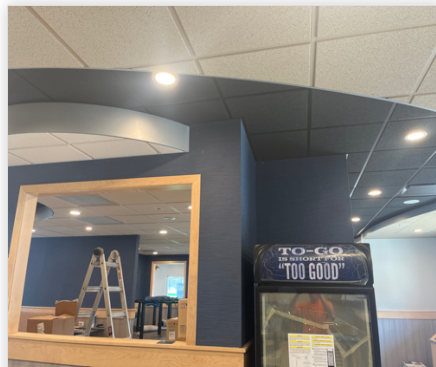
**Issue Name :** RTU-1 (dining) missing return.  
**Description :** Plans call for (5) 16" returns. (4) 18" returns are installed, and not in precise locations.  
**Created By :** National TAB **Assigned To :** National TAB - Will Turnbough  
**Status :** Open  
**Originated Date :** 08/18/2022 - Michael McDonnell - National TAB

- **08/19/2022 National TAB - Michael McDonnell**
  - Due to limited ceiling space MC increased size of returns from 16" to 18" and deleted one return grille. Unit is achieving design airflow and return not causing issues.

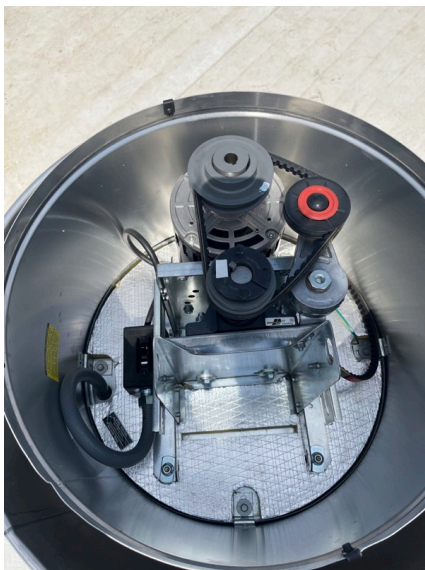
PRV-2  
Disconnect installed.

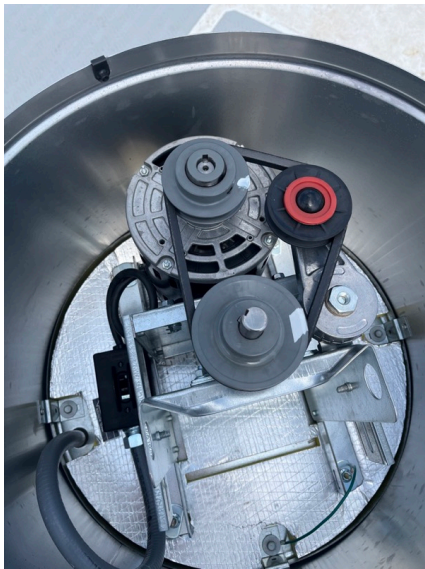
PRV-3  
Disconnect installed.

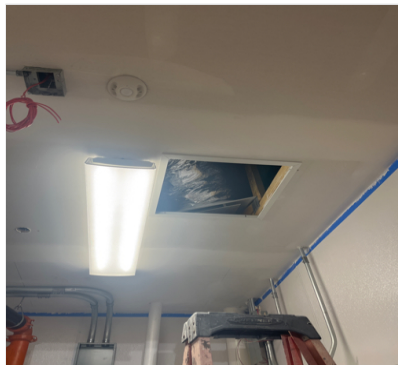
FuseITbab8411dfa26416...

Diffuser 2-14 not yet installed. 10" neck diffuser shipped to site. MC is installing a 12-10" reducer on the diffuser. RTU-1 only has 4 returns installed. Plans call for 5.

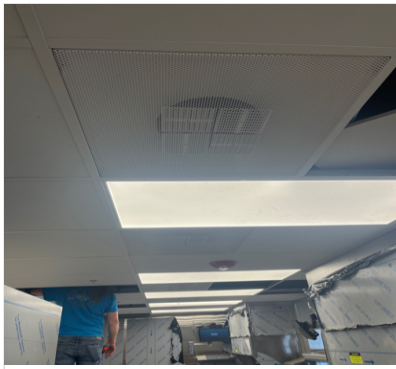
FuseITa78f7084356b4a6...

Perforated diffusers are installed on the cook line? (4-ways will disrupt hood capture)	Yes
---	-----
