**Report: TAB Report**  
**Function: Test, Adjust, & Balance**  
**Date: 03/12/2026**  
**Completed By: National TAB**

**PROJECT**  
**12-29-25 QT #1415 PHOENIX, AZ**

Project: 12-29-25 QT #1415 PHOENIX, AZ

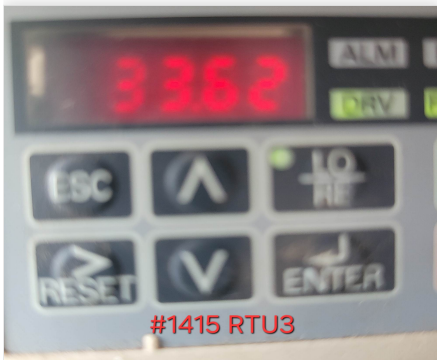
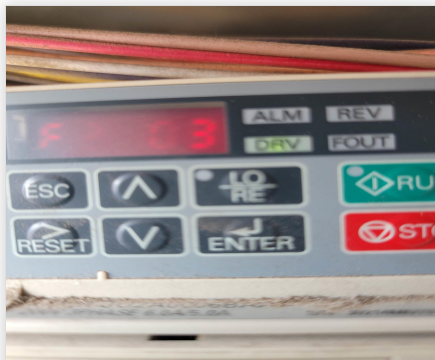
**Issue Name :** RTU3 LOW AIR FLOW, LOUD NOISE  
**Description :** Unit VFD won't stay at 38Hz unless put into LO/RE mode - even though it shows 38Hz, it was actually running at 33.62. Keeps reverting to 20.3 Hz if run w/o LO/RE. Unit is making a very loud noise. Video in files. Cannot continue TAB.  
**Created By :** National TAB                      **Assigned To :** National TAB - Dan Hertenstein  
**Status :** Open  
**Priority :** Urgent                                      **Asset Tag :** RT-3  
**Originated Date :** 01/02/2026 - Christine Weale - National TAB
