Report: TAB REPORT
Function: Test, Adjust, & Balance
Date: 09/19/2023

**09-18-23 BARTACO - WEST HARTFORD, CT
(REVIVE)**

971 Farmington Ave

Issue List

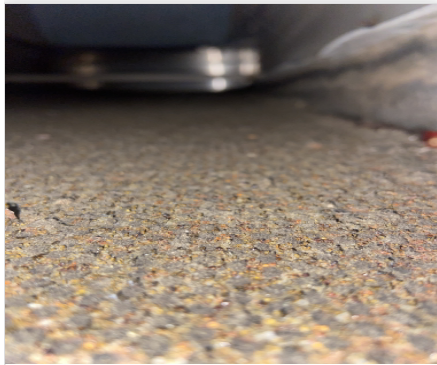
100percent-covered-in..
09/20/2023

Issue Name : CLOGGED MAU PSP(BOTH HOODS)
Description : PSP on both hoods is 100% clogged. Technician attempted to clean them out but as soon as the seal was broken dirty and debris poured out of the PSP and all over the kitchen area. These should be cleaned at night after closing so that the PSP diffusers can be pulled down and thoroughly cleaned.
Created By : National TAB **Assigned To :** National TAB - Will Turnbough
Status : Open
Originated Date : 09/20/2023 - JOASH ALBIN - National TAB

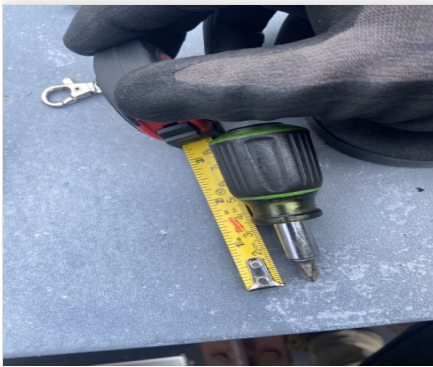
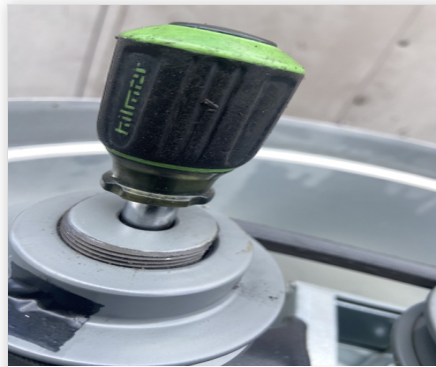
Howdeep-the-bore-is.j..
09/20/2023

Issue Name : DISH EXHAUST BORE ALIGNMENT IS OFF
Description : BORE ALIGNMENT IS OFF ON MOTOR SHEAVE, ITS LEVEL AND NOT CAUSING ANY ISSUES CURRENTLY, BUT THERE IS A 1.125" GAP BETWEEN THE TOP OF THE BORE AND THE TOP OF THE SHEAVE.

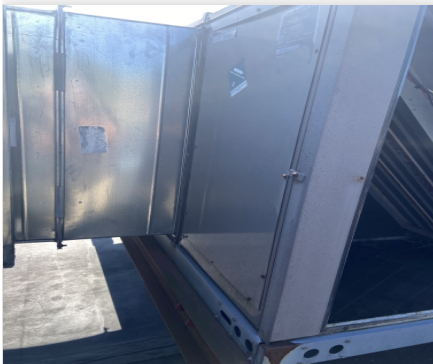
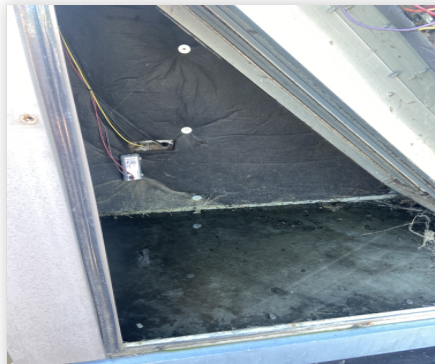
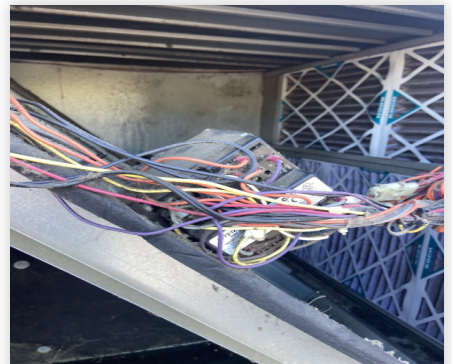
**NOOAACCESS
09/20/2023**

Issue Name : ECONMOZER for RTUs HAVE NO OA ACCESS/HOOD
Description : RTU-1, and 2 do not have OA access, economizers appear to have been installed, but have no air access preventing them from being until used. Recommend installing hood and OA FILTERS so that the units can pull in outside air to bring you building into balance.

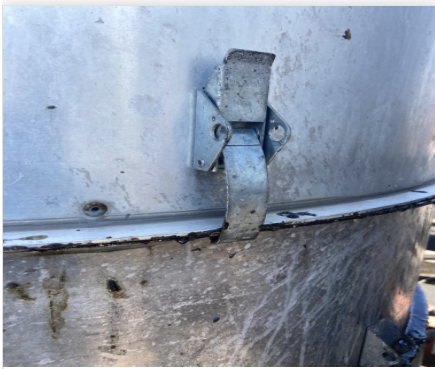
Missingbolt-screw.jpe..
09/20/2023

Issue Name : KEF-1&2 Caps not able to secured
Description : ALL CLIPS MISSING SCREWS AND BOLTS TO KEEP CAPS ON THD UNITS
Created By : National TAB **Assigned To :** National TAB - Will Turnbough
Status : Open
Originated Date : 09/20/2023 - JOASH ALBIN - National TAB

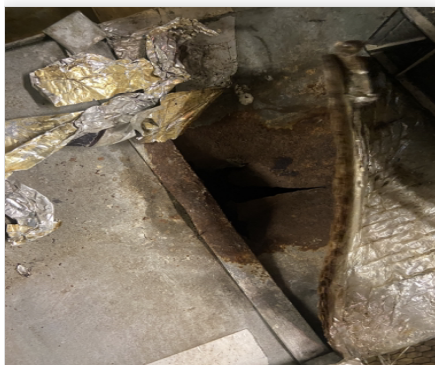
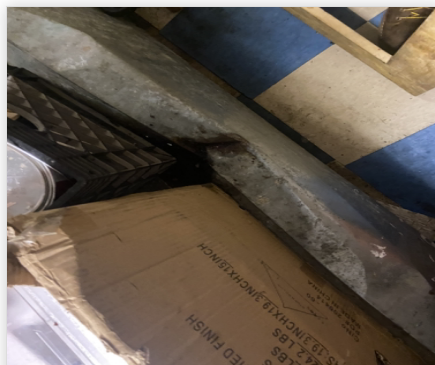
Majorhole
09/19/2023

Issue Name : MAU damaged duct work
Description : MAU has significant damage to the internal duct system. Ductwork looks like it has been used as a shelf and eventually a part of it gave way and flattened. Repairs spur to have been made, but there are small holes in bent parts of the sheet metal and a large whole that has experienced heavy damage resulting in a loss of significant air designed for the Hoods that is instead push air into the attic.
Created By : National TAB **Assigned To :** National TAB - Will Turnbough
Status : Open
Originated Date : 09/19/2023 - JOASH ALBIN - National TAB
