Report: TAB

Function: Test, Adjust, & Balance

Date: 03/05/2026

**03-02-26 CHIPOTLE #5312 RENTON, WA
(NORTH BENSON)**

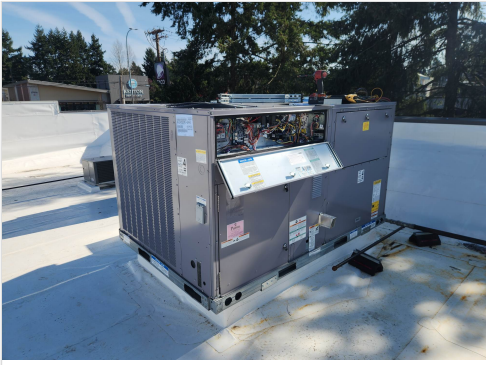
Unit Data - PHOTO LOG

Asset: RTU1

Unit Data		
	Design	Actual
MFG	CARRIER	CARRIER
Serial Num	-	0624P64345
Model Num	48FEEM09C2M5-8WAC0	48FCFN09D3M5A6
Type	RTU	RTU
Configuration	VERTICAL	VERTICAL
Num OA Filters 1	-	1
OA Filter Size 1	-	20.5X29.5
Num Final Filter 1	-	4
Final Filter Size 1	-	20X20X2
Num Final Filter 2	-	
Final Filter Size 2	-

Test Data		
	Design	Actual
SF CFM	3400	3430
SF RPM	-	1859
RA CFM	2600	2641
OA CFM	800	789
RL Voltage	-	208/208/208
RL Amperage	-	5.85/5.85/5.85
SF Rotation	-	CCW
SF System SetPt	-	6.8VDC
RA Damper Position	-	75%
Min OA Damper Position	-	25%
Min OA Damper Type	-	MOTORIZED
OA Enthalpy Setpt	-	ES5

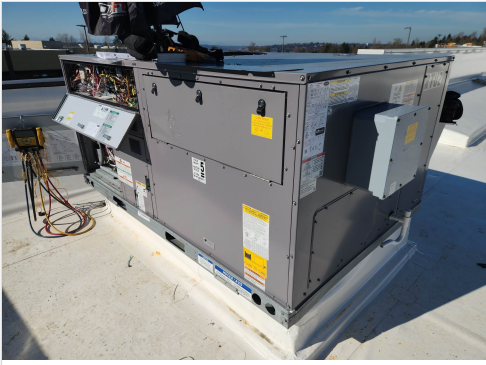
Unit Data - PHOTO LOG

Asset: RTU2

Unit Data		
	Design	Actual
MFG	CARRIER	CARRIER
Serial Num	-	3225P61701
Model Num	48FEEM08C2M5-8WAC0	48FEEM08C2M5A8
Type	RTU	RTU
Configuration	VERTICAL	VERTICAL
Num OA Filters 1	-	1
OA Filter Size 1	-	35X19
Num Final Filter 1	-	4
Final Filter Size 1	-	20X20X2
Num Final Filter 2	-	
Final Filter Size 2	-

Test Data		
	Design	Actual
SF CFM	3000	3172
SF RPM	-	1601
RA CFM	2300	2483
OA CFM	700	689
RL Voltage	-	208/208/208
RL Amperage	-	5.1/5.1/5.1
SF Rotation	-	CCW
SF System SetPt	-	6.3VDC
RA Damper Position	-	75%
Min OA Damper Position	-	25%
Min OA Damper Type	-	MOTORIZED
OA Enthalpy Setpt	-	N/A

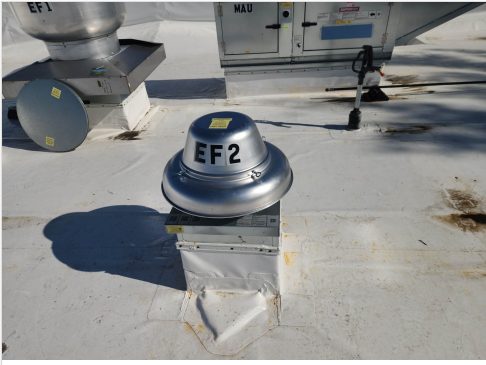
Unit Data - PHOTO LOG

Asset: EF2

Unit Data		
	Design	Actual
MFG	CAPTIVEAIRE	CAPTIVEAIRE
Model Num	DR12HFA	DR12HFA
Serial Num	-	7391706
Type	DOWNBLAST	DOWNBLAST
Configuration	VERTICAL	VERTICAL

Test Data		
	Design	Actual
CFM	150	150
Fan RPM	1293	1288
Fan Rotation	-	CCW
Motor RPM	-	1288
System SetPt	-	69%
RL Voltage	-	NA
RL Amperage	-	NA
Total ESP	0.600"	0.45"
Fan Inlet SP	-	-0.45"
Fan Discharge SP	-	ATM

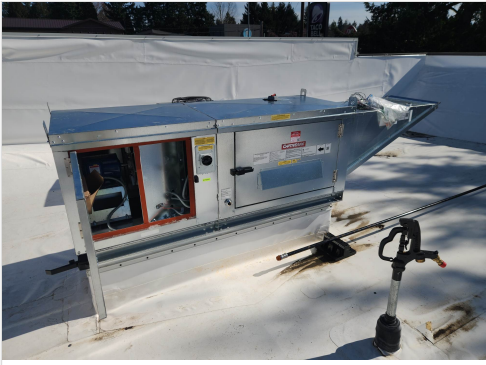
Unit Data - PHOTO LOG

Asset: MAU1

Unit Data		
	Design	Actual
MFG	CAPTIVEAIRE	CAPTIVEAIRE
Model Num	A1-D.250-15D	A1-D.250-15D
Serial Num	-	7391706
Type	MAU	MAU
Configuration	VERTICAL	VERTICAL

Test Data		
	Design	Actual
CFM	1300	1336
SF RPM	1551	1687
Motor RPM	-	1687
SF System SetPt	-	58.2HZ
RL Voltage	-	212/212/212
RL Amperage	-	2.95/2.95/2.95
Total ESP	-	NA
Fan Discharge SP	-	NA
