**Report: TAB Report**  
**Function: Test, Adjust, & Balance**  
**Date: 07/09/2025**  
**Completed By: National TAB**

## 07-07-25 ALBERTSONS #1662 PEORIA, AZ

10641 W OLIVE AVE

Project: 07-07-25 ALBERTSONS #1662 PEORIA, AZ

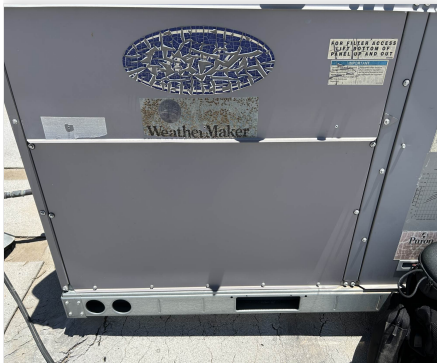
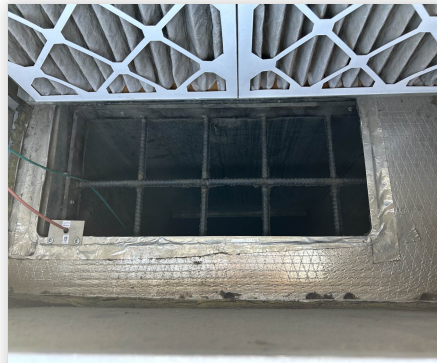
**Issue Name :** AC-4 NO OUTSIDE AIR VENT INSTALLED  
**Description :** AC-1 has no OA vent installed. Unable to set outside air. Recommend installing OA vent.  
**Created By :** National TAB                      **Assigned To :** National TAB - Will Turnbough  
**Status :** Open  
**Priority :** Medium                                      **Asset Tag :**  
**Originated Date :** 07/09/2025 - David Nicolas Sanchez - National TAB

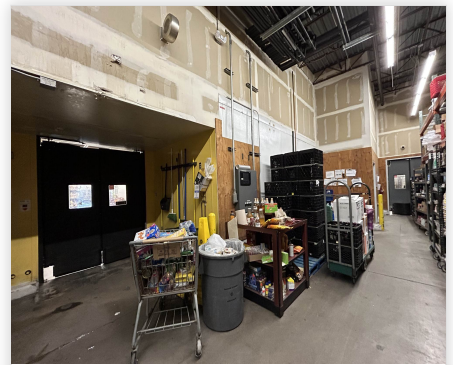
**Issue Name :** EF-8 NOT FUNCTIONAL  
**Description :** EF-8 is not functional and unable to be powered on. Unable to locate janitorial room and appears to be removed.  
**Created By :** National TAB                      **Assigned To :** National TAB - Will Turnbough  
**Status :** Open  
**Priority :** Medium                                      **Asset Tag :**  
**Originated Date :** 07/09/2025 - David Nicolas Sanchez - National TAB

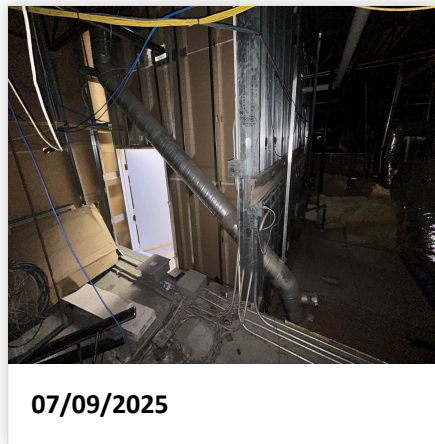
**Issue Name :** UNABLE TO LOCATE EF-7  
**Description :** Unable to locate EF-7. Employee restroom has been removed. Space does not exist.  
**Created By :** National TAB                      **Assigned To :** National TAB - Will Turnbough  
**Status :** Open  
**Priority :** Medium                                      **Asset Tag :**  
**Originated Date :** 07/09/2025 - David Nicolas Sanchez - National TAB

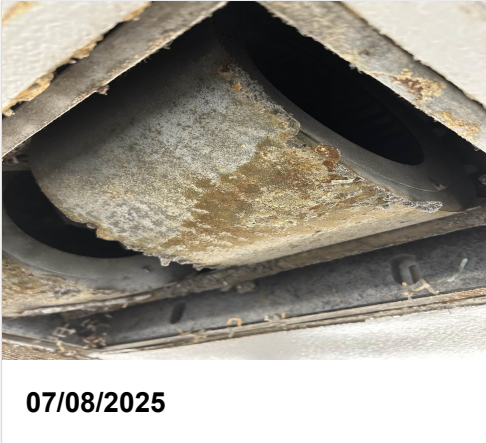
Notes:  
Unit is not operational. Unable to power on. Unit appears to be corroded. Recommend service or replacing.
