**Report: TAB Report**  
**Function: Test, Adjust, & Balance**  
**Date: 07/09/2025**  
**Completed By: National TAB**

## 07-07-25 ALBERTSONS #1662 PEORIA, AZ

10641 W OLIVE AVE

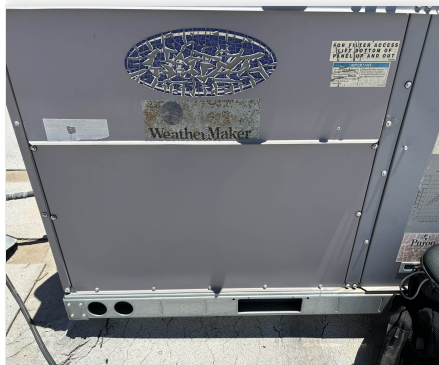
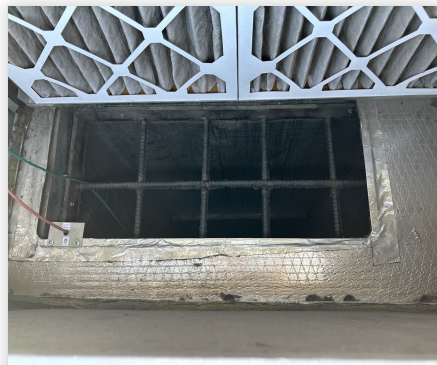
**Issue Name :** AC-4 NO OUTSIDE AIR VENT INSTALLED  
**Description :** AC-1 has no OA vent installed. Unable to set outside air. Recommend installing OA vent.  
**Created By :** National TAB                      **Assigned To :** National TAB - Will Turnbough  
**Status :** Open  
**Priority :** Medium                                      **Asset Tag :**  
**Originated Date :** 07/09/2025 - David Nicolas Sanchez - National TAB

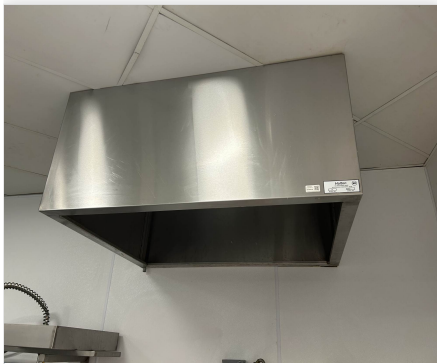
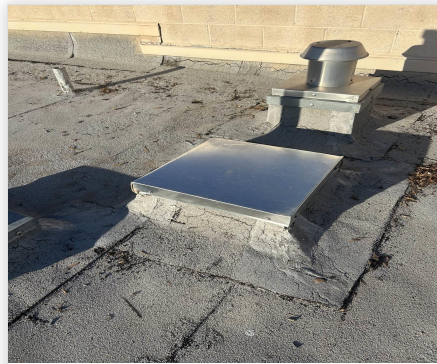
**Issue Name :** EF-2 ABANDONED  
**Description :** Unable to locate EF-2. Unit has been abandoned or removed.  
**Created By :** National TAB                      **Assigned To :** National TAB - Will Turnbough  
**Status :** Open  
**Priority :** InfoOnly                                      **Asset Tag :**  
**Originated Date :** 07/09/2025 - David Nicolas Sanchez - National TAB

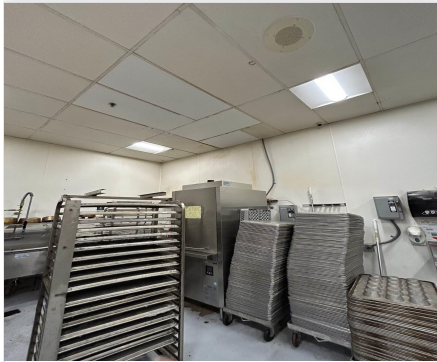
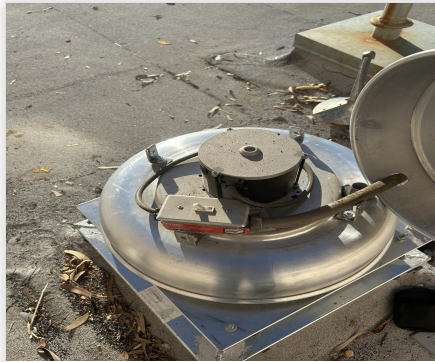
**Issue Name :** EF-3 NOT FUNCTIONAL  
**Description :** EF-3 is not functional. Unable to power up unit. Unit appears to be abandoned.  
**Created By :** National TAB                      **Assigned To :** National TAB - Will Turnbough  
**Status :** Open  
**Priority :** Medium                                      **Asset Tag :**  
**Originated Date :** 07/09/2025 - David Nicolas Sanchez - National TAB

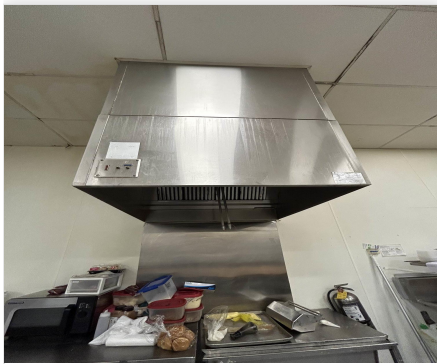
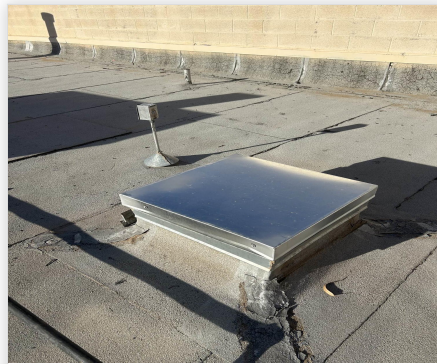
**Issue Name :** EF-4 ABANDONED  
**Description :** EF-4 has been abandoned. Unable to locate unit on rooftop.  
**Created By :** National TAB                      **Assigned To :** National TAB - Will Turnbough  
**Status :** Open  
**Priority :** InfoOnly                                      **Asset Tag :**  
**Originated Date :** 07/09/2025 - David Nicolas Sanchez - National TAB

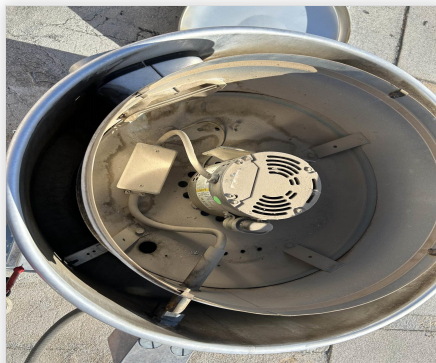
**Issue Name :** EF-5 & 6 SPEED CONTROLLER NOT INSTALLED  
**Description :** Speed controller not installed. Units are high on airflow but unable to change fan speed. Recommend installing speed controller to lower airflow.  
**Created By :** National TAB                      **Assigned To :** National TAB - Will Turnbough  
**Status :** Open  
**Priority :** **Medium**                                      **Asset Tag :**  
**Originated Date :** 07/09/2025 - David Nicolas Sanchez - National TAB

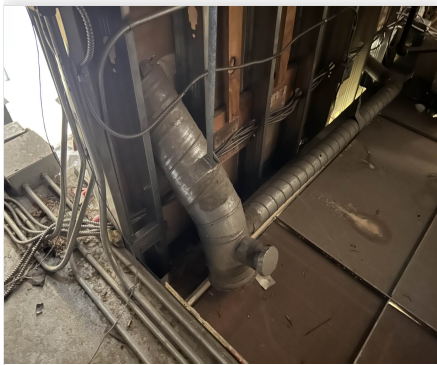
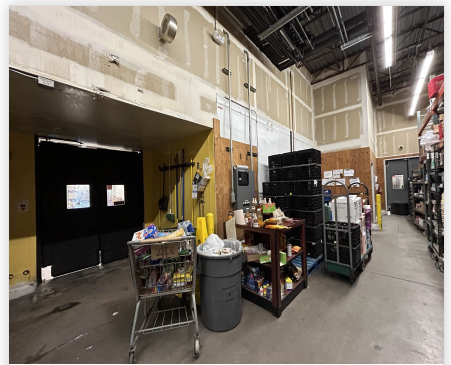
**Issue Name :** EF-8 NOT FUNCTIONAL  
**Description :** EF-8 is not functional and unable to be powered on. Unable to locate janitorial room and appears to be removed.  
**Created By :** National TAB                      **Assigned To :** National TAB - Will Turnbough  
**Status :** Open  
**Priority :** Medium                                      **Asset Tag :**  
**Originated Date :** 07/09/2025 - David Nicolas Sanchez - National TAB

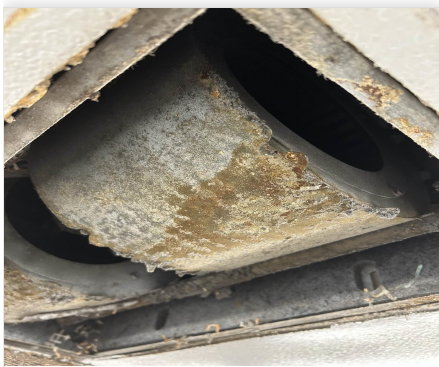
**Issue Name :** EF-9 NOT FUNCTIONAL  
**Description :** Unit is not operational appears to be corroded. Unable to power on. Recommend service or replacing.  
**Created By :** National TAB                      **Assigned To :** National TAB - Will Turnbough  
**Status :** Open  
**Priority :** Medium                                      **Asset Tag :**  
**Originated Date :** 07/09/2025 - David Nicolas Sanchez - National TAB

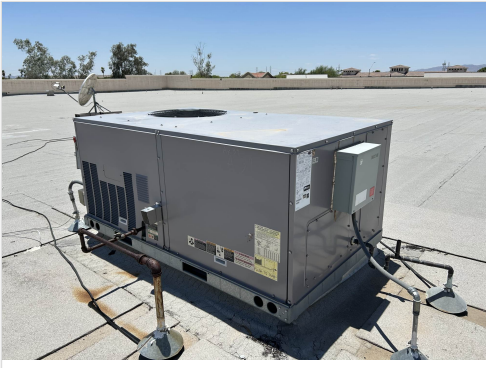
Asset: AC4

Notes:  
No OA vent installed. Unable to set outside air.

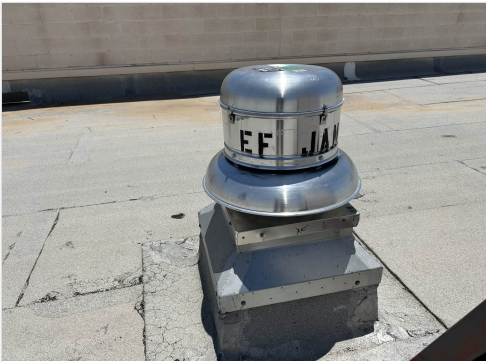
### Unit Data - PHOTO LOG

Notes:  
Unit is not operational. Unable to power on. Unit appears to be corroded. Recommend service or replacing.
