Report: TAB Report
Function: Test, Adjust, & Balance
Date: 07/09/2025
Completed By: National TAB

07-07-25 ALBERTSONS #1662 PEORIA, AZ

Project Summary

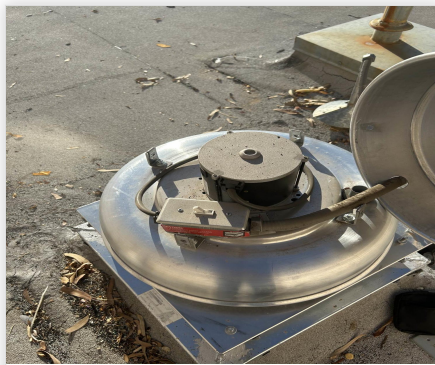
Issue Name : EF-3 NOT FUNCTIONAL
Description : EF-3 is not functional. Unable to power up unit. Unit appears to be abandoned.
Created By : National TAB **Assigned To :** National TAB - Will Turnbough
Status : Open
Priority : Medium **Asset Tag :**
Originated Date : 07/09/2025 - David Nicolas Sanchez - National TAB

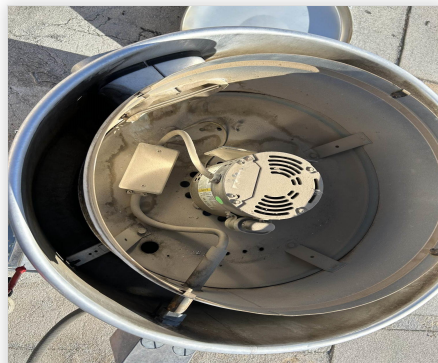
Issue Name : EF-5 & 6 SPEED CONTROLLER NOT INSTALLED
Description : Speed controller not installed. Units are high on airflow but unable to change fan speed. Recommend installing speed controller to lower airflow.
Created By : National TAB **Assigned To :** National TAB - Will Turnbough
Status : Open
Priority : Medium **Asset Tag :**
Originated Date : 07/09/2025 - David Nicolas Sanchez - National TAB

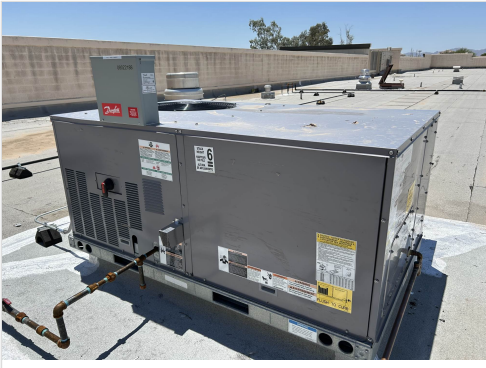
Asset: AC2

Notes:
Balanced base on tonnage. 3 ton unit = 1200 CFM.

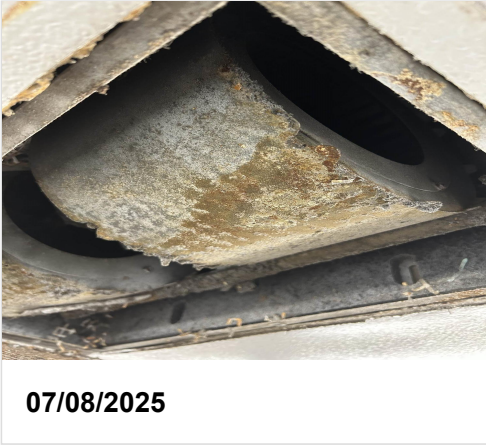
Unit is not operational. Unable to power on. Unit appears to be corroded. Recommend service or replacing.
