Report: TAB REPORT
Function: Test, Adjust, & Balance
Date: 11/07/2024
Completed By: National TAB

PROJECT
Daybreak Market Wesley Chapel, FL

Scope for the Daybreak Market in Wesley Chapel is to balance (1) RTU, (1) EF, and all associated air devices. Reason for the visit is to address concerns of negative building pressure and to ensure the equipment is properly balanced.

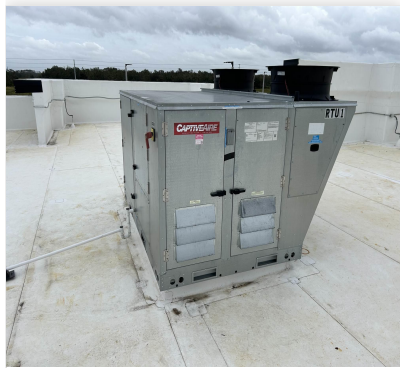
RTU 1 PICTURE

Initially the RTU was found running 50HZ and the airflow was measured as 4735 CFM (73% of design). The mechanical contractor indicated that there had been an issue in the past where the RTU had tripped off. The supply fan VFD had been set to 60 Hz which caused it to overamp and trip off. To keep the unit running they had set to 50Hz.

Fan speed was increased to 57Hz and at this speed the airflow was 89% of design. At 58Hz, the airflow was at and sometimes exceeding the full load rating of the motor. Left at 57 Hz to prevent the unit from tripping off again.

Total supply airflow is 89% design. Fan speed cannot be increased further without overramping.

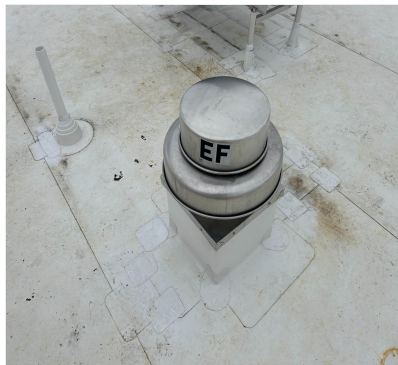
EHAUST FAN PIC.

The exhaust fan was initially found operating at 660 CFM (146% of design). This was reduced and balanced to 444 CFM (98% of design).

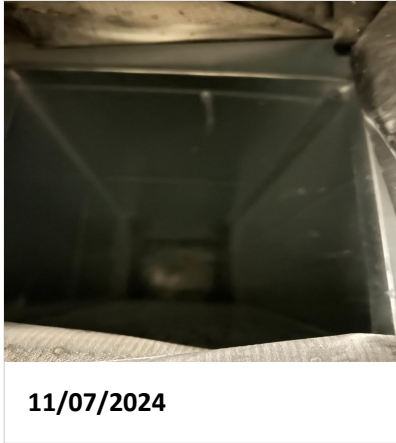
For restroom fan(s) is the back draft damper installed and can it fully open?

No

Not Installed

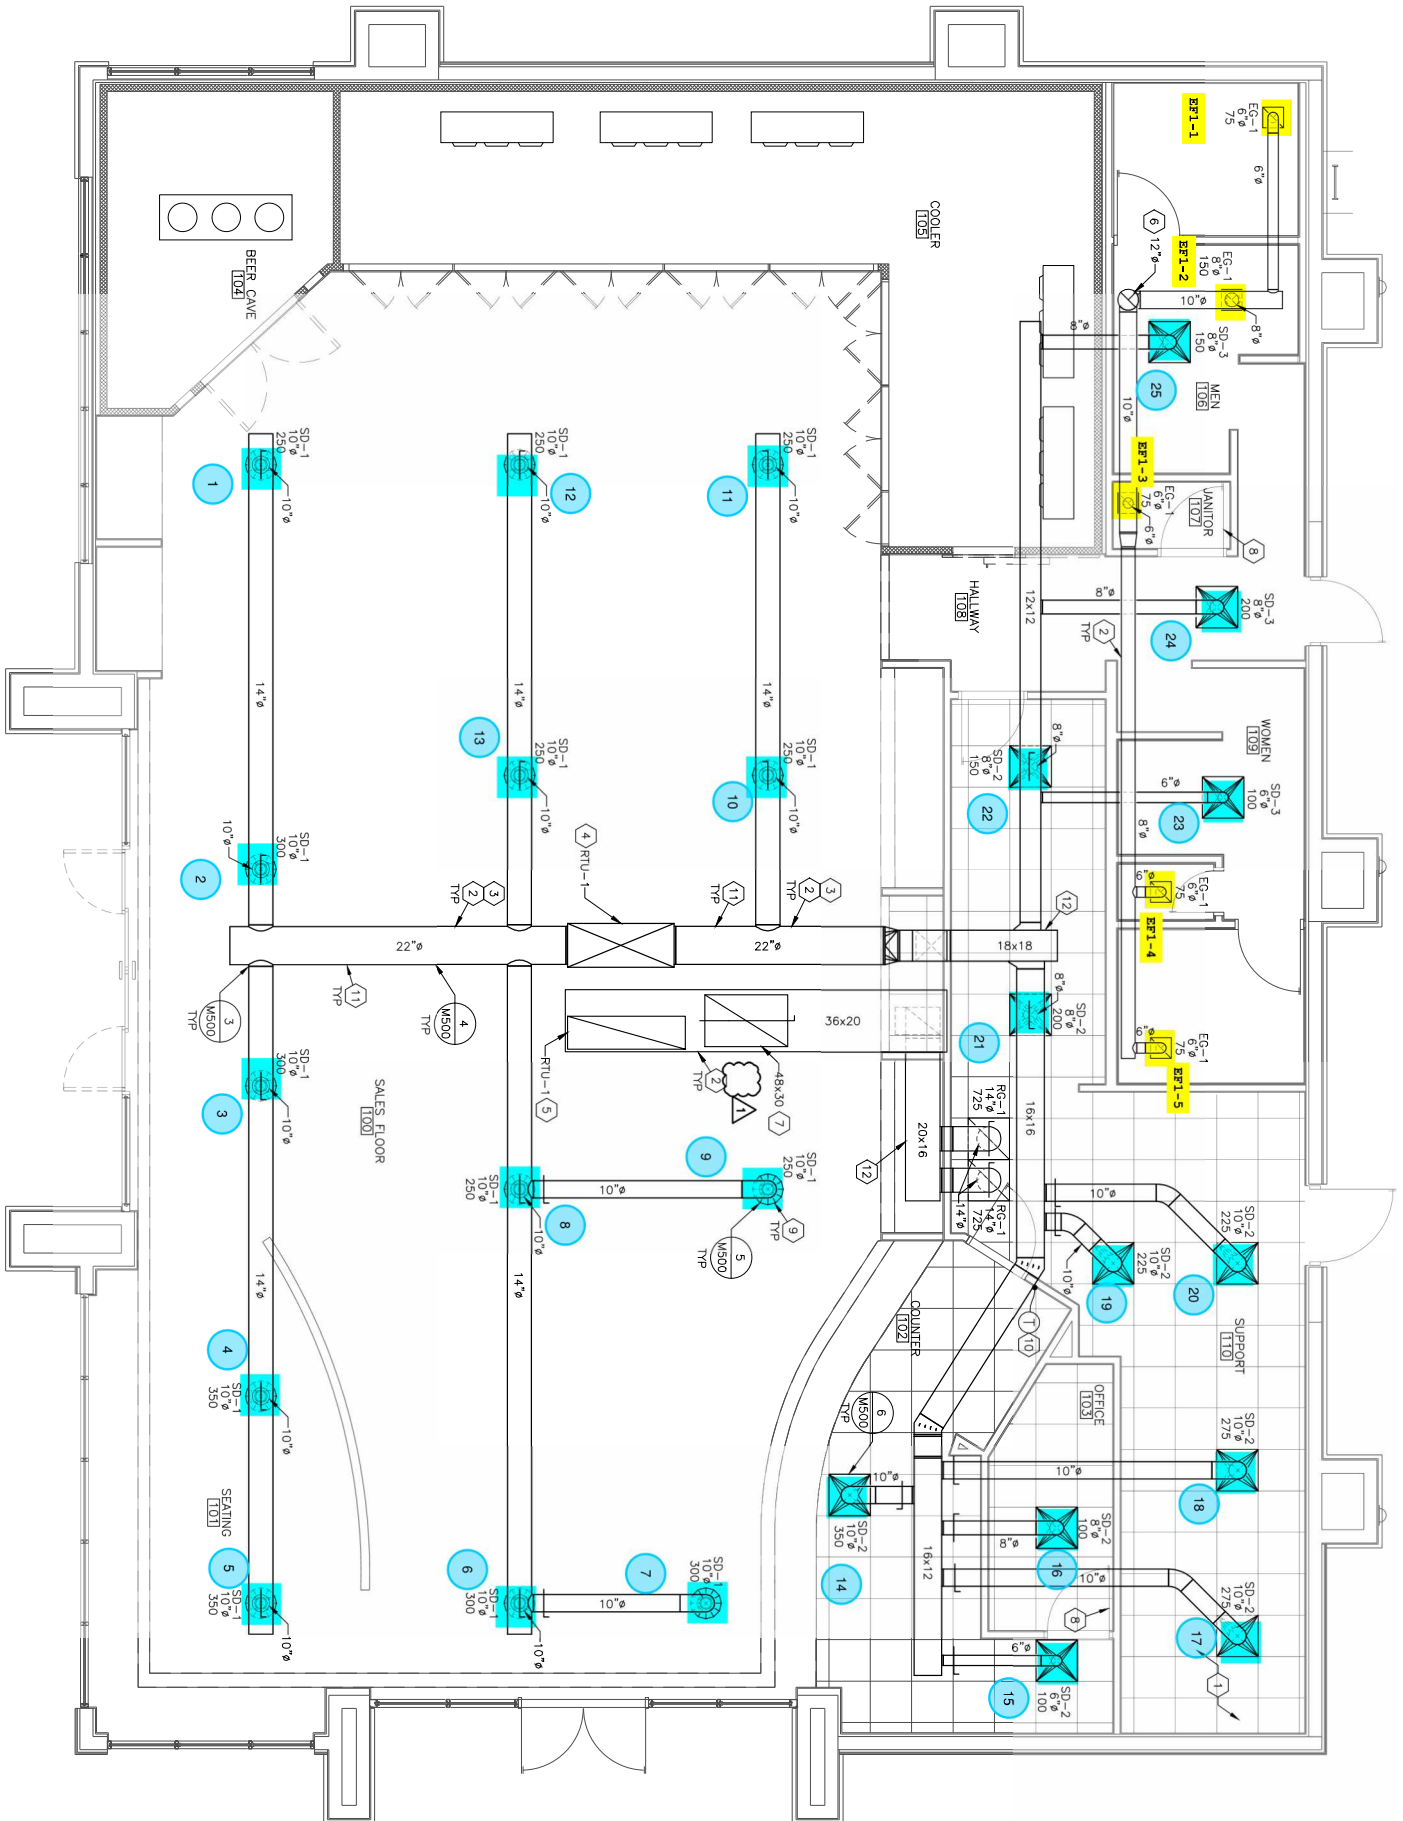
MECHANICAL PLAN

The diffusers are unbalanced and the airflow to the employee areas is low. There is a branch damper that was found that is not on the plans and it was confirmed to be fully open. Also verified that all individual volume dampers are fully open. Unable to push air to the employee area without dropping the total flow below design and being a possible detriment to the overall unit performance.

Asset	Notes	Date	Written By
SGRD15	Verified all diffusers in employee area were fully open. Unable to push air to them without reducing total airflow below design and being a detriment to the overall unit performance.	11/07/2024	Will Turnbough
