Report: TAB REPORT
Function: Test, Adjust, & Balance
Date: 11/07/2024
Completed By: National TAB

PROJECT
Daybreak Market Wesley Chapel, FL

Project: Daybreak Market Wesley Chapel, FL

Scope for the Daybreak Market in Wesley Chapel is to balance (1) RTU, (1) EF, and all associated air devices. Reason for the visit is to address concerns of negative building pressure and to ensure the equipment is properly balanced.

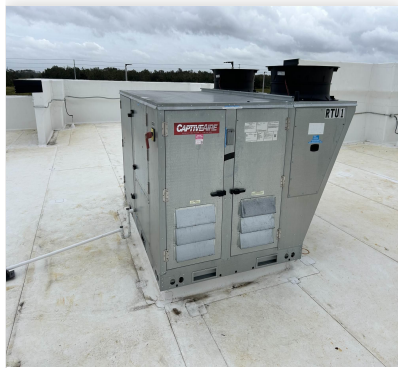
RTU 1 PICTURE

Total supply airflow is 89% design. Fan speed cannot be increased further without overramping.

Fan speed was increased to 57Hz and at this speed the airflow was 89% of design. At 58Hz, the airflow was at and sometimes exceeding the full load rating of the motor. Left at 57 Hz to prevent the unit from tripping off again.

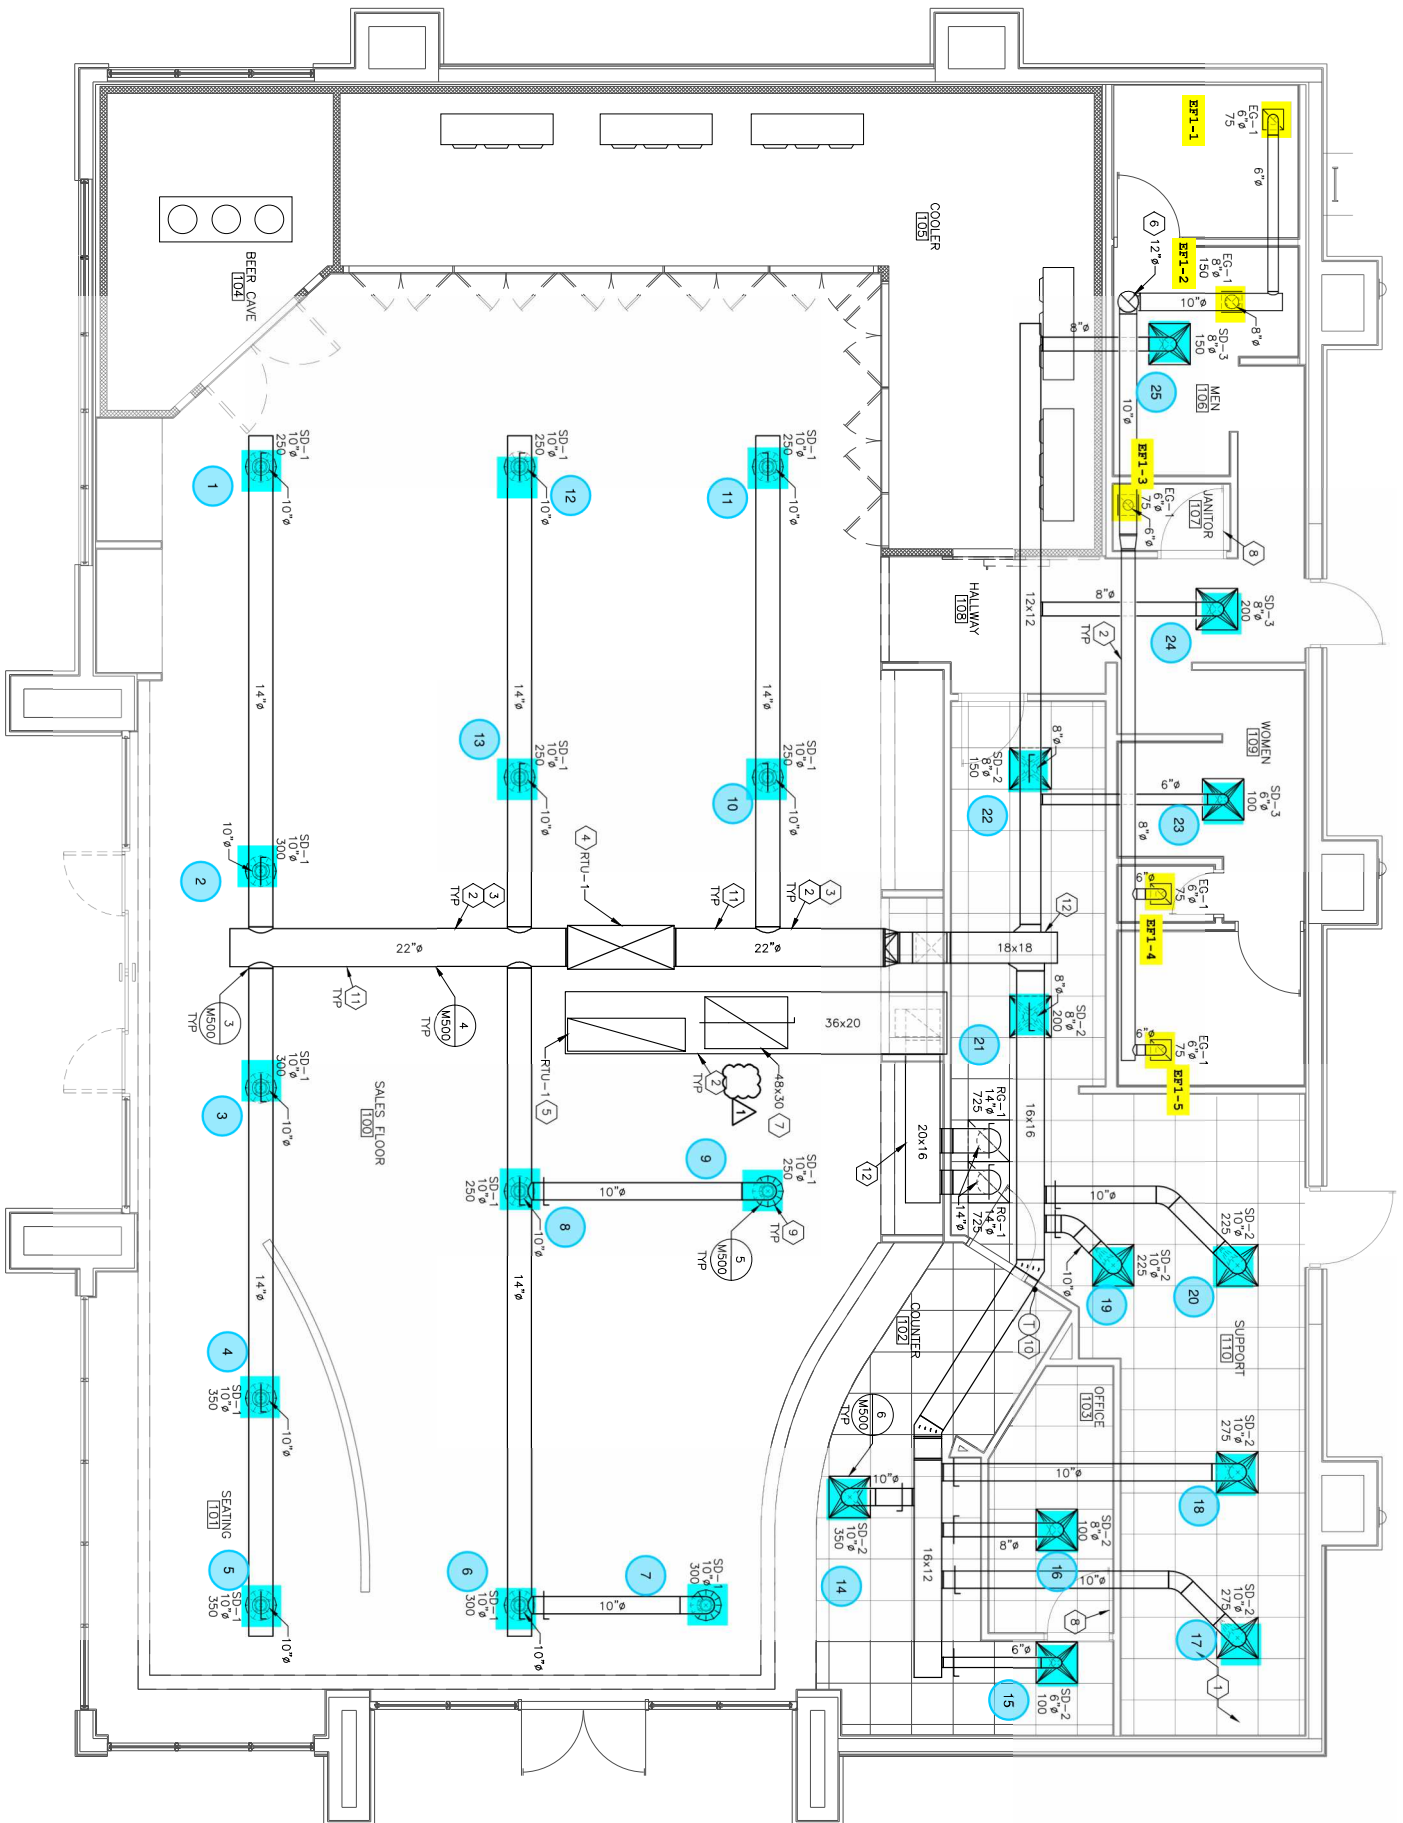
MECHANICAL PLAN

The diffusers are unbalanced and the airflow to the employee areas is low. There is a branch damper that was found that is not on the plans and it was confirmed to be fully open. Also verified that all individual volume dampers are fully open. Unable to push air to the employee area without dropping the total flow below design and being a possible detriment to the overall unit performance.

Asset	Notes	Date	Written By
SGRD15	Verified all diffusers in employee area were fully open. Unable to push air to them without reducing total airflow below design and being a detriment to the overall unit performance.	11/07/2024	Will Turnbough
