**Report: TAB Report**  
**Function: Test, Adjust, & Balance**  
**Date: 12/04/2025**  
**Completed By: National TAB**

## 11-24-25 WAWA #7207 CINCINNATI, OH

5308 Fields Ertel Rd

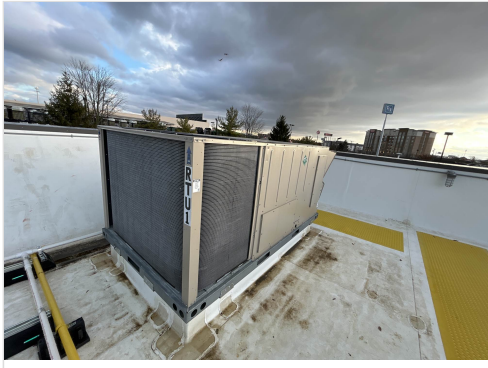
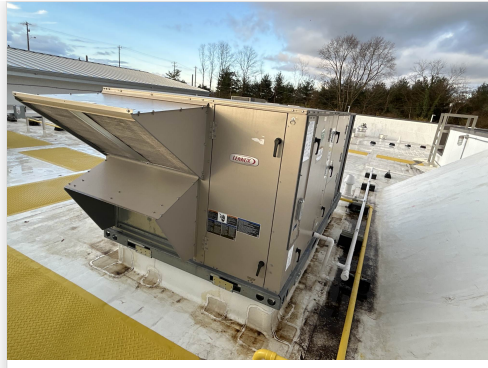
## Unit Data - PHOTO LOG

Asset: RTU1

AREA:BOH

Unit Data		
	Design	Actual
MFG	LENNOX	LENNOX
Serial Num	-	5624J00867
Model Num	LCT150H4E	LCT150H4E
Type	RTU	RTU
Configuration	VERTICAL	VERTICAL
Num OA Filters 1	-	2
OA Filter Size 1	-	16"x25"
Num Final Filter 1	-	4
Final Filter Size 1	-	20"x25"x2"

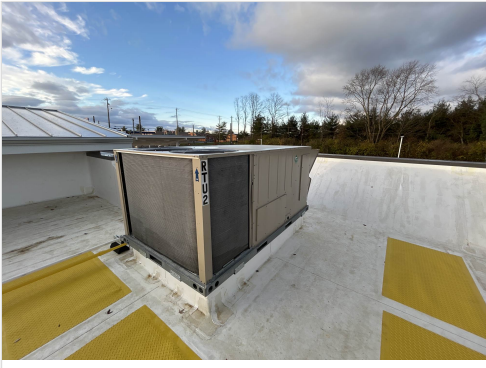
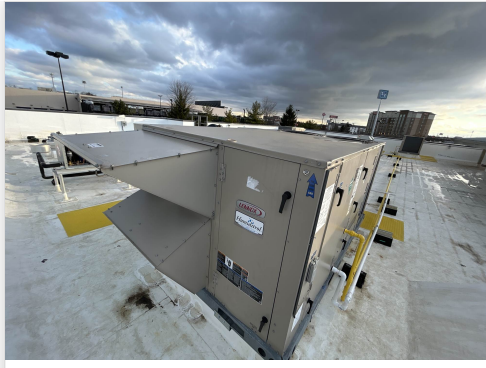
## Unit Data - PHOTO LOG

Asset: RTU2

AREA:SALES

Unit Data		
	Design	Actual
MFG	LENNOX	LENNOX
Serial Num	-	5624L01992
Model Num	LGT102H4E	LGT102H4E
Type	RTU	RTU
Configuration	VERTICAL	VERTICAL
Num OA Filters 1	-	2
OA Filter Size 1	-	16"x25"
Num Final Filter 1	-	4
Final Filter Size 1	-	20"x25"x2"

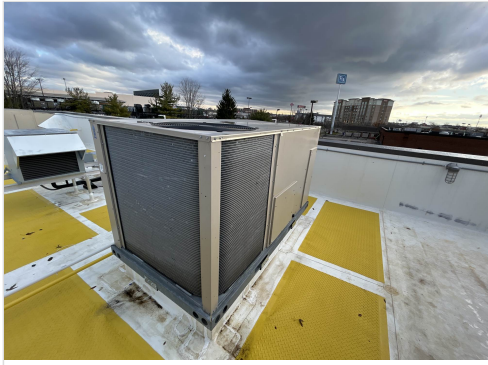
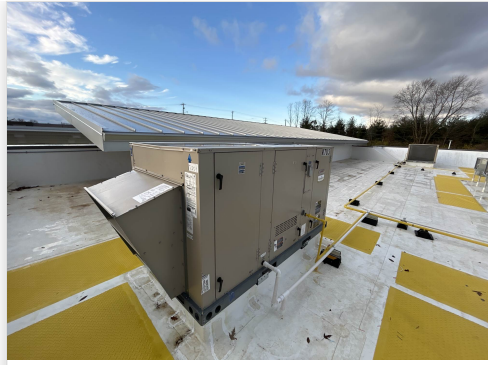
## Unit Data - PHOTO LOG

Asset: RTU3

AREA:FOH

Unit Data		
	Design	Actual
MFG	LENNOX	LENNOX
Serial Num	-	5624L06390
Model Num	LGT072H4E	LGT072H4E
Type	RTU	RTU
Configuration	VERTICAL	VERTICAL
Num OA Filters 1	-	1
OA Filter Size 1	-	31"x16"
Num Final Filter 1	-	4
Final Filter Size 1	-	20"X20"X2"

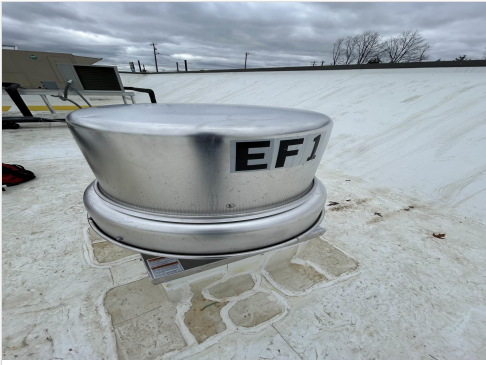
## Unit Data - PHOTO LOG

Asset: EF1

AREA:RESTROOMS

Unit Data		
	Design	Actual
<b>MFG</b>	GREENHECK	GREENHECK
<b>Model Num</b>	GB-098-6	GB-098-6-1-19-X
<b>Serial Num</b>	-	26715587
<b>Type</b>	DOWNBLAST	DOWNBLAST
<b>Configuration</b>	VERTICAL	VERTICAL

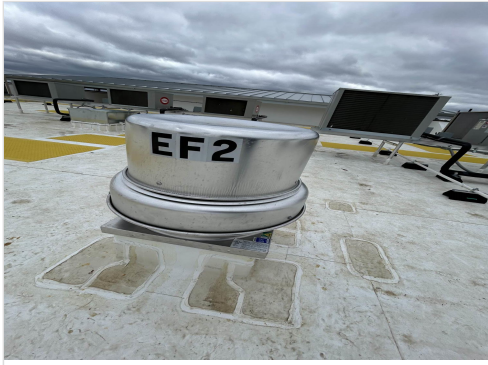
## Unit Data - PHOTO LOG

Asset: EF2

AREA:BOH

Unit Data		
	Design	Actual
MFG	GREENHECK	GREENHECK
Model Num	GB-098-6	GB-098-6-1-19-X
Serial Num	-	26715588
Type	DOWNBLAST	DOWNBLAST
Configuration	VERTICAL	VERTICAL
