**Report: TAB Report
Function: Test, Adjust, & Balance
Date: 04/05/2023**

Coconut Grove - Kings Island

Project: Coconut Grove - Kings Island

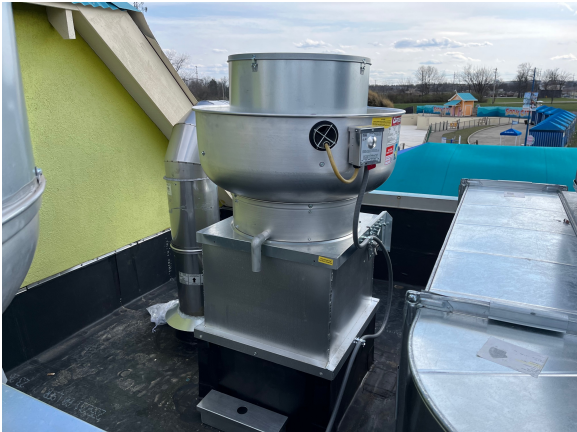
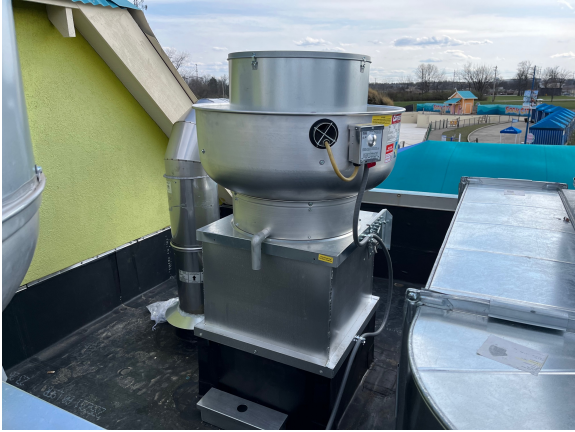
KEF 7

Test Data		
	Design	Actual
CFM	3000	2175
Fan RPM	1119	811
Fan Rotation	-	CCW
Motor RPM	-	1150
System SetPt	-	35 HZ
RL Voltage	-	208
RL Amperage	-	6.1
Total ESP	-	0.75"
Fan Inlet SP	-	-0.75"
Fan Discharge SP	-	ATM

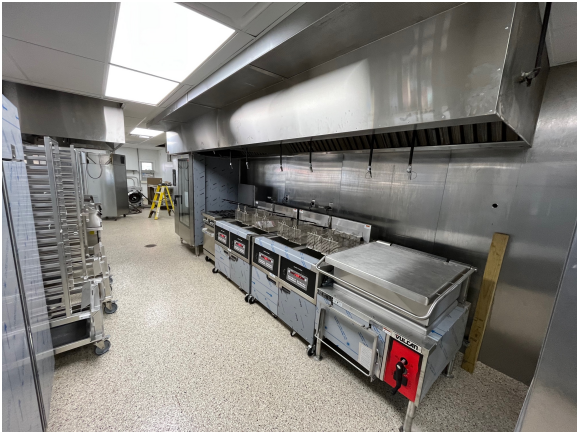
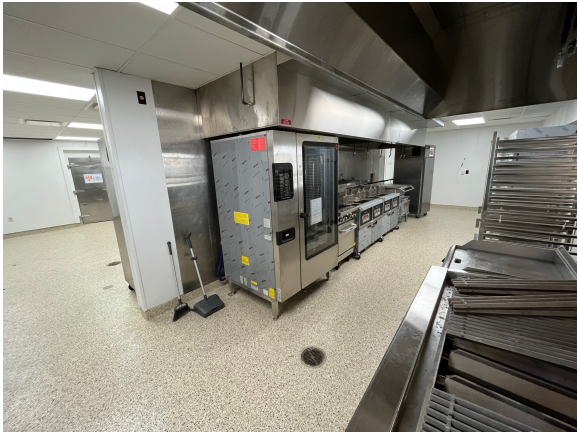
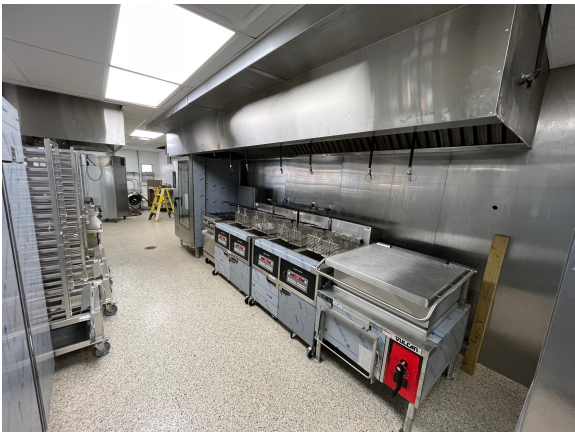
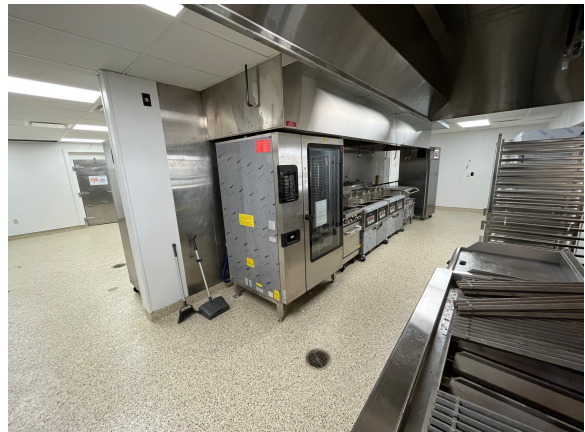
MAIN HOOD

Test Data Exhaust		
	Design	Actual
Filter Type	BAFFLE	BAFFLE
Filter Size 1	-	20X20
Filter Qty 1	-	5
Filter AK factor size 1	-	2.68
Filter Total AK Area	-	13.4
Filter1 FPM	-	143
Filter2 FPM	-	151
Filter3 FPM	-	168
Filter4 FPM	-	155
Filter5 FPM	-	156
Filter Ave FPM(corr)	-	155
CFM	2150	2077

Test Data Supply		
	Design	Actual
Total AK Area	-	10.20
Kv factor (Vel)	-	0.87
Num of Readings	-	12
Reading1 FPM	-	161
Reading2 FPM	-	154
Reading3 FPM	-	111
Reading4 FPM	-	116
Reading5 FPM	-	118
Reading6 FPM	-	129
Reading7 FPM	-	145
Reading8 FPM	-	144
Reading9 FPM	-	111
Reading10 FPM	-	121
Reading11 FPM	-	144
Reading12 FPM	-	133
Reading13 FPM	-	
Reading14 FPM	-	
Ave FPM(corr)	-	132
CFM	1400	1174

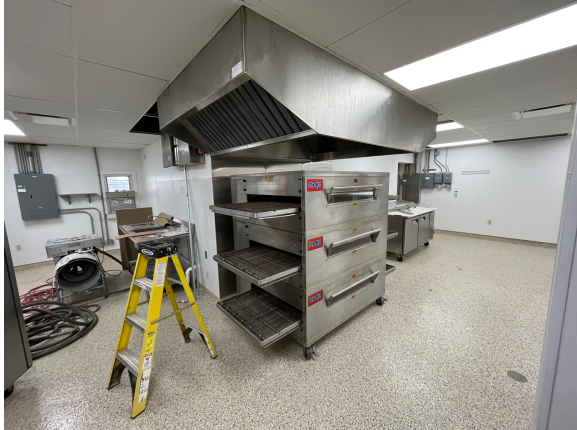
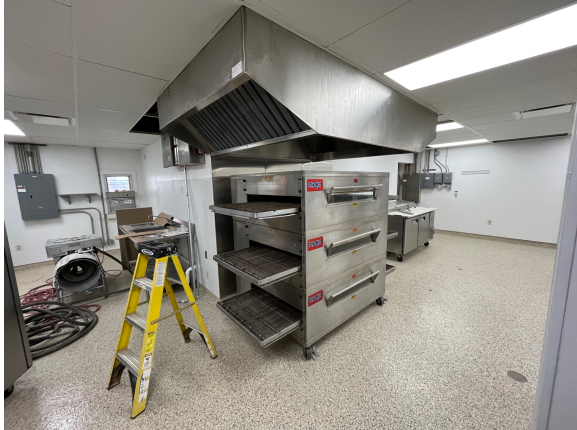
PIZZA HOOD

Test Data		
	Design	Actual
Exhaust CFM	3000	2175

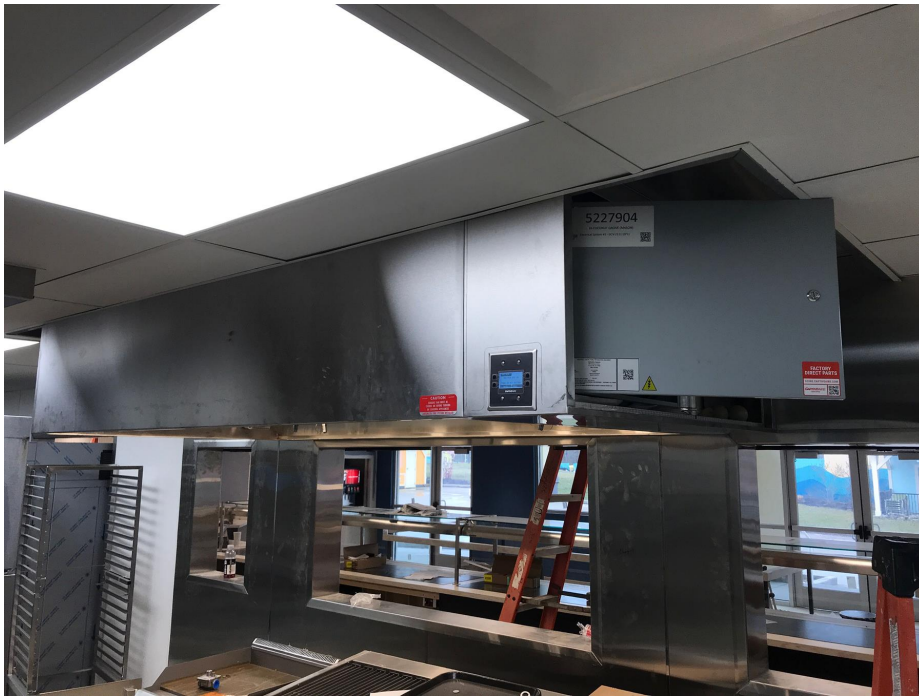
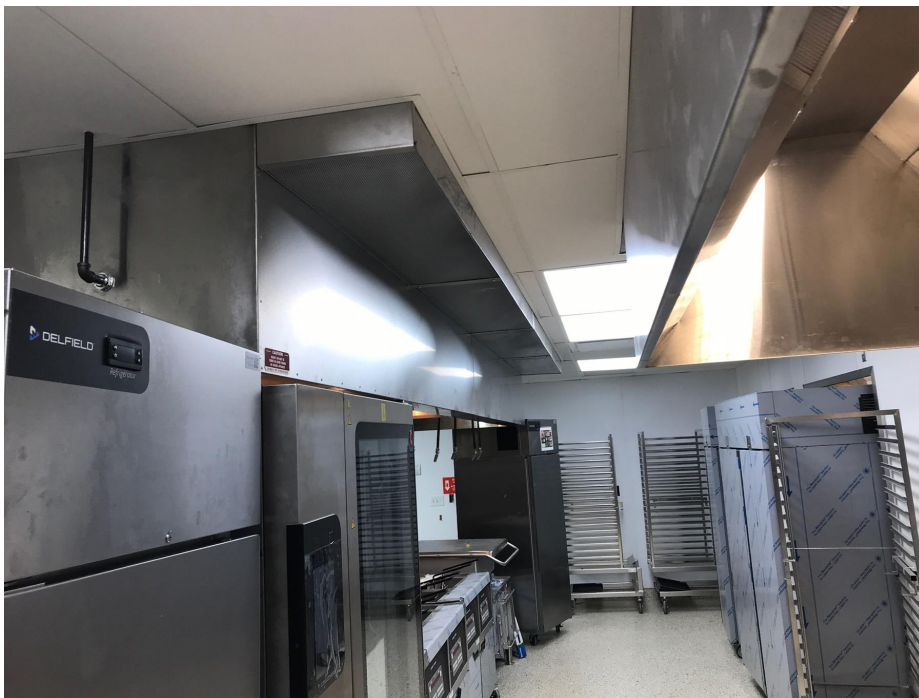
Hood 1 (HD1) (HD1)

Model: 5430ND-2WI-PSP-SS **Length:** 8' 6.00"
Exhaust CFM: Design = 2550 Initial = 2220 Final = 2220 (87.1% of design)
Other Notes:

Other Notes:
double nut not properly used. PSP missing rear hanging rods

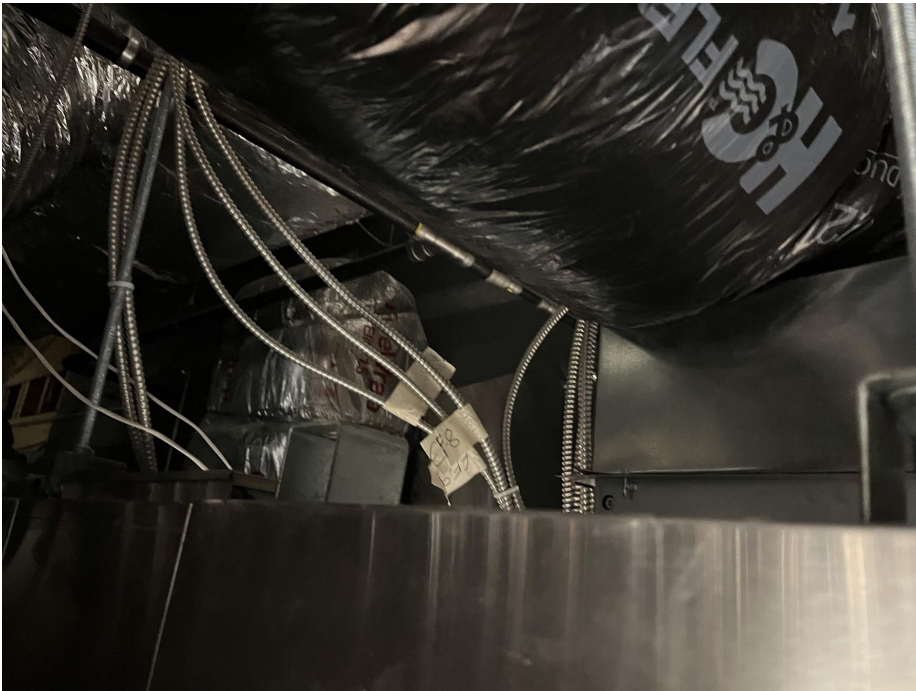
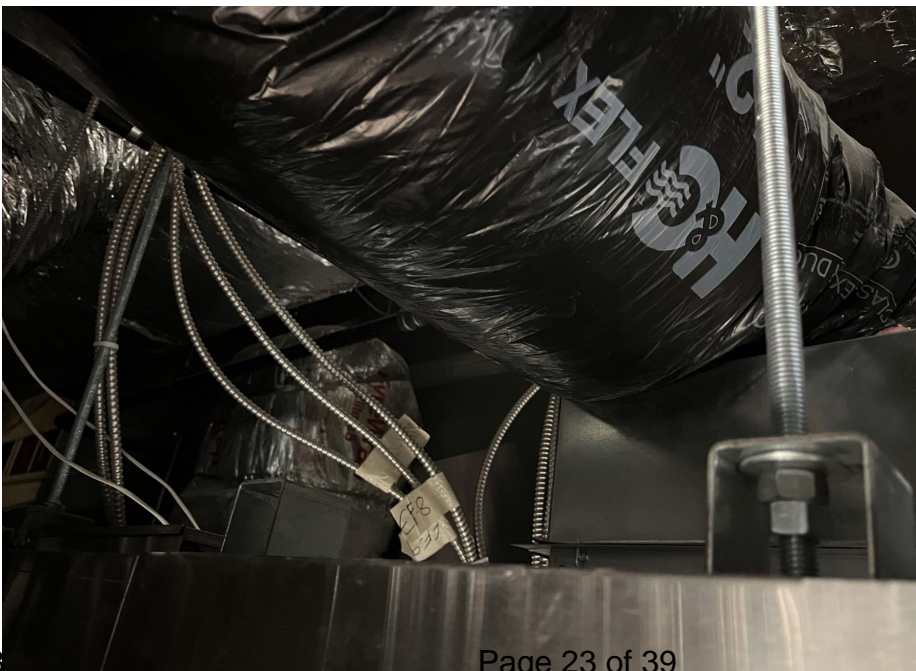
Hung Using appropriate material to safely secure hood. Design: **Yes** Actual: **No**

COOKING EQUIPMENT ON AND OPERATING	Design: Yes	Actual: No
COOKING EQUIPMENT INSTALLED AS CLOSE TO BACK WALL AS POSSIBLE	Design: Yes	Actual: No
Was a smoke test performed on Hood System?	Design: Yes	Actual: Yes

Talked with sales office about low air flow. Told CAS Service too leave as is.
 See attachment(s): [20230317132247.mp4]

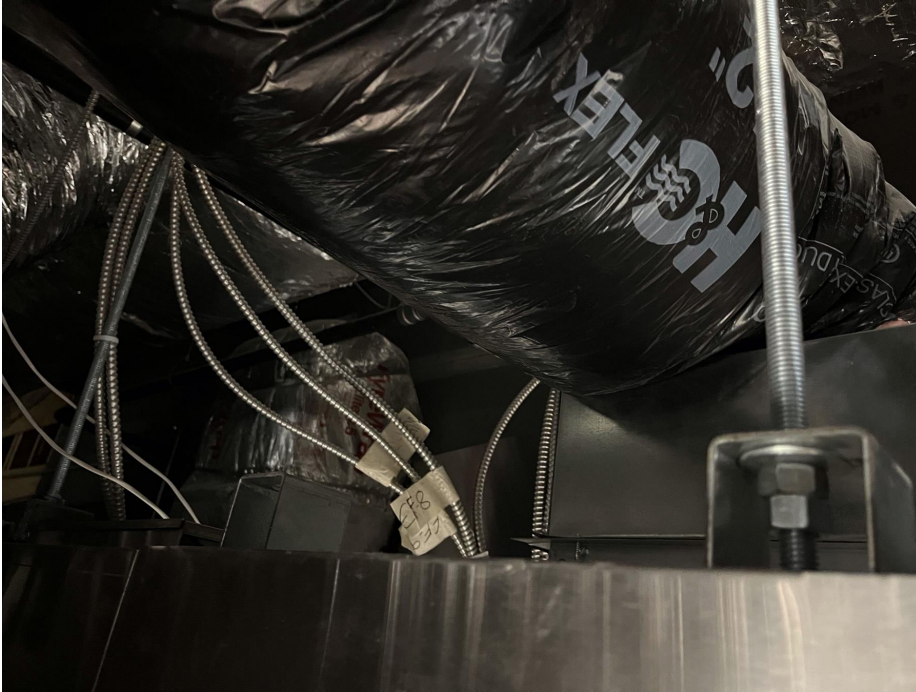
Hood 2 (PSP-EXHD) (PSP-EXHD)

Hung Using appropriate material to safely secure hood.

Design: **Yes**

Actual: **No**

Orientation: Front **Length:** 17' 6.00" **Width:** 14.00" **Banks:** 2
Blanks: 2
CFM: Design = 2800 Initial = 1615 Final = 1615 (57.7% of design)
Velocity: Design = 157 Initial = 90 Final = 90 (57.3% of design)

Talked with sales office about low air flow. Told CAS Service too leave as is.

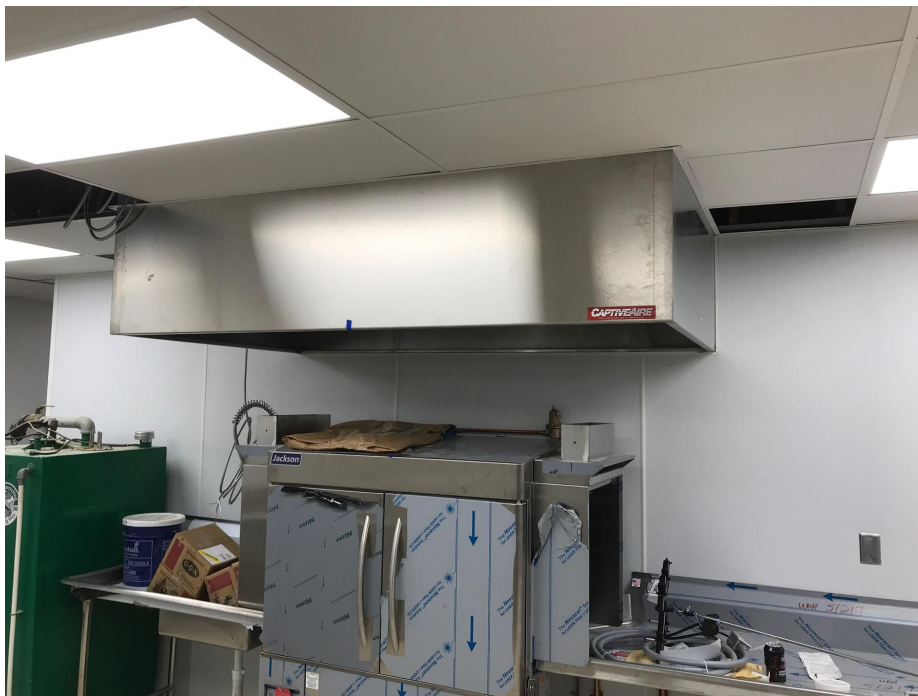
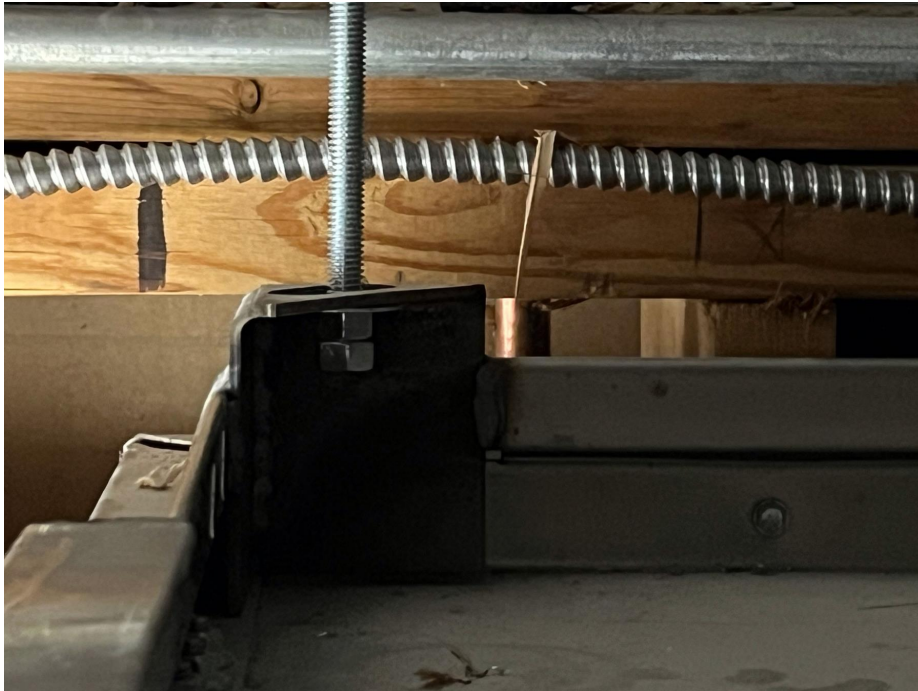
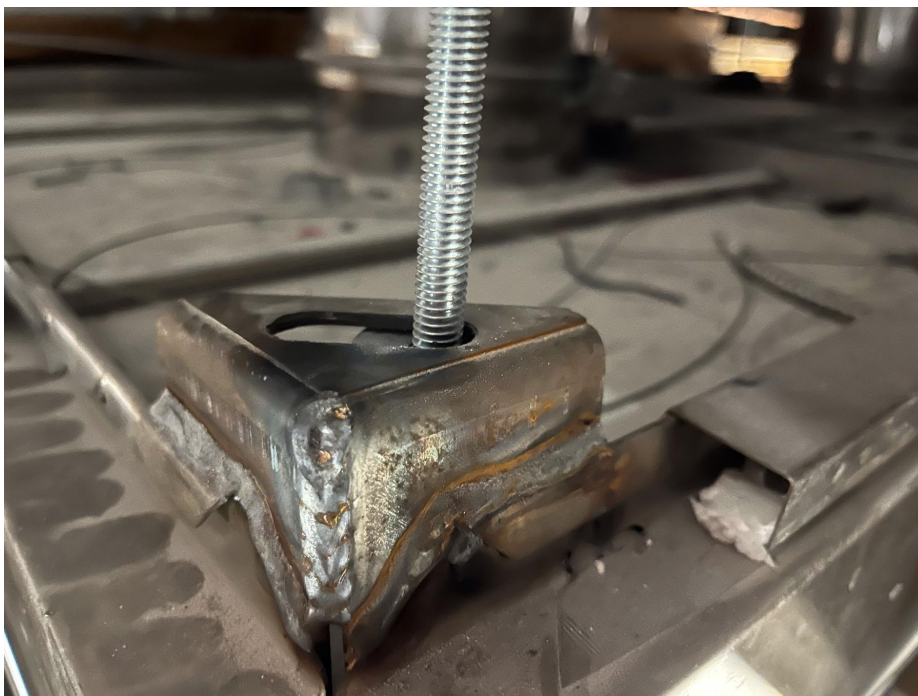
Hood 3 (HD2-DISH) (HD2-DISH)

Model: 4824VHB-G **Length:** 7' 0.00"
Exhaust CFM: Design = 900 Initial = 708 Final = 894 (99.3% of design)

Hood hung with 3/8 rod. Double nut not properly used

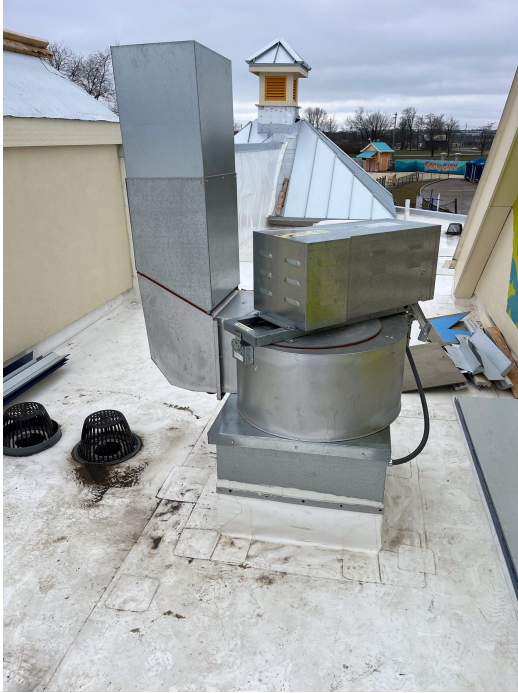
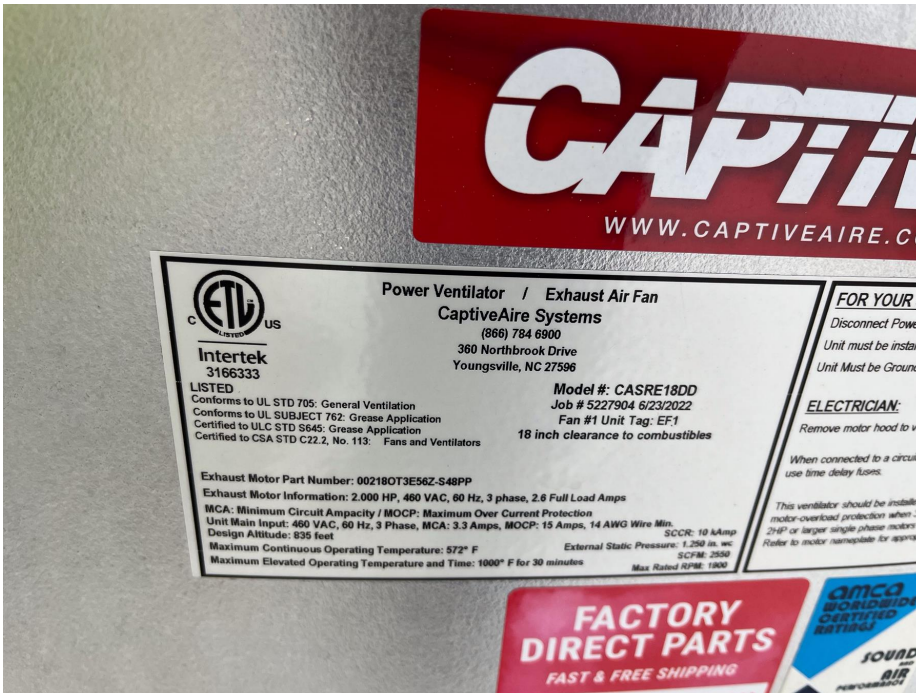
Fan 1 - CASRE18DD (EF1) (EF1)

Exhaust CFM: Design = 2550 Actual = 2220 (87.1% of design)

Record the VFD HZ		Actual: 45
VOLTS	Design: 460	Actual: 480
HP	Design: 2	Actual: 2
HUB SET SCREW TIGHT	Design: Yes	Actual: Yes
FAN LEVEL	Design: Yes	Actual: Yes
ROTATION	Design: Correct	Actual: Correct
FAN VIBRATION	Design: Good	Actual: Good
RPM - DESIGN	Design: 1333	Actual: 1275
RPM - MAX	Design: 1900	Actual: N/A
RPM - MAX RECOMMENDED	Design: 1700	Actual: N/A
FLA	Design: 2.6	Actual: 2.5
OVERLOAD SET POINT	N/A	
PHASE	Design: 3	Actual: 3
FAN WITHIN 5 MILES OF COAST		Actual: No
INSPECT ALL EXTERIOR SIDES OF UNIT. ANY VISIBLE DAMAGE	Design: No	Actual: No

Talked with sales office about low air flow. Told CAS Service too leave as is.

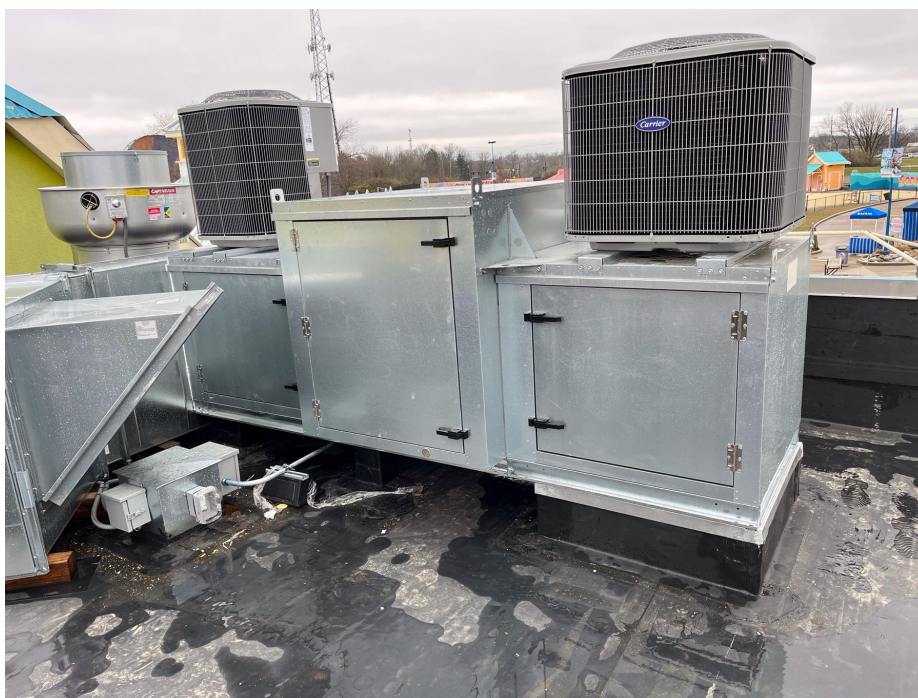
Fan 2 - A2-20D-MPU (SF-MPU1) (SF-MPU1)

Supply CFM: Design = 4450 Actual = 2814 (63.2% of design)

VOLTS	Design: 460	Actual: 480
HP	Design: 3	Actual: 3
HUB SET SCREW TIGHT	Design: Yes	Actual: Yes
FAN LEVEL	Design: Yes	Actual: Yes
ROTATION	Design: Correct	Actual: Correct
FAN VIBRATION	Design: Good	Actual: Good
RPM - DESIGN	Design: 1597	Actual: 1053
RPM - MAX	Design: 2400	Actual: N/A
RPM - MAX RECOMMENDED	Design: 2000	Actual: N/A
FLA	Design: 4.3	Actual: 4.2

Talked with sales office about low air flow. Said he'd have mechanical contractor look into airflow restrictions. Told CAS Service too leave as is.

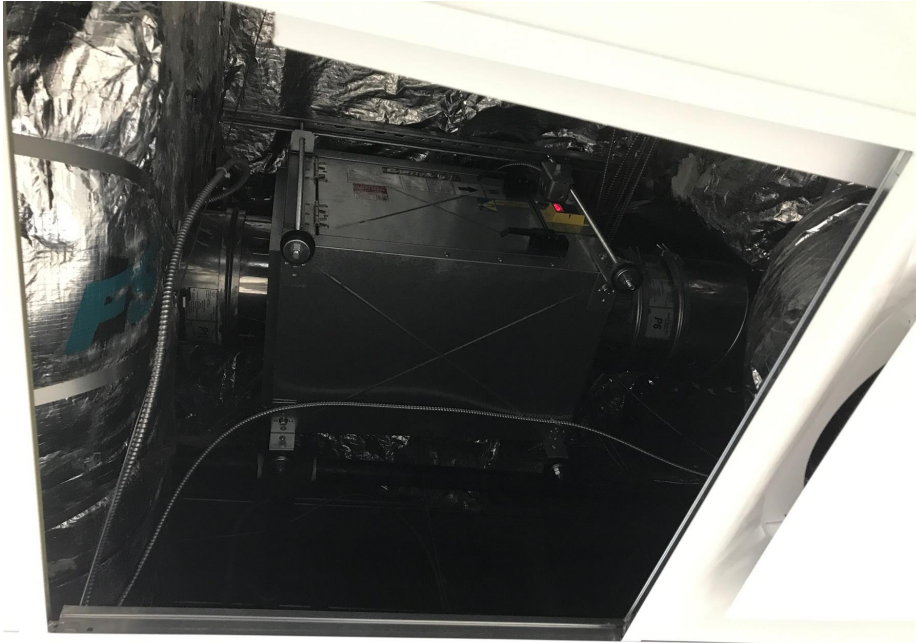
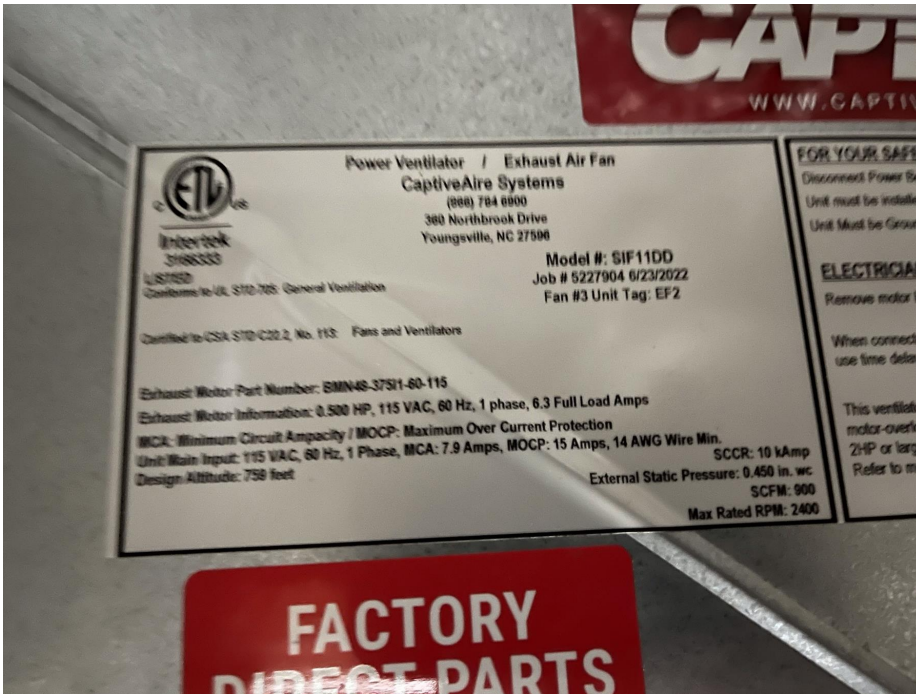
Fan 3 - SIF11DD (EF2) (EF2)

Exhaust CFM: Design = 900 Actual = 894 (99.3% of design)

Record the ECM Speed		Actual: 90
VOLTS	Design: 115	Actual: 119
HP	Design: 0.5	Actual: 0.5
HUB SET SCREW TIGHT	Design: Yes	Actual: Yes
FAN LEVEL	Design: Yes	Actual: Yes
ROTATION	Design: Correct	Actual: Correct
FAN VIBRATION	Design: Good	Actual: Good
RPM - DESIGN	Design: 1483	Actual: 1620
RPM - MAX	Design: 2400	Actual: N/A
RPM - MAX RECOMMENDED	Design: 2000	Actual: N/A
FLA	Design: 6.3	Actual: 4.8
PHASE	Design: 1	Actual: N/A
FAN WITHIN 5 MILES OF COAST		Actual: No
INSPECT ALL EXTERIOR SIDES OF UNIT. ANY VISIBLE DAMAGE	Design: No	Actual: No
SPEED CONTROL VOLTAGE	Design: 65	Actual: N/A

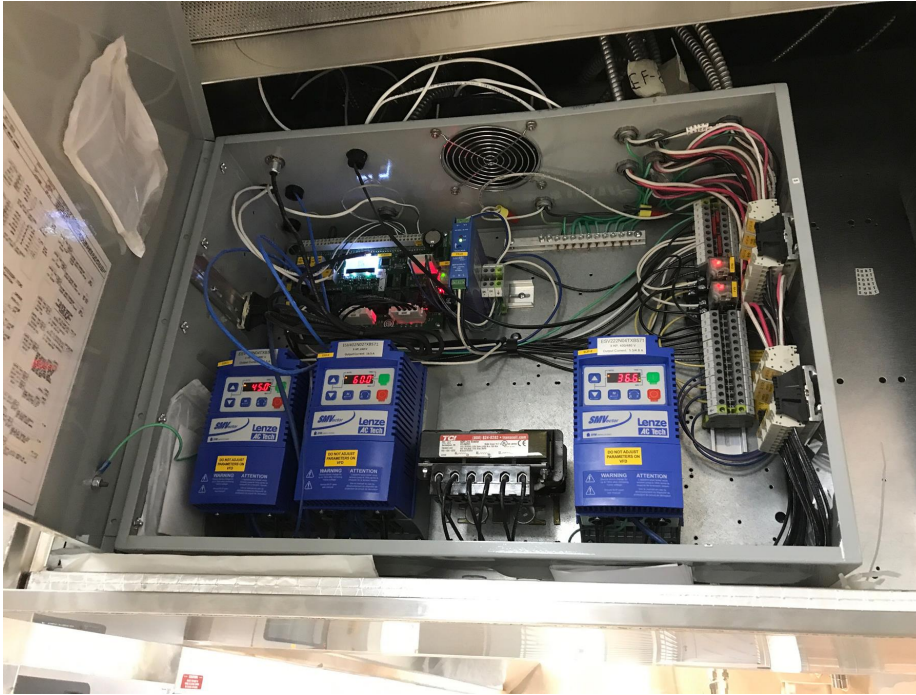
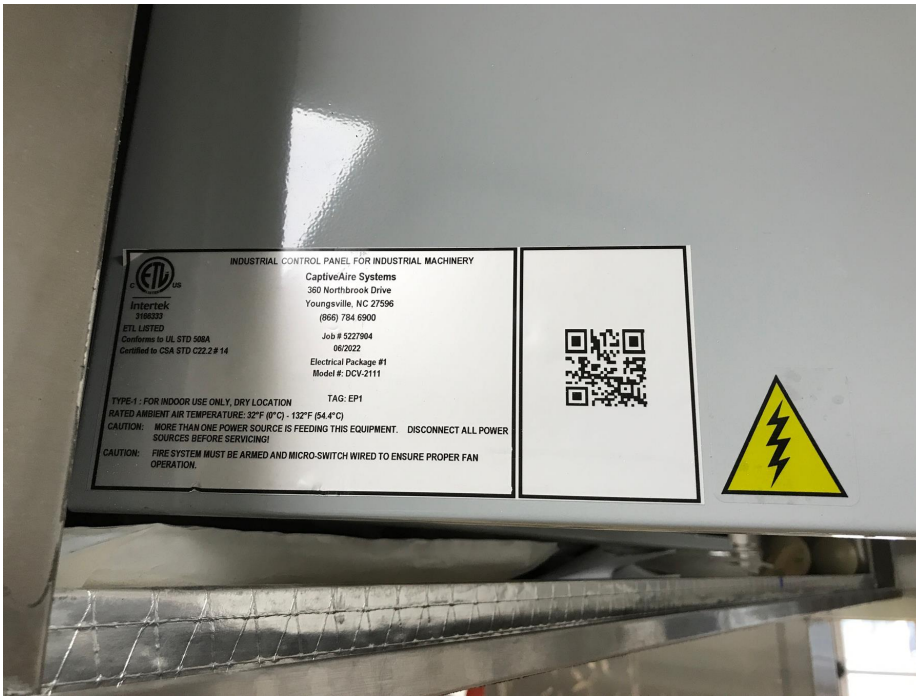
ECP 1 - DCV-2111 (EP1) (EP1)

ROOM TEMPERATURE OFFSET	Design: 21	Actual: 21
HOW MANY FAN ZONES ARE THERE	Design: 1	Actual: 1
HYSTERESIS TEMPERATURE		Actual: 2
Room Sensor Type		Actual: Preset
What is Preset temperature set to?		Actual: 75

ALL TEMP SENSORS ARE WIRED IN	Design: Yes	Actual: Yes
Do any of the light circuits exceed 1400W?	Design: No	Actual: No
ALL LIGHTS WORK	Design: Yes	Actual: Yes
ALL FAULTS CLEARED	Design: Yes	Actual: Yes
ECPM03 HARDWARE REVISION	Design: 04	Actual: 04
ECPM03 PROGRAM VERSION	Design: 2.15.04	Actual: 2.15.04
CASHMI HARDWARE REVISION	Design: 03	Actual: 03
CASHMI PROGRAM VERSION	Design: 2.15.04	Actual: 2.15.04
ECPM03 DATE AND TIME ACCURATE	Design: Yes	Actual: Yes
Smoke Test Performed on all Hoods? Upload Video	Design: Yes	Actual: Yes

120V Line Ran from SF1 for MUA(s)	Design: Yes	Actual: Yes
Damper interlock wiring ran to MAU?	Design: Yes	Actual: No

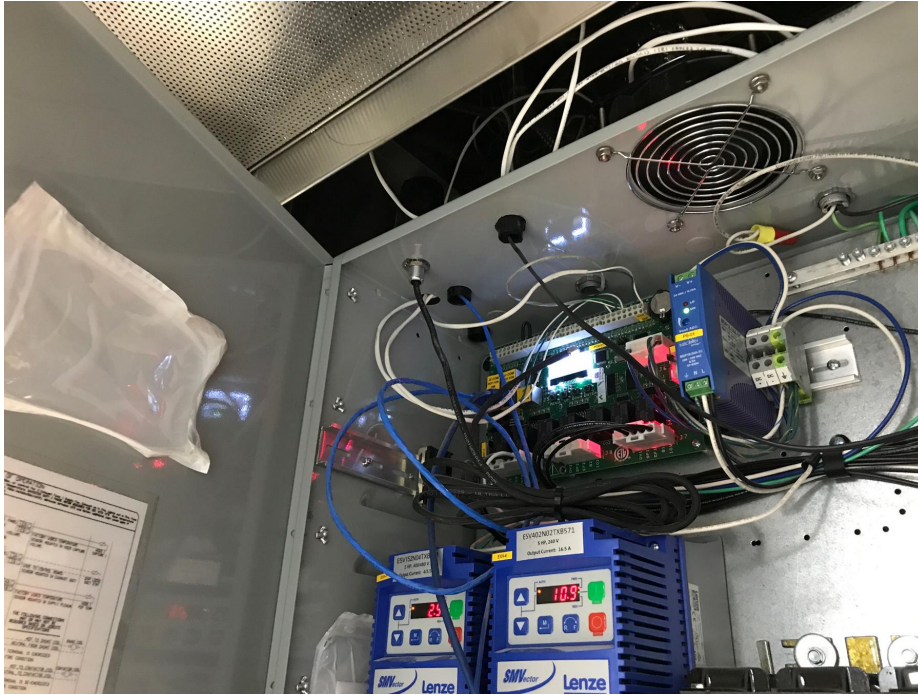
BMS & Monitoring

Scada not installed at time of sdv

BMS TYPE	Design: CASLink	Actual: CASLink
CASLINK COMMUNICATION TYPE	Design: Cellular	Actual: Cellular
Cellular status is Active Online?	Design: Yes	Actual: No
CASLink Registration Wizard was completed?	Design: Yes	Actual: No
CASLink Module has a current heartbeat?	Design: Yes	Actual: No
All devices connected to the SCADA are reporting live data?	Design: Yes	Actual: No
Devices were assigned to an area and named appropriately?	Design: Yes	Actual: No
