Report: TAB

Function: Test, Adjust, & Balance

8589 Hesperian & S St (Hayward CA)

Project: 8589 Hesperian & S St (Hayward CA)

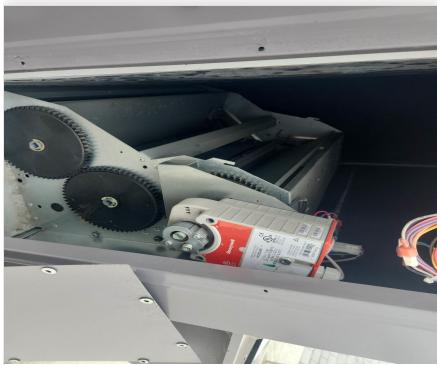
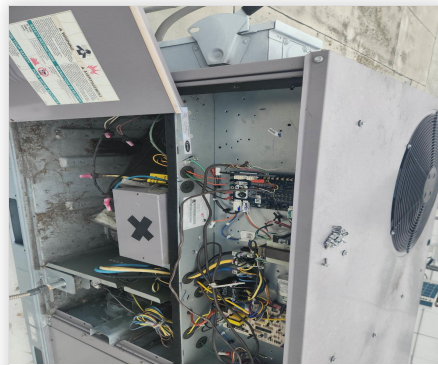
04/24/2025

Issue Name : RTU-1, 2, AND 3 DO NOT HAVE ECONOMIZER CONTROLLERS INSTALLED
Description : RTU-1, 2, and 3 do not have economizer controllers installed. Units had to have OA manually set. Recommend to have controllers installed for proper operations.

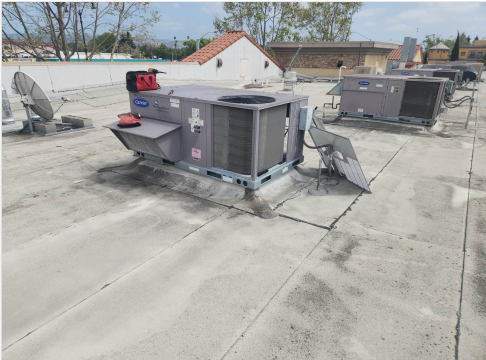
Unit Data - PHOTO LOG

Asset: RTU-1

Test Data		
	Design	Actual
SF CFM	1200	1144
SF RPM	-	1447
RA CFM	1115	1063
OA CFM	85	81
RL Voltage	208	213
RL Amperage	-	2.71
VFD Max SetPt	-	N/A
VFD Min SetPt	-	N/A
SF Motor Freq(HZ)	-	N/A
OA Damper Position	-	~5% OPEN
Brake Horse Power	-	NA

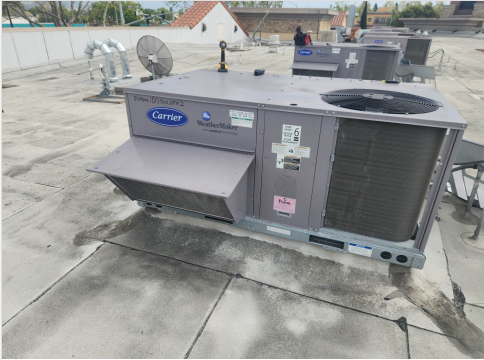
Unit Data - PHOTO LOG

Issue Name : RTU-2 FAN AND HEATING ISSUES.
Description : RTU-2's fan will ramp up and down periodically causing inconsistent airflows. The unit also trips its internal transformer when heating is energized. Recommend to have unit serviced for proper operations.
Created By : National TAB **Assigned To :** National TAB - Zack Eismin
Status : Pending
Priority : High **Asset Tag :**
Originated Date : 04/24/2025 - Zack Eismin - National TAB

Asset: RTU-2

Test Data		
	Design	Actual
SF CFM	1200	1159
SF RPM	-	1456
RA CFM	990	952
OA CFM	210	207
RL Voltage	208	213
RL Amperage	-	2.36
VFD Max SetPt	-	N/A
VFD Min SetPt	-	N/A
SF Motor Freq(HZ)	-	N/A
OA Damper Position	-	~18%
Brake Horse Power	-	NA

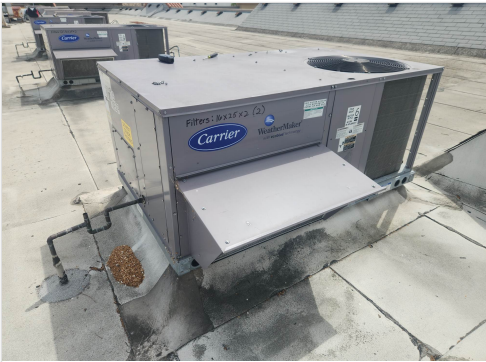
Unit Data - PHOTO LOG

Asset: RTU-3

Test Data		
	Design	Actual
SF CFM	1200	1212
SF RPM	-	1478
RA CFM	990	1001
OA CFM	210	211
RL Voltage	208	213
RL Amperage	-	3.01
VFD Max SetPt	-	N/A
VFD Min SetPt	-	N/A
SF Motor Freq(HZ)	-	N/A
OA Damper Position	-	~18% OPEN
Brake Horse Power	-	NA

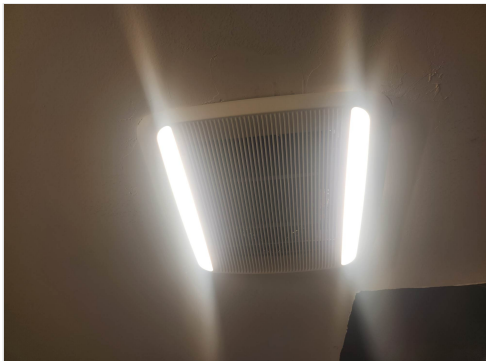
Unit Data - PHOTO LOG

Asset: EF1

Test Data		
	Design	Actual
CFM	110	109
RL Voltage	208	NA
RL Amperage	-	NA
Discharge ESP	-	0.12"
Total ESP	0.1	0.12"

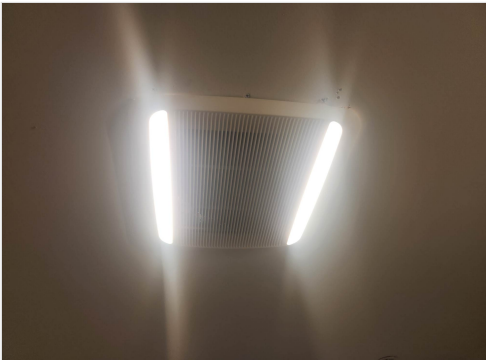
Unit Data - PHOTO LOG

Asset: EF2

Test Data		
	Design	Actual
CFM	110	111
RL Voltage	208	NA
RL Amperage	-	NA
Discharge ESP	-	0.13"
Total ESP	0.1	0.13"
