Report: TAB Report
Function: Test, Adjust, & Balance
Date: 03/24/2025
Completed By: National TAB

PROJECT
03-24-25 CAVA MARLTON, NJ

Project: 03-24-25 CAVA MARLTON, NJ

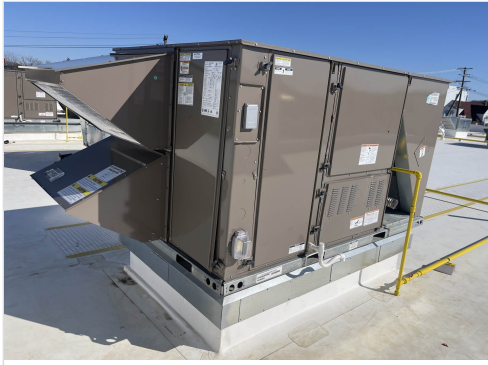
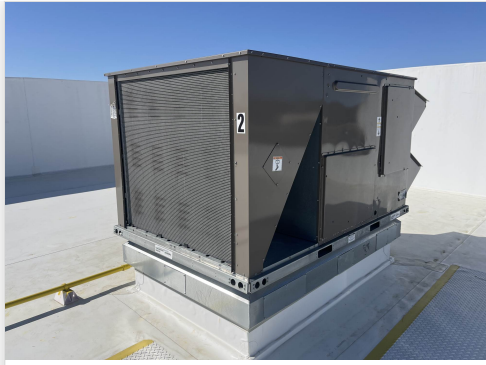
Unit Data - PHOTO LOG

Model Number: ZJ120S24U2D6RC2E3
 Serial Number: N274480011
 FOR OUTDOOR USE ONLY
 Power Supply: 208/230 - 3 - 50
 Power Source: 208/230 - 3 - 50
 Maximum Operating Voltage Range: 187V / 225V
 Short Circuit Current: 5
 Factory Output: 208/230

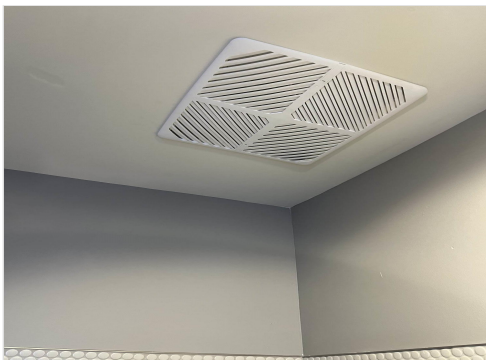
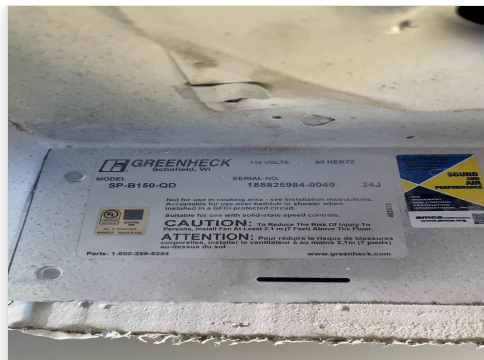
Unit Data - PHOTO LOG

[1] EF HIGH ON FLOW, NOT EQUIPPED WITH SPEED SWITCH. NOT EXPECTED TO CAUSE COMFORT ISSUE

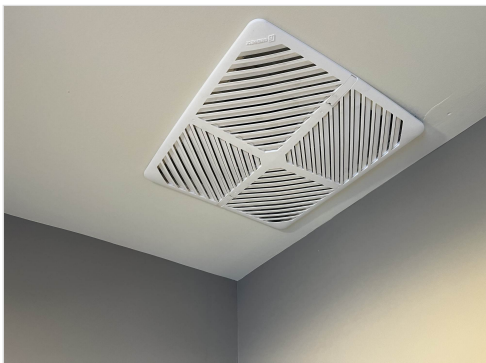
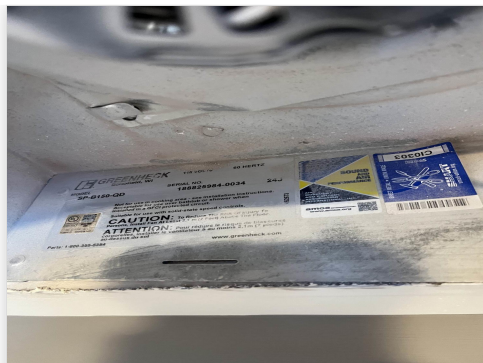
Unit Data - PHOTO LOG

[1] EF HIGH ON FLOW, NOT EQUIPPED WITH SPEED SWITCH. NOT EXPECTED TO CAUSE COMFORT ISSUE
