**Report: TAB REPORT**  
**Function: Test, Adjust, & Balance**  
**Date: 12/08/2023**

**12-04-23 FREDDYS - INDIANAPOLIS, IN  
(96TH ST)**

Project: 12-04-23 FREDDYS - INDIANAPOLIS, IN (96TH ST)

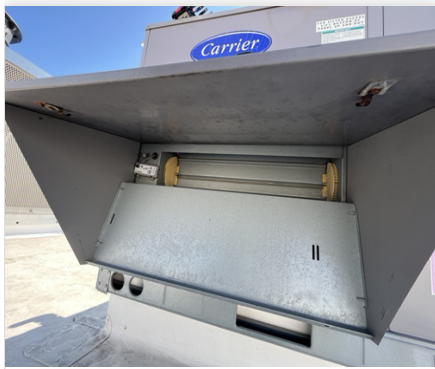
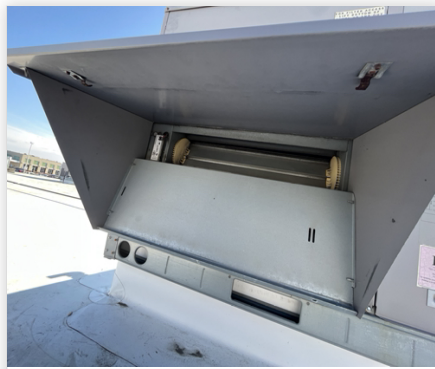
**Issue Name :** OA filters for RTU-1/RTU-2 missing  
**Description :** OA filters are not installed for RTU-1/RTU-2 dining room Carrier units. Recommend installing correct size OA mesh filter.  
**Created By :** National TAB                      **Assigned To :** National TAB - Dylan Crisman  
**Status :** Open  
**Priority :**    **Asset Tag :**  
**Originated Date :** 12/05/2023 - Dylan Crisman - National TAB

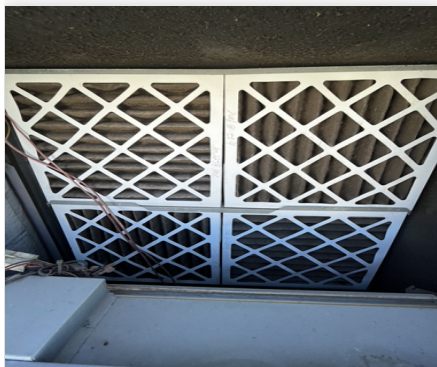
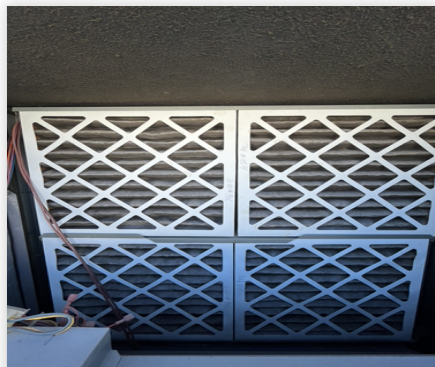
**Issue Name :** RTU-1/RTU-2 final filters dirty  
**Description :** Recommend replacing final filters with correct 16x16x2 pleated filters. Current ones are dirty.  
**Created By :** National TAB                      **Assigned To :** National TAB - Dylan Crisman  
**Status :** Open  
**Priority :**    **Asset Tag :**  
**Originated Date :** 12/05/2023 - Dylan Crisman - National TAB

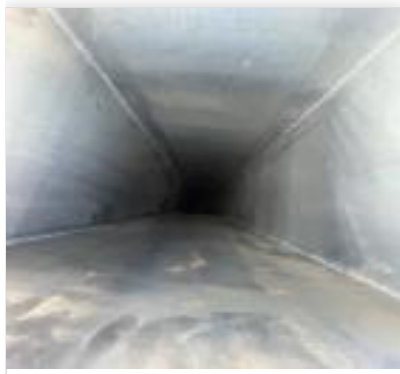
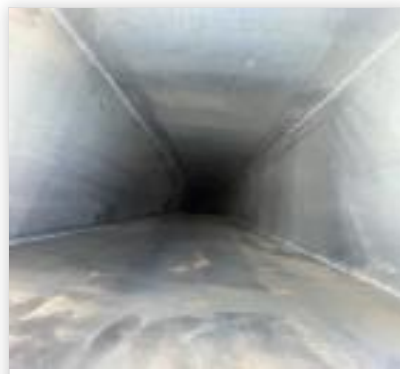
EF-2  
12/04/2023

Lean fan back. Is grease duct installation adequate and is duct ran all the way to the base of the fan?

There is no major leakage around base of fan?

No
