**Report: TAB REPORT
Function: Test, Adjust, & Balance
Date: 12/01/2022**

11-28 CULVERS - GRAND JUNCTION, CO

Name : SITE PICTURES **Status :** NotSubmitted
Assigned Organization : National TAB **Asset :**
Requesting Organization : National TAB

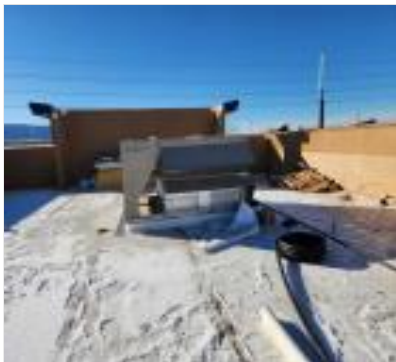
RTU-1

Unit Data		
	Design	Actual
MFG	LENNOX	LENNOX
Serial Num	-	5622D05972
Model Num	LGH156H4B	LGH156H4B
Type	RTU	RTU
Configuration	VERTICAL	VERTICAL
Num OA Filters 1	-	3
OA Filter Size 1	-	23X14
Num Final Filter 1	-	6
Final Filter Size 1	-	24X24X2

Test Data		
	Design	Actual
SF CFM	6150	6382
SF RPM	-	784
RA CFM	4000	4440
OA CFM	1750	1942
RL Voltage	-	210/211/211
RL Amperage	-	7.9/7.9/7.8
SF Rotation	-	CCW
RA Damper Position	-	60%
Min OA Damper Position	-	40%
Min OA Damper Type	-	MOTORIZED
OA Enthalpy Setpt	-	MINIMUM

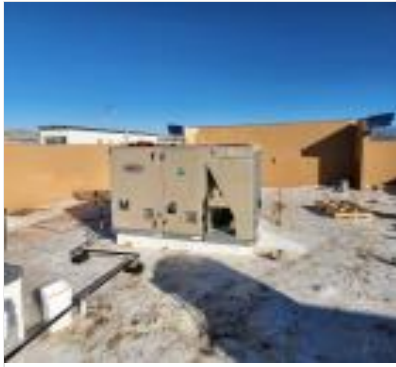
RTU-2

Unit Data		
	Design	Actual
MFG	LENNOX	LENNOX
Serial Num	-	5622D06006
Model Num	LGH156H4B	LGH156H4B
Type	RTU	RTU
Configuration	VERTICAL	VERTICAL
Num OA Filters 1	-	3
OA Filter Size 1	-	23X14
Num Final Filter 1	-	6
Final Filter Size 1	-	24X24X2

Test Data		
	Design	Actual
SF CFM	6150	6299
SF RPM	-	789
RA CFM	4450	4450
OA CFM	1700	1857
RL Voltage	-	210/211/211
RL Amperage	-	7.4/7.29/7.19
SF Rotation	-	CCW
RA Damper Position	-	60%
Min OA Damper Position	-	40% OPEN
Min OA Damper Type	-	MOTORIZED
OA Enthalpy Setpt	-	MINIMUM

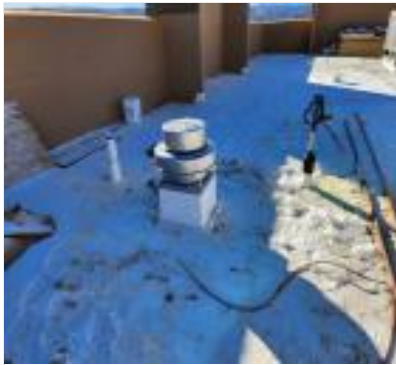
PRV-1

Unit Data		
	Design	Actual
MFG	ACCUREX	ACCUREX
Model Num	XRED-095-D	XRED-095-D
Serial Num	-	20594322
Type	DOWNBLAST	DOWNBLAST
Configuration	VERTICAL	VERTICAL

Test Data		
	Design	Actual
CFM	375	481
Fan RPM	1479	1550
Fan Rotation	-	CCW
Motor RPM	-	1550
System SetPt	-	100%
RL Voltage	-	NA
RL Amperage	-	NA
Total ESP	0.5"	0.53"
Fan Inlet SP	-	-0.53"

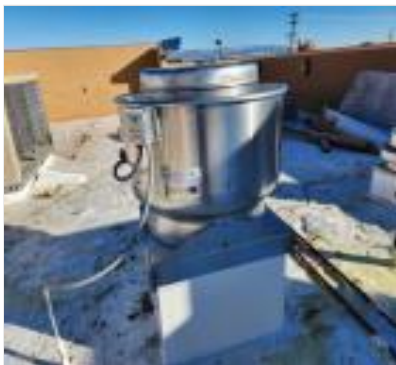
PRV-2

Unit Data		
	Design	Actual
MFG	ACCUREX	ACCUREX
Model Num	XRUB-160XP-15	XCUBE-240XP-15-1-34-6
Serial Num	-	20584232
Type	UPBLAST	UPBLAST L
Configuration	VERTICAL	VERTICAL

Test Data		
	Design	Actual
CFM	1500	1642
Fan RPM	2411	1360
Fan Rotation	-	CCW
Motor RPM	-	1760
RL Voltage	-	210/210/209
RL Amperage	-	3.1/3.1/3.14
Suction ESP	-	-1.163"
Discharge ESP	-	ATM
Total ESP	2.337"	1.163

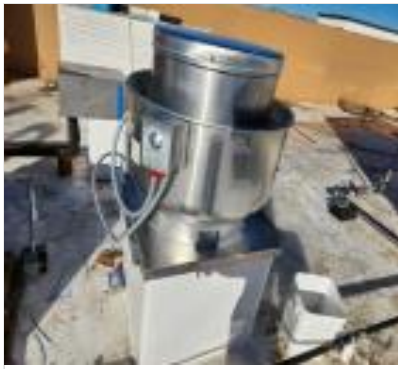
PRV-3

Unit Data		
	Design	Actual
MFG	ACCUREX	ACCUREX
Model Num	XRUB-140-7	XRUB-140-7
Serial Num	-	20594275
Type	UPBLAST	UPBLAST
Configuration	VERTICAL	VERTICAL

Test Data		
	Design	Actual
CFM	1500	1631
Fan RPM	1377	1102
Fan Rotation	-	CCW
Motor RPM	-	1760
RL Voltage	-	209/209/210
RL Amperage	-	1.7/1.7/1.65
Suction ESP	-	-0.47"
Discharge ESP	-	ATM
Total ESP	1"	0.47"

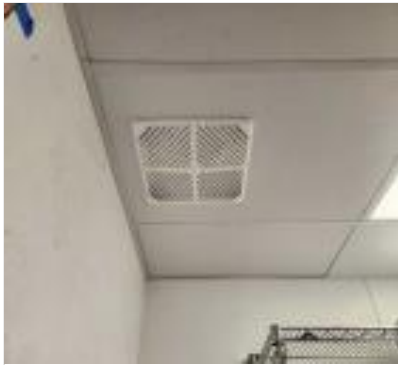
EF-1A

Unit Data		
	Design	Actual
MFG	ACCUREX	ACCUREX
Model Num	XCRB80	XCRB80
Serial Num	-	NL
Type	CEILING	CEILING
Configuration	VERTICAL	VERTICAL

Test Data		
	Design	Actual
CFM	75	68
Fan RPM	885	900
Fan Rotation	-	CCW
Motor RPM	-	900
System SetPt	-	100%
RL Voltage	-	114
RL Amperage	-	0.13
Total ESP	0.125"	NA
Fan Inlet SP	-	NA
Fan Discharge SP	-	ATM

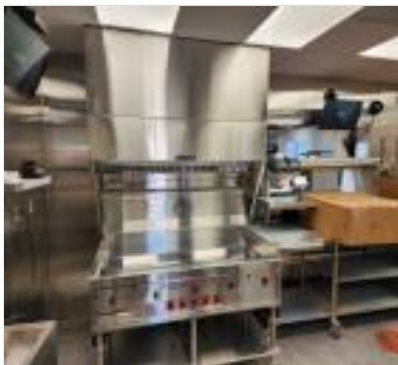
HOOD 1

Unit Data		
	Design	Actual
MFG	ACCUREX	ACCUREX
Model Num	XGEP-64-S	XGEP-64-S
Job / Serial Num	-	20533285
Type	TYPE I LOW PROXIMITY	TYPE I LOW PROXIMITY
Hood length	64	64"
Hood Width	23	23"

Test Data Exhaust		
	Design	Actual
Filter Type	GREASE GRABBER	GREASEGRABBER
Filter Size 1	16X16	16X16
Filter Qty 1	4	4
Filter AK factor size 1	1.53	1.53
Filter Total AK Area	6.12	6.12
Filter1 FPM	-	318
Filter2 FPM	-	243
Filter3 FPM	-	218
Filter4 FPM	-	298
Filter Ave FPM(corr)	-	269
CFM	1500	1646

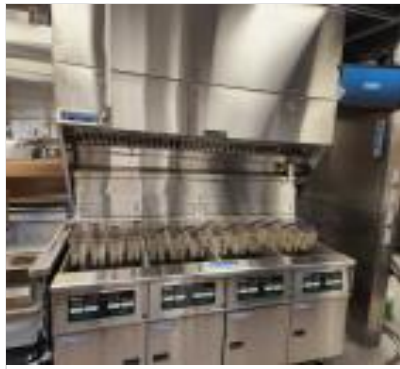
HOOD 2

Design	Actual
MFG	ACCUREX	ACCUREX
Model Num	XXEP-83-S	XXEP-83-S
Job / Serial Num	-	20533281
Type	TYPE I LOW PROXIMITY	TYPE I CANOPY
Hood length	83	83"
Hood Width	23	23"

Design	Actual
Filter Type	XTRACTOR	XTRACTOR
Filter Size 1	16X16	16X16
Filter Qty 1	5	5
Filter AK factor size 1	1.53	1.53
Filter Total AK Area	7.65	7.65
Filter1 FPM	-	214
Filter2 FPM	-	186
Filter3 FPM	-	182
Filter4 FPM	-	202
Filter5 FPM	-	201
Filter Ave FPM(corr)	-	197
CFM	1500	1507
