Report: TAB REPORT
Function: Test, Adjust, & Balance
Date: 10/25/2023

**09-04-23 CHICK-FIL-A #05049 -
CHRISTIANSBURG, VA (CHRISTIANSBURG
FSU) NEW STORE**

Project Summary

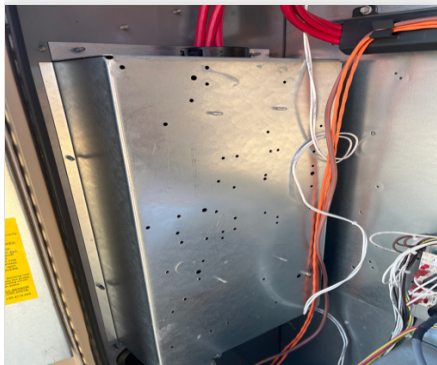
AC2
09/06/2023

Issue Name : Non-Critical - AC2 / GFI Outlet
Description : AC2 GFI outlet is not installed. This is a Lennox factory issue. Page: M-401 Detail: Rooftop Unit Schedule Note: 17
Created By : National TAB **Assigned To :** National TAB - Dale Wheeler
Status : Open
Originated Date : 09/06/2023 - Dale Wheeler - National TAB

YES / AC1 & AC3 NO / AC2 GFI NOT INSTALLED

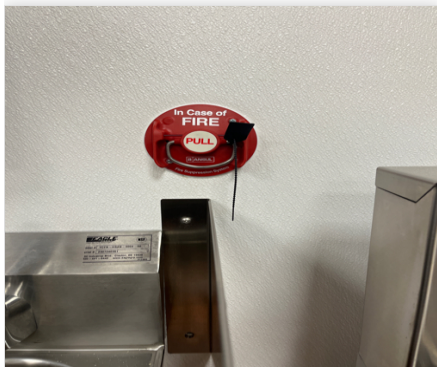
ANSUL
09/05/2023

Issue Name : Non-Critical - Ansul Pull Station / Labels
Description : Ansul pull stations are not labeled. Page: M-301 Detail: 1 / Notes
Created By : National TAB **Assigned To :** National TAB - Dale Wheeler
Status : Open
Originated Date : 09/05/2023 - Dale Wheeler - National TAB

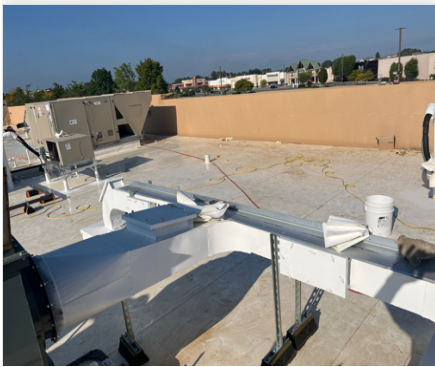
EF2
09/06/2023

Issue Name : Non-Critical - EF2 / Cleanout Door
Description : EF2 grease duct installed slightly different then shown on prints causing one grease cleanout door to be located in a different location then shown on prints. Page: M-250 Detail: 1
Created By : National TAB **Assigned To :** National TAB - Dale Wheeler
Status : Open
Originated Date : 09/06/2023 - Dale Wheeler - National TAB

EF2 / GREASE DUCT IS INSTALLED SLIGHTLY DIFFERENT THEN SHOWN IN PRINTS, ONE CLEANOUT DOOR IS INSTALLED IN A DIFFERENT LOCATION THEN SHOWN ON PRINTS. EF1 / IS MISSING ONE GREASE CLEANOUT DOOR

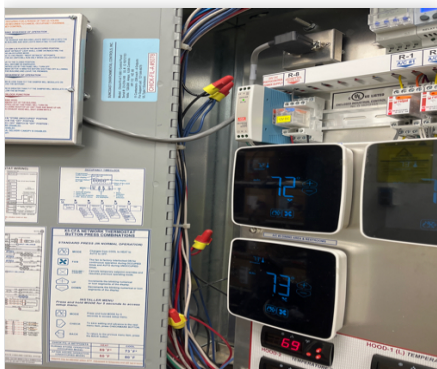
Cover
09/05/2023

Issue Name : Non-Critical - T500 Panel / High Voltage Cover
Description : High voltage wiring cover is not installed on the T-500 panel.
Created By : National TAB **Assigned To :** National TAB - Dale Wheeler
Status : Open
Originated Date : 09/05/2023 - Dale Wheeler - National TAB

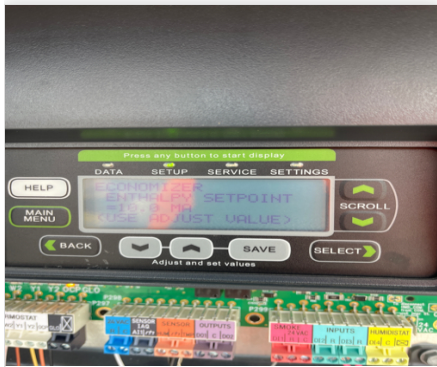
ENRHALPY
09/07/2023

Issue Name : Review+Rectify - AC1, AC2, AC3 / Enthaly Offeset
Description : Prodigy boards for all units would not allow the enthalpy offset to be set lower than 10.0. Lennox needs to provide information / solution as to why their boards will not allow the enthalpy offset to be set to 5.0
Created By : National TAB **Assigned To :** National TAB - Dale Wheeler
Status : Open
Originated Date : 09/07/2023 - Dale Wheeler - National TAB

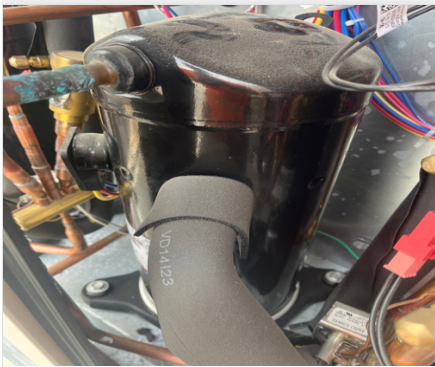
COMPRESSOR2
09/07/2023

Issue Name : Review+Rectify - AC3 & AC1 / Compressor 1 & Compressor 2
Description : AC3 compressor 1 will not run due an alarm for high pressure. AC1 compressor 2 contactor engages, but compressor will not turn on. Mechanical has been made aware of these issues.

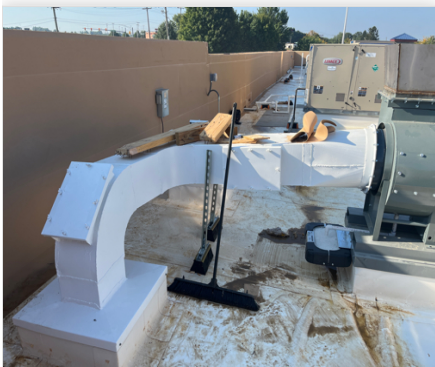
EF1
09/06/2023

Issue Name : Review+Rectify - EF1 / Grease Cleanout Door
Description : EF1 is missing one grease cleanout door per prints. Page: M-250 Detail: 1
Created By : National TAB **Assigned To :** National TAB - Dale Wheeler
Status : Open
Originated Date : 09/06/2023 - Dale Wheeler - National TAB

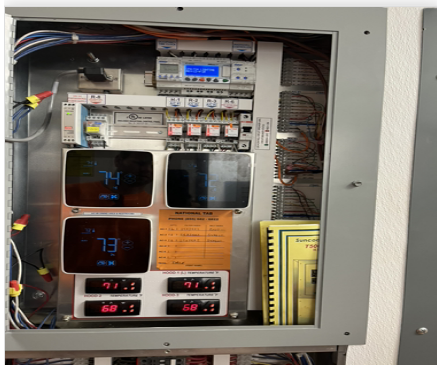
T-500
09/11/2023

Issue Name : Review+Rectify - T500 Panel / Capture Jets
Description : Capture jets do not turn off on Hood1L, Hood1R, Hood2, Hood3 when store is placed into unoccupied mode.
Created By : National TAB **Assigned To :** National TAB - Dale Wheeler
Status : Open
Originated Date : 09/11/2023 - Dale Wheeler - National TAB

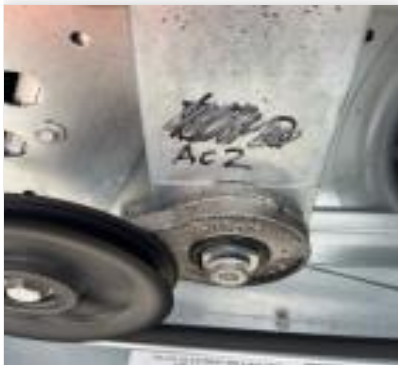
AC2
09/07/2023

EACH AC BELT TENSIONER POSITION MARKED

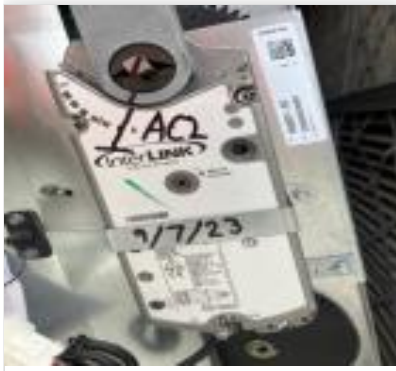
AC2
09/07/2023

ECONOMIZER POSITIONS MARKED AND DATED FOR EACH AC

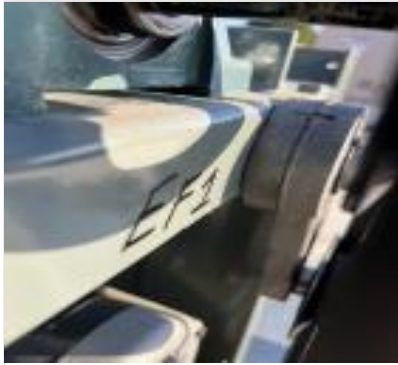
EF1
09/07/2023

EACH EF BELT TENSIONER POSITION MARKED

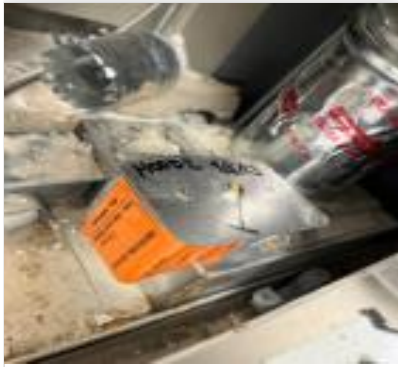
HOOD2
09/07/2023

CAPTURE JET FINAL SETTINGS (MARKED AND DATED)

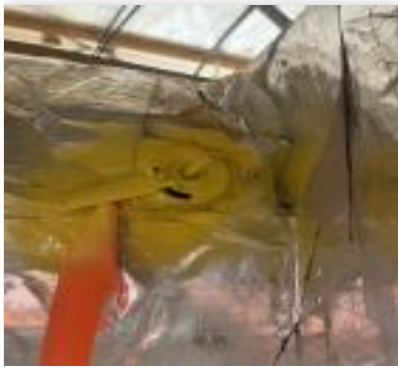
DAMPER
09/07/2023

ONE MARKED BALANCING DAMPER
