Report: TAB REPORT
Function: Test, Adjust, & Balance
Date: 11/22/2024
Completed By: National TAB

11-18-24 CAVA DURHAM, NC (SOUTHPOINT)

8128 RENAISSANCE PARKWAY

Project: 11-18-24 CAVA DURHAM, NC (SOUTHPOINT)

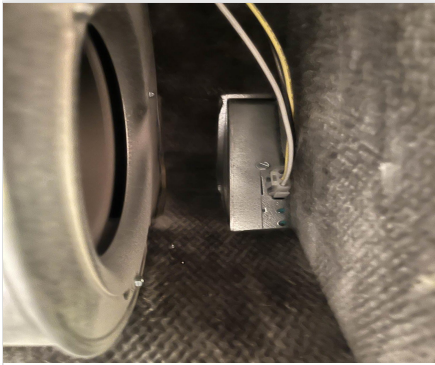
Issue Name : CEF1 & CEF2 / Speed Controllers
Description : CEF1 & CEF2 speed controllers are not installed, unable to balance fans to design cfm.
Created By : National TAB **Assigned To :** National TAB - Brianna Biggs
Status : Open
Priority : Urgent **Asset Tag :**
Originated Date : 11/22/2024 - Dale Wheeler - National TAB

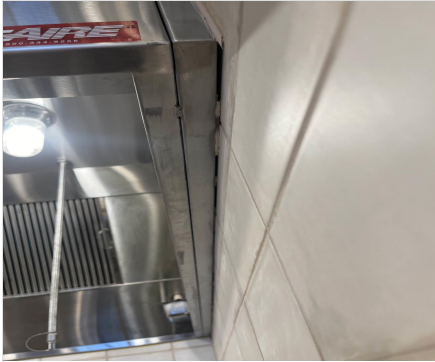
Issue Name : Cooking Hood / Caulk
Description : The side of the hood up against the wall needs caulked.
Created By : National TAB **Assigned To :** National TAB - Dale Wheeler
Status : Open
Priority : Low **Asset Tag :**
Originated Date : 11/22/2024 - Dale Wheeler - National TAB

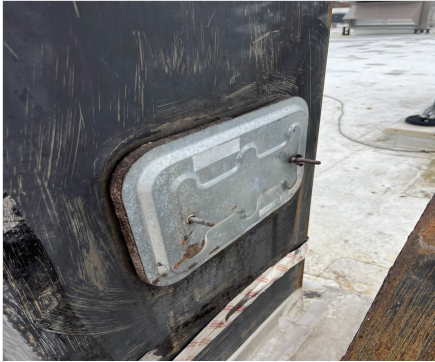
Issue Name : EF1 / Grease Cleanout Door
Description : EF1 grease cleanout door is missing wingnut.
Created By : National TAB **Assigned To :** National TAB - Dale Wheeler
Status : Open
Priority : Medium **Asset Tag :**
Originated Date : 11/22/2024 - Dale Wheeler - National TAB

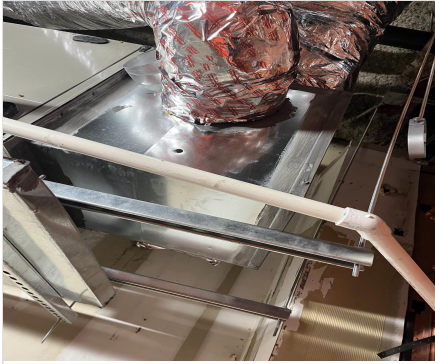
Issue Name : EF1, FCU1, FCU2, FCU3 / I.D. Labels
Description : EF1, FCU1, FCU2, FCU3 ID Labels are not installed.
Created By : National TAB **Assigned To :** National TAB - Dale Wheeler
Status : Open
Priority : Low **Asset Tag :**
Originated Date : 11/22/2024 - Dale Wheeler - National TAB

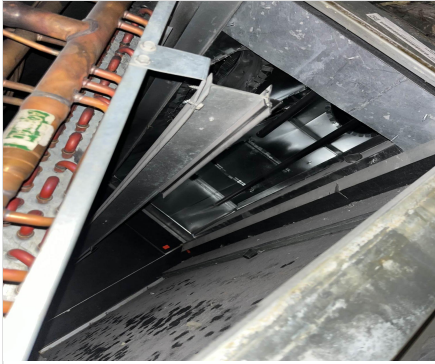
Issue Name : FCU1, FCU2, FCU3 / Filters
Description : FCU1, FCU2, FCU3 filters are not installed.
Created By : National TAB **Assigned To :** National TAB - Dale Wheeler
Status : Open
Priority : Medium **Asset Tag :**
Originated Date : 11/22/2024 - Dale Wheeler - National TAB

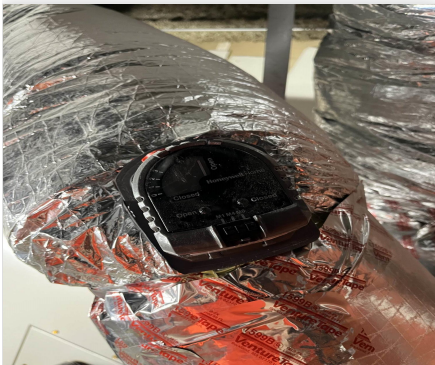
Issue Name : FCU1, FCU2, FCU3 / Mechanical Dampers
Description : FCU1, FCU2, FCU3 mechanical Fresh air dampers are not wired and 100% open. FCU1 had a manual hand damper installed, FCU2 & FCU3 do not, unable to balance fresh air to design cfm for FCU2 & FCU3.
Created By : National TAB **Assigned To :** National TAB - Dale Wheeler
Status : Open
Priority : High **Asset Tag :**
Originated Date : 11/22/2024 - Dale Wheeler - National TAB

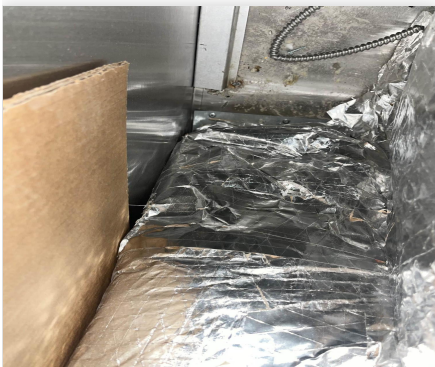
Issue Name : FCU2 / Missing Dampers
Description : FCU2 is missing dampers on SGRD6 (Hood ACPSP) unable to balance ACPSP to design cfm. Due to this issue SGRD1 through SGRD5 are low of design cfm. Unit total is within design cfm.
Created By : National TAB **Assigned To :** National TAB - Dale Wheeler
Status : Open
Priority : High **Asset Tag :**
Originated Date : 11/22/2024 - Dale Wheeler - National TAB

- [1] SGRD6 (HOOD ACPSP) DOES NOT HAVE DAMPERS INSTALLED UNABLE TO BALANCE ACPSP TO DESIGN CFM. THIS ISSUE CAUSED SGRD1 THROUGH SGRD5 TO BE LOW OF DESIGN CFM. UNIT TOTAL IS WITHIN DESIGN.
- [2] MECHANICAL OA DAMPER IS NOT WIRED DAMPER IS 100% OPEN. MANUAL DAMPER NOT INSTALLED.
- [3] AMPS HAD TO BE TAKEN WITH BLOWER DOOR OFF.

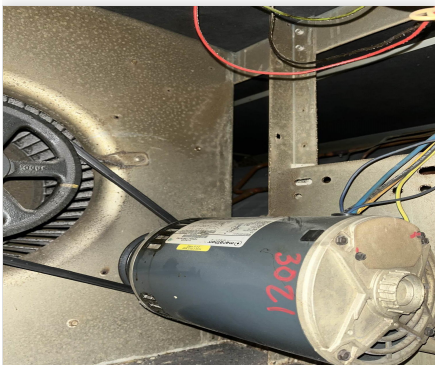
Issue Name : FCU3 / Blower Motor
Description : FCU3 blower motor is running at 831 RPM motor should be running at 1725 RPM per tag. Blower motor is either internally wired wrong, or is a bad motor and needs to be replaced. FCU3 is an existing unit and is unable to reach design cfm, all supply dampers were left 100% open to allow for max air flow.
Created By : National TAB **Assigned To :** National TAB - Dale Wheeler
Status : Open
Priority : Urgent **Asset Tag :**
Originated Date : 11/22/2024 - Dale Wheeler - National TAB

- [1] FCU MOTOR IS RUNNING AT 831RPM MOTOR SHOULD BE RUNNING AT 1725 RPM PER TAG. MOTOR IS EITHER WIRED WRONG INTERNALLY OR IS BAD AND NEEDS REPLACED. FCU3 IS EXISTING AND IS UNABLE TO REACH DESIGN CFM. ALL DAMPERS WERE LEFT 100% OPEN TO ALLOW FOR MAX AIR FLOW.
- [2] MECHANICAL OA DAMPER IS NOT WIRED. MANUAL DAMPER NOT INSTALLED.
- [3] AMPS HAD TO BE TAKEN WITH BLOWER DOOR OFF.

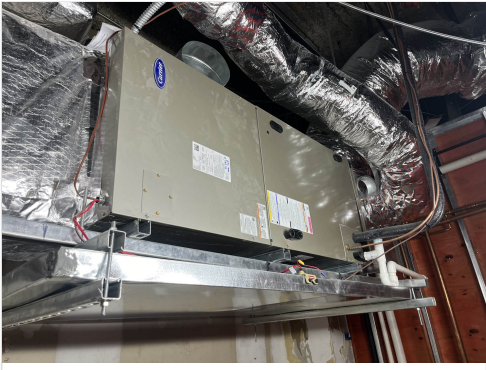
Unit Data - PHOTO LOG

Asset: FCU1

Unit Data		
	Design	Actual
MFG	CARRIER	CARRIER
Serial Num	-	1424F03444
Model Num	FJ4DNXD60L	FJ4DNXD60L
Type	FCU	FCU
Configuration	VERTICAL	VERTICAL
Num OA Filters 1	-	N/A
OA Filter Size 1	-	N/A
Num Final Filter 1	-	NO FILTERS INSTALLED
Final Filter Size 1	-	NO FILTERS INSTALLED

Test Data		
	Design	Actual
SF CFM	1375	1476
SF RPM	-	DD
RA CFM	1238	1329
OA CFM	137	147
RL Voltage	-	207
RL Amperage	-	4.5
SF Rotation	-	CCW
SF System SetPt	-	HIGH
RA Damper Position	-	NO DAMPER
Min OA Damper Position	-	MANUAL HAND DAMPER
Min OA Damper Type	-	MANUAL HAND DAMPER

General	
	Actual
Fan Rotation Correct	YES
Unit Filters Clean	NO
Condensate Drain Installed	YES

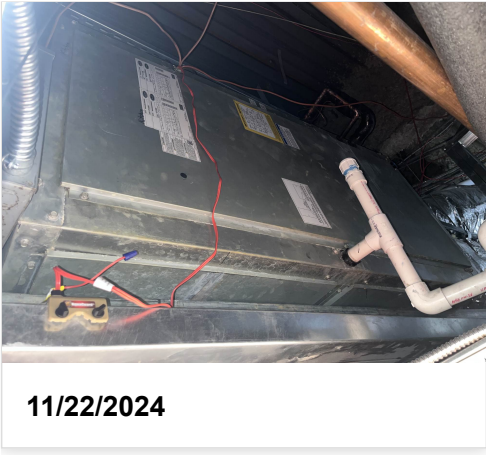
Unit Data - PHOTO LOG

Asset: FCU-X2

Test Data		
	Design	Actual
SF CFM	2425	2660
SF RPM	-	801
RA CFM	2158	1998
OA CFM	267	662
RL Voltage	-	207/208/208
RL Amperage	-	4.4/4.6/4.5
SF Rotation	-	CCW
RA Damper Position	-	NO DAMPER
Min OA Damper Position	-	MECHANICAL DAMPER NOT WIRED
Min OA Damper Type	-	MECHANICAL DAMPER

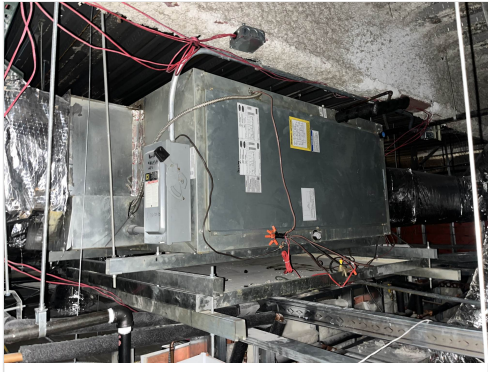
Unit Data - PHOTO LOG

Asset: FCU-X3

Test Data		
	Design	Actual
SF CFM	3000	1639
SF RPM	-	452
RA CFM	2460	1485
OA CFM	540	154
RL Voltage	-	207/208/207
RL Amperage	-	4.2/4.1/4.6
SF Rotation	-	CCW
RA Damper Position	-	NO DAMPERS
Min OA Damper Position	-	100% OPEN
Min OA Damper Type	-	MECHANICAL DAMPER NOT WIRED

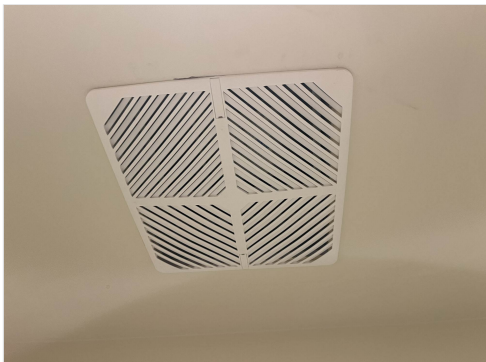
Unit Data - PHOTO LOG

Asset: CEF1

Test Data		
	Design	Actual
CFM	100	165
Fan RPM	-	DD / 1000
Fan Rotation	-	CCW
Motor RPM	-	DD / 1000
System SetPt	-	HIGH
RL Voltage	-	120
RL Amperage	-	0.51
Total ESP	-	N/R
Fan Inlet SP	-	N/R
Fan Discharge SP	-	ATM

Notes:
 [1] SPEED CONTROLLER IS NOT INSTALLED UNABLE TO BALANCE FAN TO DESIGN CFM.

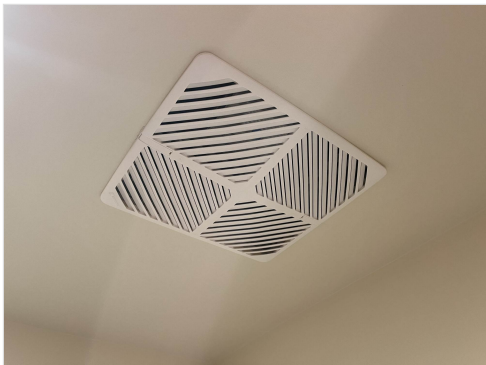
Unit Data - PHOTO LOG

Asset: CEF2

Test Data		
	Design	Actual
CFM	100	197
Fan RPM	-	DD / 1000
Fan Rotation	-	CCW
Motor RPM	-	DD / 1000
System SetPt	-	HIGH
RL Voltage	-	121
RL Amperage	-	0.51
Total ESP	-	N/R
Fan Inlet SP	-	N/R
Fan Discharge SP	-	ATM

Notes:
[1] SPEED CONTROLLER IS NOT INSTALLED UNABLE TO BALANCE FAN TO DESIGN CFM.

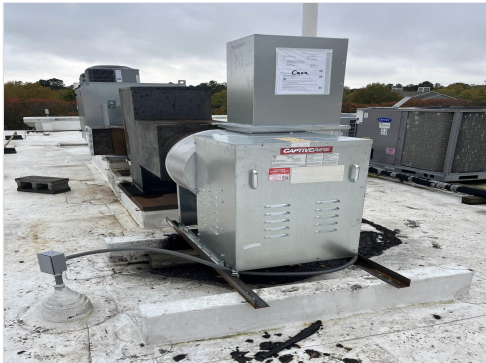
Unit Data - PHOTO LOG

Asset: EF1

Test Data		
	Design	Actual
CFM	2117	2198
Fan RPM	1555	DD / 1740
Fan Rotation	-	CCW
Motor RPM	-	DD / 1740
System SetPt	-	63.3 HZ.
RL Voltage	-	207/205/205
RL Amperage	-	4.1 AVG.
Total ESP	1.0"	-0.132"
Fan Inlet SP	-	0.132"
Fan Discharge SP	-	ATM

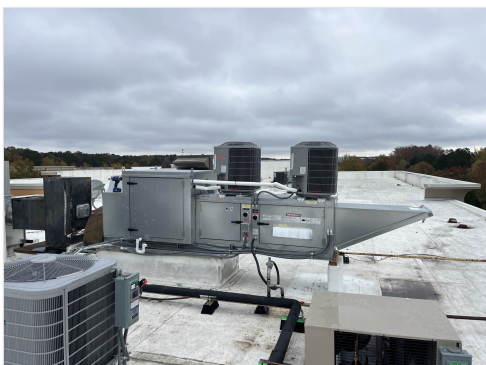
Unit Data - PHOTO LOG

Asset: MUA1

Test Data		
	Design	Actual
CFM	1712	1609
SF RPM	2162	DD / 1745
Motor RPM	-	DD / 1745
SF System SetPt	-	80.6 HZ.
RL Voltage	-	207/205/206
RL Amperage	-	5.6 AVG.
Total ESP	-	N/R
Fan Discharge SP	-	N/R

Gas Heat		
	Design	Actual
Heater Operates (y/n)	-	YES
Flame Status (pass/fail)	-	PASS
Inlet Air Temp SetPt	55	55
Discharge Air Temp SetPt	60	60
Air Flow Switch SP Actual	-	0.377"

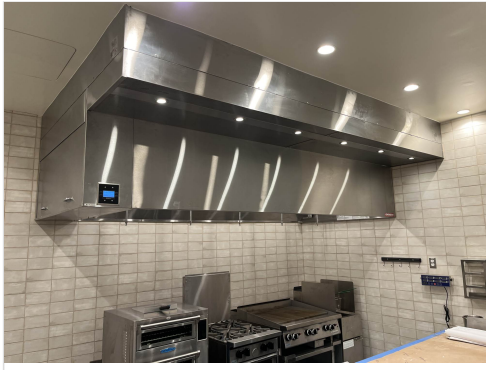
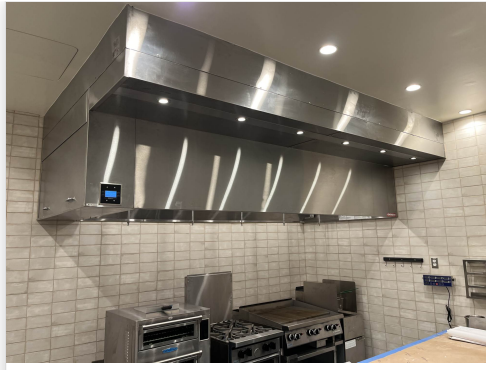
Unit Data - PHOTO LOG

Asset: HD1

Unit Data		
	Design	Actual
MFG	CAPTIVEAIRE	CAPTIVEAIRE
Model Num	6030-ND-2-ACPSP-F	6030-ND-2-ACPSP-F
Job / Serial Num	-	6754747
Type	TYPE I CANOPY	TYPE I CANOPY
Hood length	127"	127"
Hood Width	60"	60"
Supply Plenum Type	-	PSP
Supply Plenum Width	14"	14"
Supply Plenum Length	140"	140"

Test Data Exhaust		
	Design	Actual
Filter Type	CAPTRATE SOLO	CAPTRATE SOLO
Filter Size 1	16X20	16X20
Filter Qty 1	7	7
Filter AK factor size 1	2.08	2.08
Filter Total AK Area	14.56	14.56
Filter1 FPM	-	134
Filter2 FPM	-	155
Filter3 FPM	-	179
Filter4 FPM	-	172
Filter5 FPM	-	149
Filter6 FPM	-	141
Filter7 FPM	-	130
Filter Ave FPM(corr)	-	151
CFM	2117	2198

Test Data Supply		
	Design	Actual
Total AK Area	13.61	13.61
Kv factor (Vel)	0.89	0.89
Num of Readings	-	8
Reading1 FPM	-	154
Reading2 FPM	-	120
Reading3 FPM	-	127
Reading4 FPM	-	112
Reading5 FPM	-	140
Reading6 FPM	-	114
Reading7 FPM	-	129
Reading8 FPM	-	142
Ave FPM(corr)	-	130
CFM	1712	1609
