Report: TAB Report
Function: Test, Adjust, & Balance
Date: 03/12/2026
Completed By: National TAB

PROJECT
02-02-26 QT #1430 SURPRISE, AZ

Project: 02-02-26 QT #1430 SURPRISE, AZ

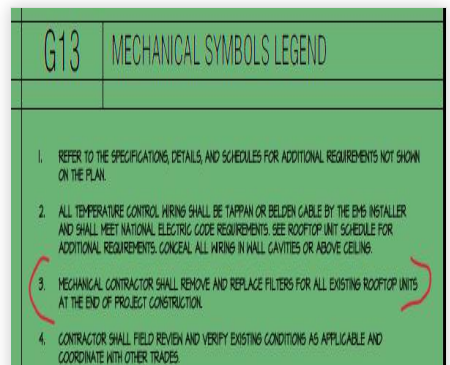
Issue Name : EXTREMELY DIRTY FINAL FILTERS
Description : ALL UNITS: See pics
Created By : National TAB **Assigned To :** National TAB - Dan Hertenstein
Status : Open
Priority : Low **Asset Tag :**
Originated Date : 03/12/2026 - Christine Weale - National TAB

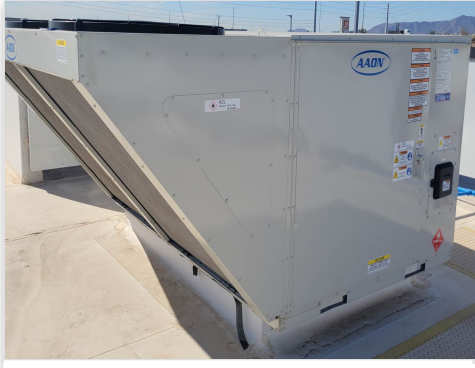
Unit Data - PHOTO LOG

General	
	Actual
Fan Rotation Correct	YES
Unit Filters Clean	NO
Condensate Drain Installed	YES

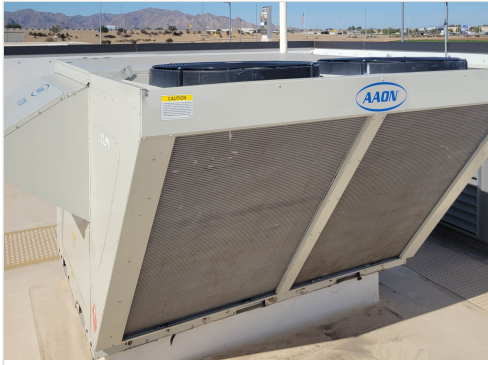
Unit Data - PHOTO LOG

RTU3 NOT RUNNING. ALARM ON VFD.

Notes:
UNIT NOT RUNNING FOR TESTING.

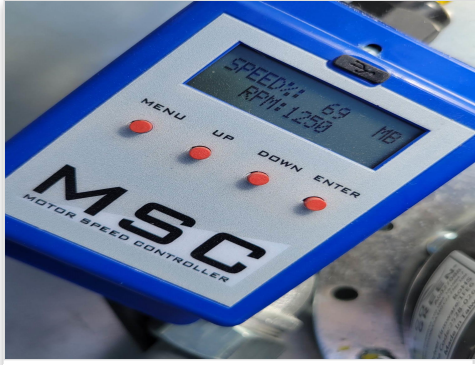
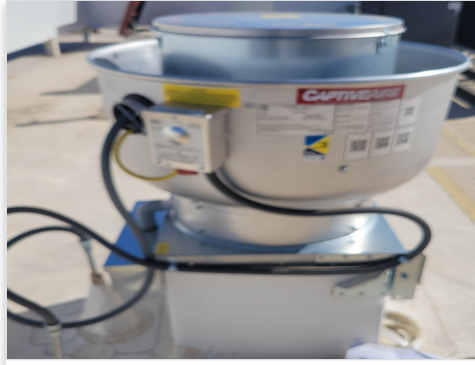
Unit Data - PHOTO LOG

Issue Name : EF3 CURB LEAK
Description : Fan is set for higher than normal, yet flow is too low. Losing quite a bit of air due to improper flange installation at curb.
Created By : National TAB **Assigned To :** National TAB - Dan Hertenstein
Status : Open
Priority : Urgent **Asset Tag :** EF3
Originated Date : 02/25/2026 - Christine Weale - National TAB

Needs to be fixed, unit left higher than normal but under FLA.

Notes:
LEAK AT CURB, SEE 'REMARKS'.
