Report: TAB Report
Function: Test, Adjust, & Balance
Date: 03/12/2026
Completed By: National TAB

02-02-26 QT #1430 SURPRISE, AZ

QUIKTRIP
4705 SOUTH 129TH EAST AVENUE
TULSA, OK 74134

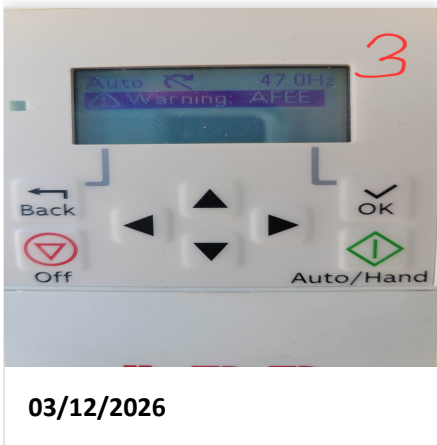
Issue Name : AFEE FAULT ON RTU3 VFD
Description : Unit will not run. QT aware.
Created By : National TAB **Assigned To :** National TAB - Dan Hertenstein
Status : Open
Priority : Urgent **Asset Tag :** RT-3
Originated Date : 02/09/2026 - Christine Weale - National TAB

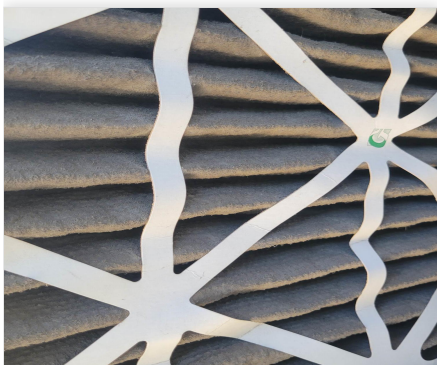
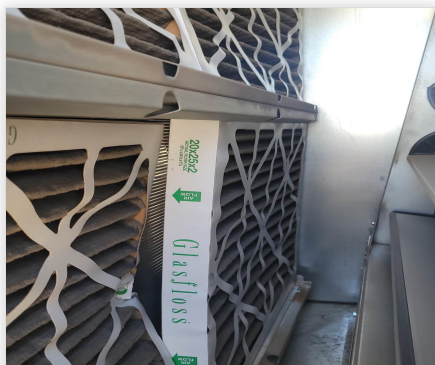
Issue Name : EXTREMELY DIRTY FINAL FILTERS
Description : ALL UNITS: See pics
Created By : National TAB **Assigned To :** National TAB - Dan Hertenstein
Status : Open
Priority : Low **Asset Tag :**
Originated Date : 03/12/2026 - Christine Weale - National TAB

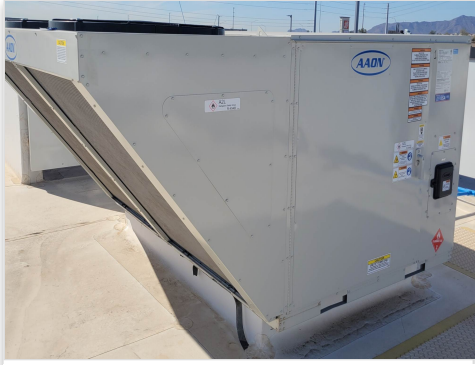
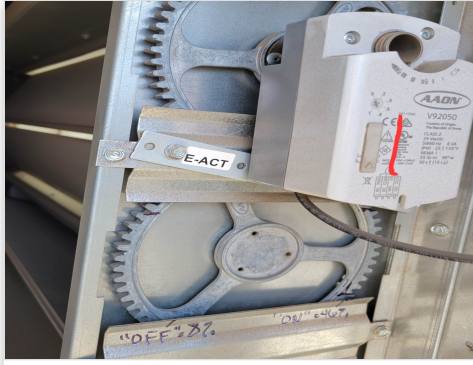
Unit Data - PHOTO LOG

Unit Data	
	Actual
MFG	AAON
Serial Num	202502-BNEK32988
Model Num	RN-013-3-0-GAAY
Num OA Filters 1	1
OA Filter Size 1	46X22
Num Final Filter 1	4
Final Filter Size 1	20X25X2

General	
	Actual
Fan Rotation Correct	YES
Unit Filters Clean	NO
Condensate Drain Installed	YES

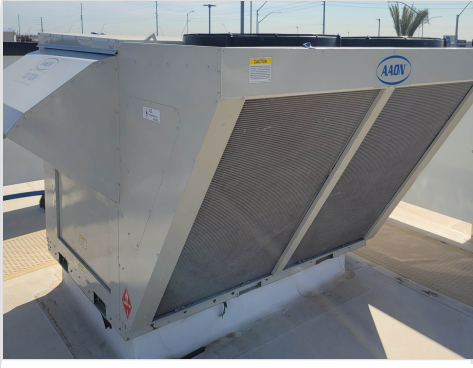
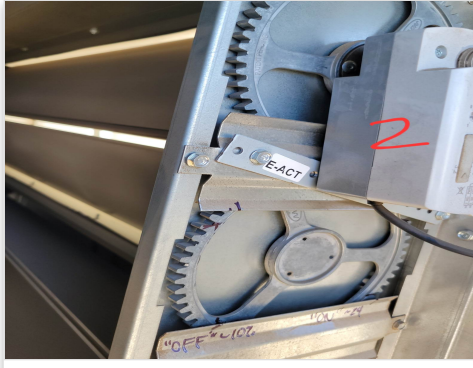
Unit Data - PHOTO LOG

Unit Data	
	Actual
MFG	AAON
Serial Num	202502-BNEK32987
Model Num	RN-013-3-0-GAAY
Num OA Filters 1	1
OA Filter Size 1	45X22
Num Final Filter 1	4
Final Filter Size 1	20X25X2

General	
	Actual
Fan Rotation Correct	YES
Unit Filters Clean	NO
Condensate Drain Installed	YES

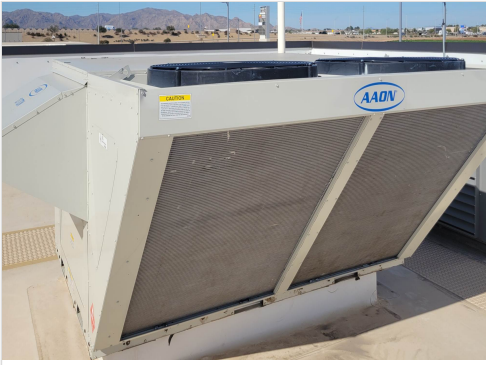
Unit Data - PHOTO LOG

Notes:
UNIT NOT RUNNING FOR TESTING.

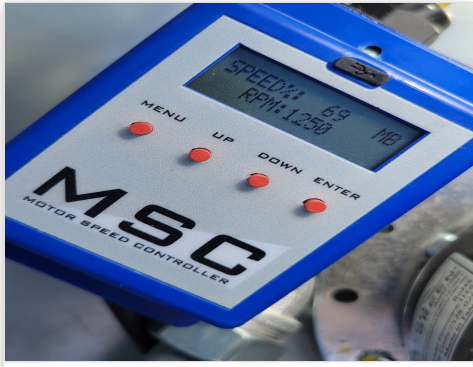
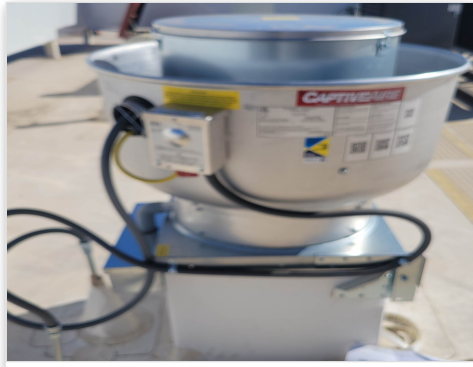
Unit Data - PHOTO LOG

Issue Name : EF3 CURB LEAK
Description : Fan is set for higher than normal, yet flow is too low. Losing quite a bit of air due to improper flange installation at curb.
Created By : National TAB **Assigned To :** National TAB - Dan Hertenstein
Status : Open
Priority : Urgent **Asset Tag :** EF3
Originated Date : 02/25/2026 - Christine Weale - National TAB

Notes:
LEAK AT CURB, SEE 'REMARKS'.

Needs to be fixed, unit left higher than normal but under FLA.
