Report By:  
United Test & Balance, Inc.  
7013 Flagler Rd,  
Nordland, WA 98358

Report: TAB REPORT  
Function: Test, Adjust, & Balance  
Date: 04/03/2024

**03-11-24 SHAKE SHACK #1453 -  
SCOTTSDALE, AZ (THE EDGE  
SCOTTSDALE) TAB. IAQ**

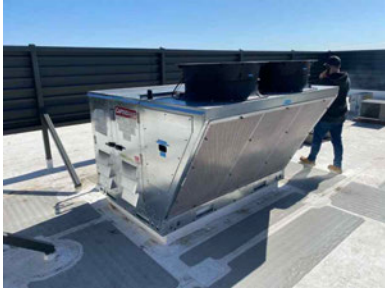
**SYSTEM/UNIT: RTU-01**

Design Airflow (CFM)	
Design Total	3000
Design Grille Total	3000
Design Return	2000
Design Min O/A	1000

Final Airflow (CFM)	
Actual Total CFM	2527
Actual Grille Total CFM	2527
Actual Return Air CFM	1465
Actual Min O/A CFM	1062
Fan CFM Test Method	Capture Hood
OA Method/Instrument	Face Velocity/RVA
OA Ak (sq ft)	4.610
OA Damper % (High Spd)	50% Open
OA Damper % (Low Spd)	-
RA Damper % (High Spd)	50% Open

Unit Data	
Make (tag)	CaptiveAire
Model # (tag)	CASRTU2-I.150-18-10T
Serial # (tag)	5842574
Location	Roof
Unit Discharge	Downblast
Cooling Coil Location	Unit / Drawthru
Coil Area (sq ft)	-
Clg Coil Vel (FPM)	-
Fan Service	Supply
Fan Type	Centrifugal (FC)
Fan Discharge	Downblast
Fan Arrangement	SWSI

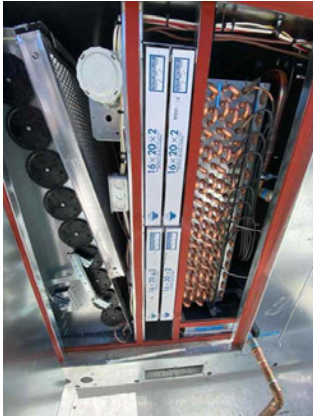
# Filters Set 1 Photo:

Filter Data	
Condition	Clean
Filter Type	Pleated
MERV Rating	8
Filter Size Set 1 (in)	16/20/2
# Filters Set 1	4
Filter Size Set 2 (in)	16/20/2
# Filters Set 2	4

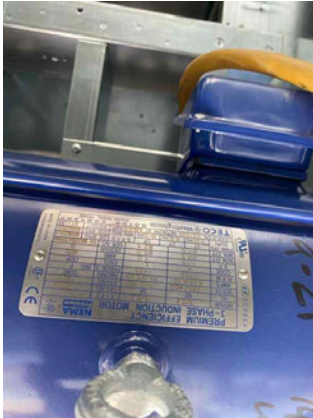
Motor Make Photo:

Motor Nameplate Data	
Motor Make	TECO
Motor Frame	182T
Motor HP	3.00
Motor RPM	1755
Motor Volts	230/460
Motor Phase	3

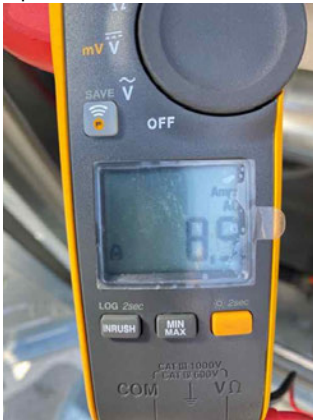
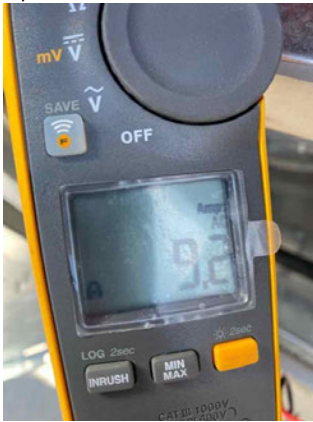
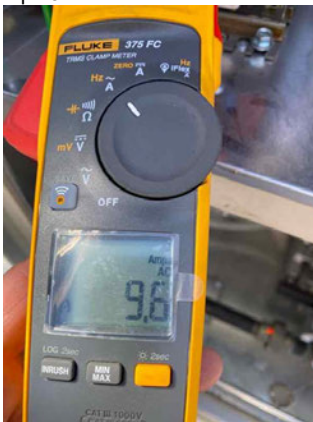
Electrical Data	
Motor Volts 2	212
Motor Volts 3	213
Motor Amps 1	8.9
Motor Amps 2	9.2
Motor Amps 3	9.6
Operating HZ	60.00
Approx. BHP	5633.7
Corr. Nameplate Amps	0.0
Starter Data	-
VFD Reference	Not Applicable

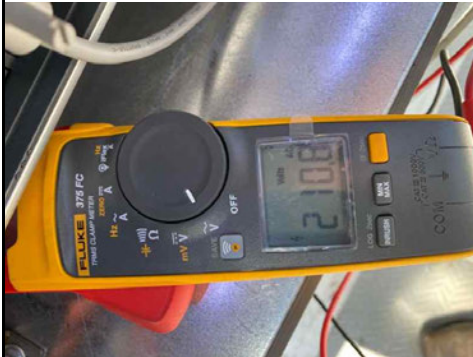
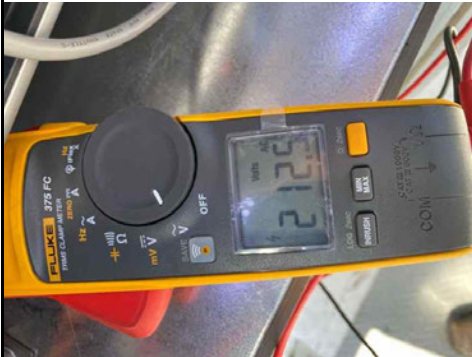
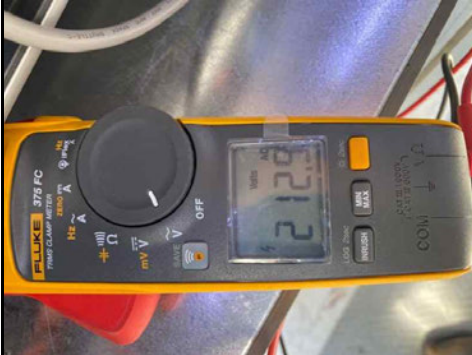
Electrical Data	
Measurement Method	V/A Meter
Motor Volts 1	211

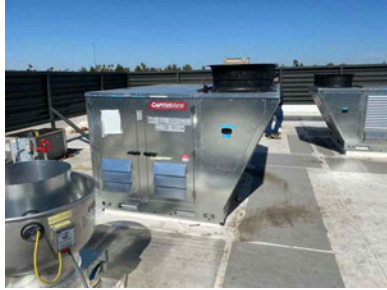
SYSTEM/UNIT: RTU-02

Design Airflow (CFM)	
Design Total	5000
Design Grille Total	4970
Design Return	1500
Design Min O/A	3500

Unit Data	
Make (tag)	CaptiveAire
Model # (tag)	CASRTU3-1.300-24-20T
Serial # (tag)	5842574
Location	Roof
Unit Discharge	Downblast
Cooling Coil Location	Unit / Drawthru
Coil Area (sq ft)	-
Clg Coil Vel (FPM)	-
Fan Service	Supply
Fan Type	Centrifugal (FC)
Fan Discharge	Downblast
Fan Arrangement	SWSI

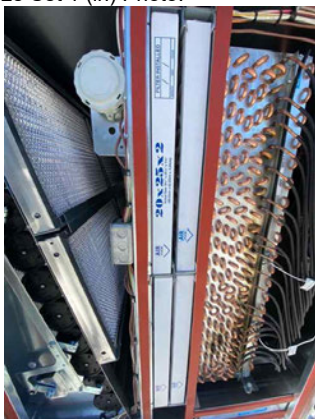
Filter Size Set 1 (in) Photo:

Filter Data	
Condition	Clean
Filter Type	Pleated
MERV Rating	8
Filter Size Set 1 (in)	20/25/2
# Filters Set 1	4
Filter Size Set 2 (in)	20/25/2
# Filters Set 2	4

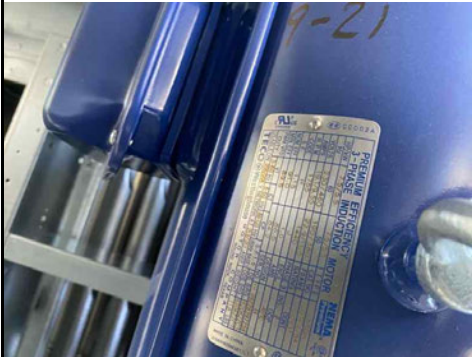
Motor Make Photo:

Motor Nameplate Data	
Motor Make	TECO
Motor Frame	213T
Motor HP	7.50
Motor RPM	1755
Motor Volts	230/460
Motor Phase	3

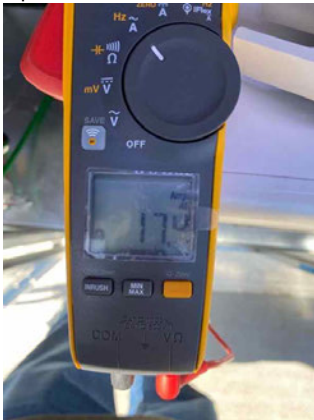
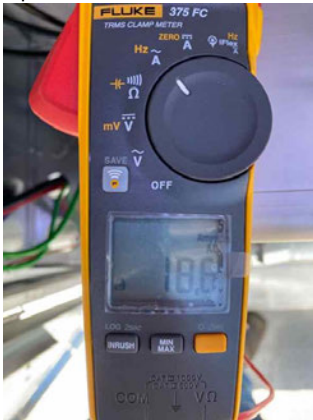
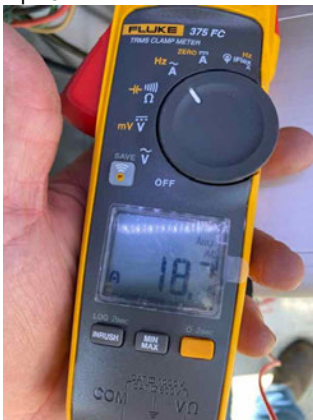
Electrical Data	
Motor Volts 2	213
Motor Volts 3	213
Motor Amps 1	17.4
Motor Amps 2	18.6
Motor Amps 3	18.7
Operating HZ	60.00
Approx. BHP	27535.5
Corr. Nameplate Amps	0.0
Starter Data	-
VFD Reference	Not Applicable

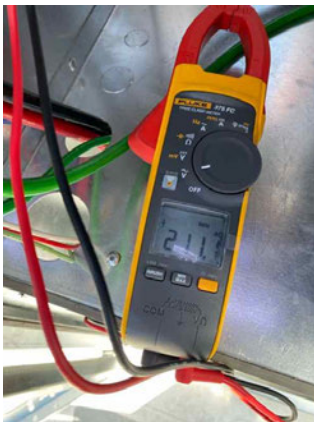
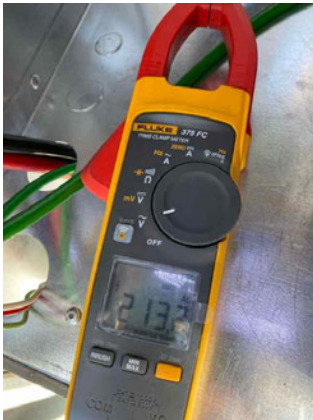
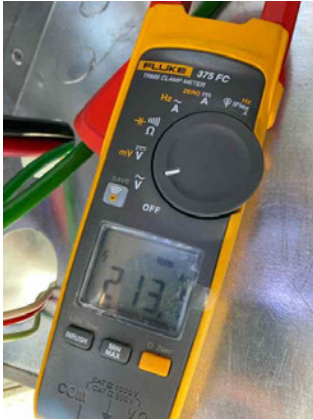
Electrical Data	
Measurement Method	V/A Meter
Motor Volts 1	211

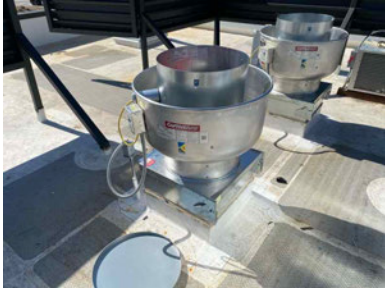
SYSTEM/UNIT: EF-01

Design Airflow (CFM)	
Design Airflow	1970
Design Grille Airflow	Not Applicable

Unit Data	
Make (tag)	CaptiveAire
Model # (tag)	DU85HFA
Serial # (tag)	5783357
Unit Location	Roof
Unit Discharge	Upblast
Fan Service	Exhaust
Fan Type	Centrifugal (AF)
Fan Discharge	Upblast
Fan Arrangement	SWSI

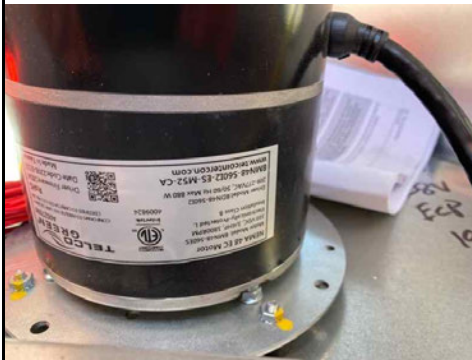
Motor Make (tag) Photo:

Motor Nameplate Data	
Motor Make (tag)	TELCO GREEN
Motor Frame (tag)	-
Motor HP (tag)	3/4
Motor RPM (tag)	1800
Motor Volts (tag)	310 VDC
Motor Phase (tag)	-
Motor Amps (tag)	-
Motor S.F. (tag)	-
Mtr % PF (tag)	-
Mtr % Eff. (tag)	-
Other Motor Data	-

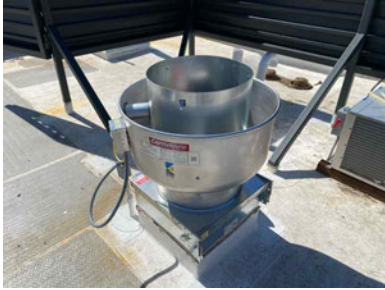
SYSTEM/UNIT: EF-02

Design Airflow (CFM)		Final Airflow (CFM)	
Design Airflow	1955	Actual Airflow	1778
Design Grille Airflow	Not Applicable	Actual Grille Airflow	Not Applicable
<b>Unit Design Data</b>		Fan CFM Test Method Face Velocity - Velgid/ADM	
Submittal Make	Not Provided	Test Method Ak (sq ft)	2.080
Submittal Model #	-	<b>Unit Data</b>	
Submittal Airflow	-	Make (tag)	CAPTIVEAIRE
Sched./Sub. Volts	Not Listed	Model # (tag)	DU85HFA
Sched./Sub. Phase	-	Serial # (tag)	5783357
Sched./Sub. HP	-	Unit Location	Roof
Submittal BHP	Not Provided	Unit Discharge	Upblast
<b>Design Static Pressures (in wg)</b>		Fan Service	Exhaust
Design External SP	Not Listed	Fan Type	Centrifugal (AF)
Submittal Total SP	-	Fan Discharge	Upblast
<b>Motor Nameplate Data</b>		Fan Arrangement	SWSI
Motor Make (tag)	TELCO GREEN	<b>Fan Design Data</b>	
Motor Frame (tag)	-	Submittal Motor RPM	Not Provided
Motor HP (tag)	3/4	Submittal Fan RPM	-
Motor RPM (tag)	1800	<b>Fan Data</b>

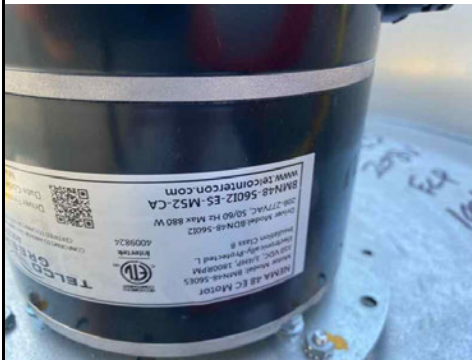
Motor Make (tag) Photo:

Motor Volts (tag)	310 VDC	Actual Fan RPM/Speed	High
Motor Phase (tag)	-	Actual Motor RPM	Not Accessible
Motor Amps (tag)	-	Speed Cont. Position	100%
Motor S.F. (tag)	-	<b>Electrical Data</b>	
Mtr % PF (tag)	-	Measurement Method	Not Accessible
Mtr % Eff. (tag)	-	Motor Volts 1	-
Other Motor Data	-	Motor Volts 2	-
<b>Drive Data</b>		Motor Volts 3	-
Drive Type	Direct Drive	Motor Amps 1	Not Accessible
Sheave Type	-	Motor Amps 2	-
Fan Sheave Make	-	Motor Amps 3	-
Fan Shv Mod# or Size (in)	-	Operating HZ	60.0
Fan Sheave Bore (in.)	-	Starter Data	Not Applicable
Motor Sheave Make	-	Approx. BHP	-
