**Report: TAB REPORT**  
**Function: Test, Adjust, & Balance**  
**Date: 08/23/2023**

**PROJECT**  
**08-07-23 WALGREENS #4721 - PUEBLO, CO**  
2900 W NORTHERN AVE  
PUEBLO, CO 81005

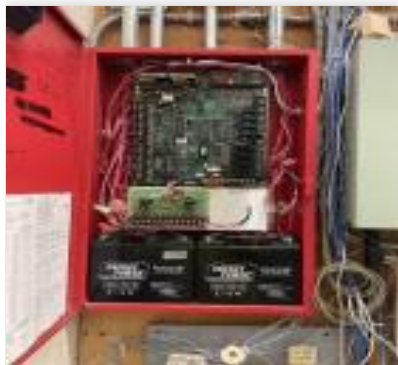
**IMG\_1306**  
**08/11/2023**

Fire alarm panel status (visual inspection where possible)

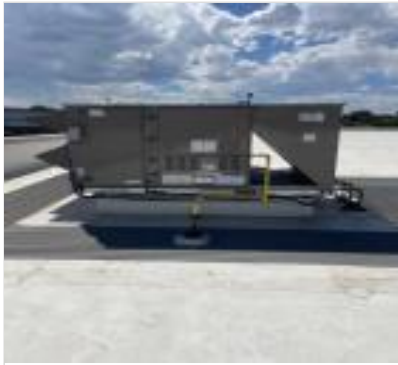
**Issue Name :** RTU-6 SUPPLY EXCEEDS DESGN AFTER PULLEY CHANGE  
**Description :** RTU-6 STILL ABOVE DESIGN CFM AFTER CHANGING FAN PULLEY TO REDUCE CFM SAW A DROP FROM 4,006 TO 2423 BUT COULD NOT BRING DOWN FURTHER. DUCT IS A STRAIGHT DROP FROM UNIT INTO THE SPACE THAT DOES NOT RESTRICT FLOW AT ALL, I USPECT THIS IS THE REASON FOR THE EXCESSIVE CFM.  
**Created By :** National TAB                      **Assigned To :** National TAB - Brianna Biggs  
**Status :** Open  
**Originated Date :** 08/10/2023 - Jordan Best - National TAB
