Report: TAB

Function: Test, Adjust, & Balance

02-09-26 Little Ceasars #35620007 - Palm Springs, CA

Budderfly

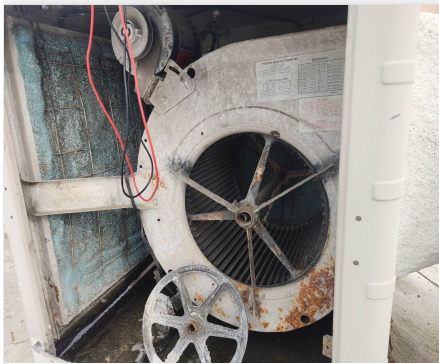
Project Issue File Details

Issue Name : MAU NOT OPERATIONAL.
Description : MAU is not operational. Recommend to have unit serviced or replaced.
Created By : National TAB **Assigned To :** National TAB - Dan Hertenstein
Status : Open
Priority : Urgent **Asset Tag :**
Originated Date : 02/09/2026 - Zack Eismin - National TAB

Have MAU serviced or replaced to increase OA into the store.

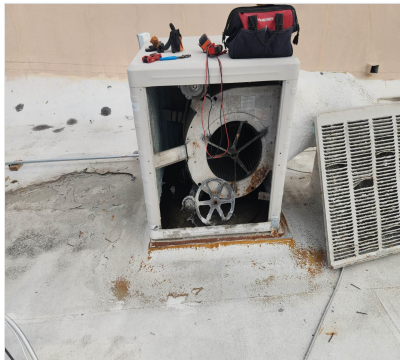
Comment:
NOT OPERATIONAL

Comment:
EXTENSIVE RUST BUILD UP AND FAN PULLY NOT CONNECTED

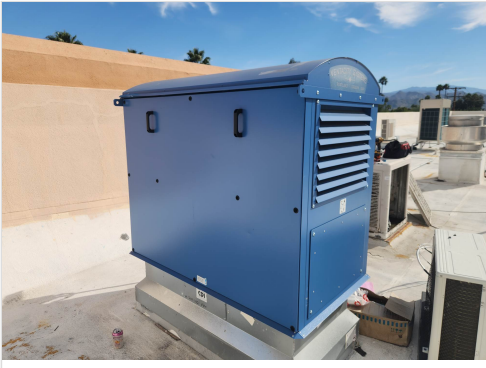
Supply Unit Data - PHOTO LOG

System/Unit: Energy Recovery Unit

Asset: ERU1

Supply Unit Data	
	Actual
Manufacturer	VENTACITY
Model Number	VS1000RTE
Serial Number	ZOE2302730

Notes:
UNIT IS NOT POWERED

Have ERV made operational.

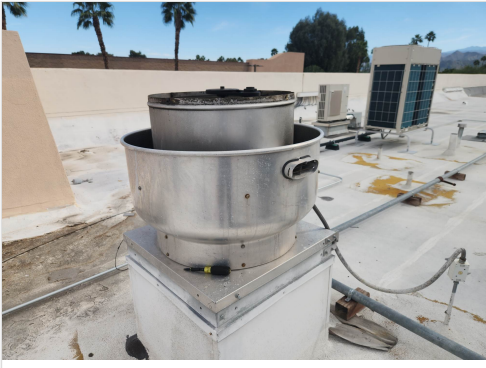
Unit Data - PHOTO LOG

System/Unit: FAN - Exhaust

Asset: EF1

Unit Data	
	Actual
MFG	ACCUREX
Model Num	XRUB-200-15-G
Serial Num	120136611003

Test Data	
	Actual
CFM	4360
Fan RPM	971
Motor RPM	1764
System SetPt	1 TURN OPEN
RL Voltage	112
RL Amperage	9.13

MOTOR SHEAVE SEIZED UNABLE TO SLOW UNIT DOWN TO 2700CFM

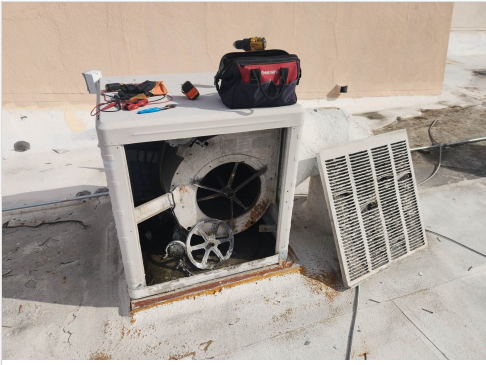
Unit Data - PHOTO LOG

System/Unit: FAN - Supply

Asset: MUA1

Unit Data	
	Actual
MFG	BRISA
Model Num	BH4000
Serial Num	2-999-532

UNIT NOT OPERATIONAL

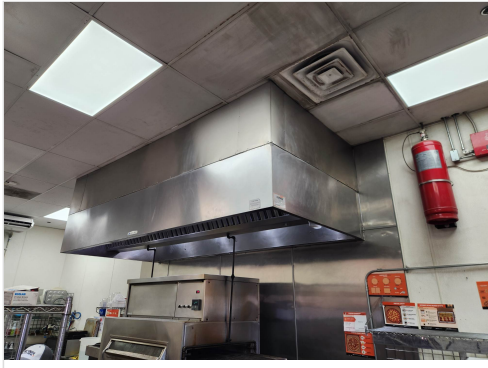
Unit Data - PHOTO LOG

System/Unit: Kitchen Hood Type I

Asset: HD1

Unit Data	
	Actual
MFG	ACCUREX
Model Num	NL
Job / Serial Num	NL
Hood length	144"
Hood Width	64"
Hood Height	24"
Supply Plenum Type	N/A
Supply Plenum Width	N/A
Supply Plenum Length	N/A

Notes:
FPM AVERAGE 109
