**Report: TAB REPORT**  
**Function: Test, Adjust, & Balance**  
**Date: 02/14/2023**

## 02-13-23 FAMILY DOLLAR - BRODHEAD, WI

2410 1ST CENTER AVE

Oliphant Heating  
208 WOLLARD BLVD

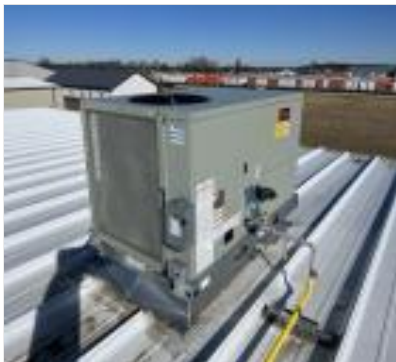
#### RTU-1

Unit Data		
	Design	Actual
MFG	CARRIER	TRANE
Serial Num	-	22293512PA
Model Num	48GCE	GBC048A3EMB
Type	RTU	RTU
Configuration	VERTICAL	VERTICAL
Num OA Filters 1	-	1
OA Filter Size 1	-	27X13.5
Num Final Filter 1	-	4
Final Filter Size 1	-	16X16X2

Test Data		
	Design	Actual
SF CFM	1750	1693
SF RPM	-	877
RA CFM	1600	1534
OA CFM	150	159
RL Voltage	-	210/210/210
RL Amperage	-	2.7/2.9/2.7
SF Rotation	-	CCW, CORRECT
Min OA Damper Position	-	1/4"
Min OA Damper Type	-	ECONOMIZER
OA Enthalpy Setpt	-	E

Notes: [1] CONSTRUCTION FILTERS STILL INSTALLED. RECOMMEND REPLACEMENT AT TURNOVER. [2] DIFFUSER TOTAL DID NOT MATCH SCHEDULED SUPPLY AIRFLOW. PROPORTIONALLY INCREASED DIFFUSERS, EXCLUDING RR, TO MATCH SCHEDULED AIRFLOW.

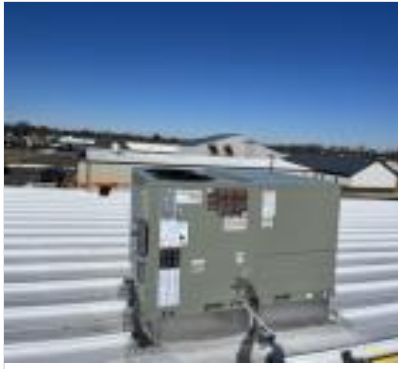
RTU-2

Test Data		
	Design	Actual
SF CFM	2800	2980
SF RPM	-	914
RA CFM	2150	2358
OA CFM	650	622
RL Voltage	-	211/210/210
RL Amperage	-	6.1/6.0/6.1
SF Rotation	-	CCW, CORRECT
Min OA Damper Position	-	1/2"
Min OA Damper Type	-	ECONOMIZER
OA Enthalpy Setpt	-	D

Notes: [1] SUPPLY AIRFLOW MEASURED AS 3206 CFM. THIS IS WITHIN ACCEPTABLE RANGE FOR A 7.5 TON UNIT BUT IS SLIGHTLY HIGH BASED ON DESIGN. THE MOTOR SHEAVE IS DEFECTIVE FROM THE FACTORY AND SEIZED AT 0 TURNS OPEN. NEW PULLEY IS ORDERED FROM TRANE BUT ON BACK ORDER. AIRFLOW OF 2980 CFM AND CALCULATED USING FAN LAW BASED ON MFG PITCH DIAMETER ONCE PULLEY IS REPLACED AND SET TO POSITION OF 2 TURNS OPEN (850 RPM) TO SHOW UNIT WILL BE WITHIN DESIGN. PHOTO DOCUMENTATION TO BE PROVIDED BY CONTRACTOR ONCE COMPLETE

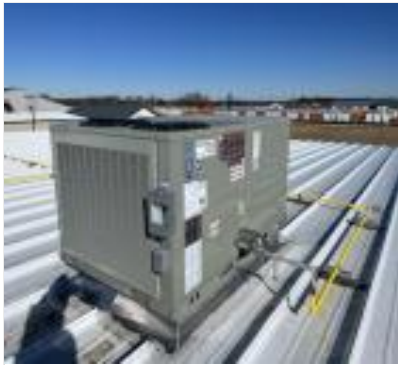
RTU-3

Test Data		
	Design	Actual
SF CFM	2800	2942
SF RPM	-	844
RA CFM	2150	2273
OA CFM	650	669
RL Voltage	-	210/210/210
RL Amperage	-	5.4/5.3/5.4
SF Rotation	-	CCW, CORRECT
Min OA Damper Position	-	ECONOMIZER
Min OA Damper Type	-	1/2"
OA Enthalpy Setpt	-	D

Notes: [1] SUPPLY AIRFLOW MEASURED AS 3165 CFM. THIS IS WITHIN ACCEPTABLE RANGE FOR A 7.5 TON UNIT BUT IS SLIGHTLY HIGH BASED ON DESIGN. THE MOTOR SHEAVE IS DEFECTIVE FROM THE FACTORY AND SEIZED AT 0 TURNS OPEN. NEW PULLEY IS ORDERED FROM TRANE BUT ON BACK ORDER. AIRFLOW OF 2942 CFM AND CALCULATED USING FAN LAW BASED ON MFG PITCH DIAMETER ONCE PULLEY IS REPLACED AND SET TO POSITION OF 2 TURNS OPEN (844 RPM) TO SHOW UNIT WILL BE WITHIN DESIGN. PHOTO DOCUMENTATION TO BE PROVIDED BY CONTRACTOR ONCE COMPLETE

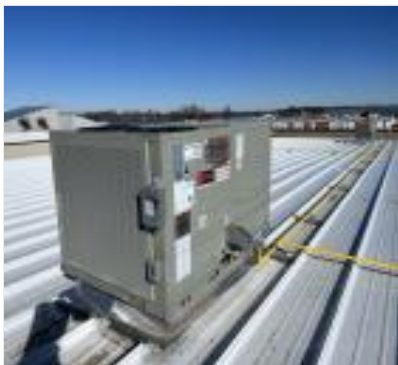
RTU-4

Test Data		
	Design	Actual
SF CFM	3500	3342
SF RPM	-	884
RA CFM	2725	2551
OA CFM	775	791
RL Voltage	-	211/212/211
RL Amperage	-	6.7/6.6/6.5
SF Rotation	-	CCW, CORRECT
Min OA Damper Position	-	1/2"
Min OA Damper Type	-	ECONOMIZER
OA Enthalpy Setpt	-	D

Notes: [1] CONSTRUCTION FILTERS STILL INSTALLED, RECOMMEND REPLACEMENT AT TURNOVER. [2] DCV OA AIRFLOW: 381 CFM @ 1/4" OPEN.

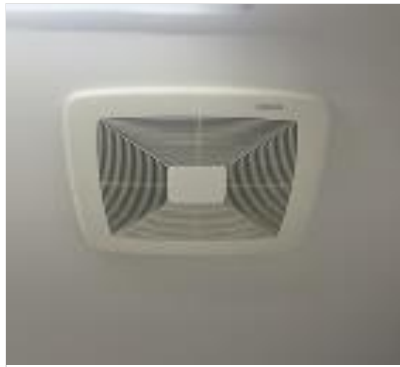
EF-1

Test Data		
	Design	Actual
<b>CFM</b>	75	91
<b>Fan RPM</b>	-	DD
<b>Fan Rotation</b>	-	CCW
<b>Motor RPM</b>	-	DD
<b>System SetPt</b>	-	SINGLE SPEED [2]
<b>RL Voltage</b>	-	NR [1]
<b>RL Amperage</b>	-	NR [1]
<b>Total ESP</b>	0.25"	NR [1]
<b>Fan Inlet SP</b>	-	ATM
<b>Fan Discharge SP</b>	-	NR [1]

Notes: [1] COULD NOT ACCESS SAFELY [2] SINGLE SPEED FAN, UNABLE TO REDUCE AIRFLOW.

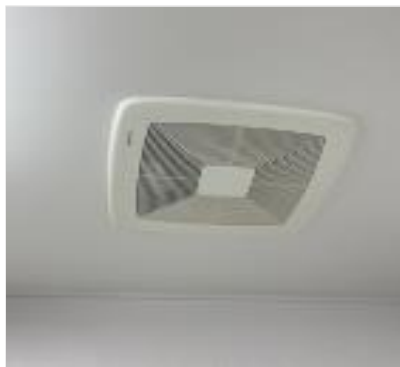
EF-2

Design	Actual
<b>CFM</b>	75	92
<b>Fan RPM</b>	-	DD
<b>Fan Rotation</b>	-	CCW
<b>Motor RPM</b>	-	DD
<b>System SetPt</b>	-	SINGLE SPEED [2]
<b>RL Voltage</b>	-	NR [1]
<b>RL Amperage</b>	-	NR [1]
<b>Total ESP</b>	0.25"	NR [1]
<b>Fan Inlet SP</b>	-	ATM
<b>Fan Discharge SP</b>	-	NR [1]

Notes: [1] COULD NOT ACCESS SAFELY [2] SINGLE SPEED FAN, UNABLE TO REDUCE AIRFLOW.
