Report: TAB REPORT
Function: Test, Adjust, & Balance
Date: 02/14/2023

**02-13-23 FAMILY DOLLAR - BROADHEAD,
WI**

Project: 02-13-23 FAMILY DOLLAR - BROADHEAD, WI

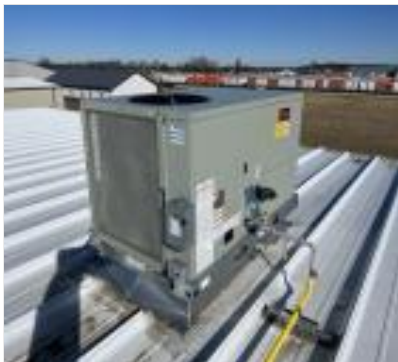
RTU-1

Unit Data		
	Design	Actual
MFG	CARRIER	TRANE
Serial Num	-	22293512PA
Model Num	48GCE	GBC048A3EMB
Type	RTU	RTU
Configuration	VERTICAL	VERTICAL
Num OA Filters 1	-	1
OA Filter Size 1	-	27X13.5
Num Final Filter 1	-	4
Final Filter Size 1	-	16X16X2

Test Data		
	Design	Actual
SF CFM	1750	1693
SF RPM	-	877
RA CFM	1600	1534
OA CFM	150	159
RL Voltage	-	210/210/210
RL Amperage	-	2.7/2.9/2.7
SF Rotation	-	CCW, CORRECT
Min OA Damper Position	-	1/4"
Min OA Damper Type	-	ECONOMIZER
OA Enthalpy Setpt	-	E

Performance Data		
	Design	Actual
MA Plenum SP	-	-0.27"
Fan Suction SP	-	-0.51"
Fan Discharge SP	-	0.32"
Total ESP	1.0"	0.59"
Fan Total SP	-	0.83"

Notes: [1] CONSTRUCTION FILTERS STILL INSTALLED. RECOMMEND REPLACEMENT AT TURNOVER.
