Report: TAB

Function: Test, Adjust, & Balance

03-31-25 WAWA #7409 CHESTERFIELD, IN

Project: 03-31-25 WAWA #7409 CHESTERFIELD, IN

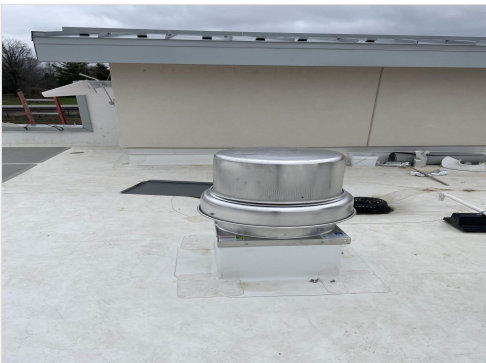
Unit Data - PHOTO LOG

| Unit Data | | |
| | Design | Actual |
| MFG | GREENHECK | GREENHECK |
| Model Num | GB-098-6 | GB-098-6 |
| Type | DOWNBLAST | DOWNBLAST |
