**Report: TAB REPORT**  
**Function: Test, Adjust, & Balance**  
**Date: 03/31/2025**  
**Completed By: National TAB**

## 03-31-25 WAWA #7409 CHESTERFIELD, IN

8770 South County Road 1000 West

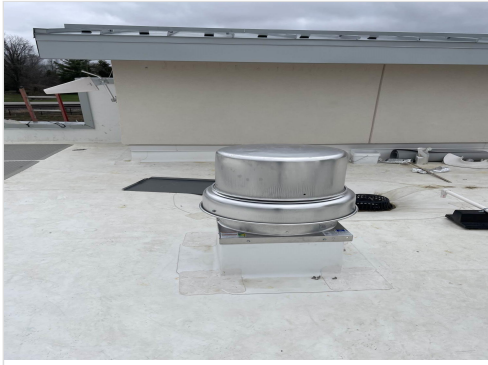
**Unit Data - PHOTO LOG**

Unit Data		
	Design	Actual
<b>MFG</b>	GREENHECK	GREENHECK
<b>Model Num</b>	GB-098-6	GB-098-6
<b>Serial Num</b>	-	26298976
<b>Type</b>	DOWNBLAST	DOWNBLAST
<b>Configuration</b>	VERTICAL	VERTICAL

Test Data		
	Design	Actual
<b>CFM</b>	375	356
<b>Fan Rotation</b>	-	CCW
<b>System SetPt</b>	-	5 TURNS OUT
<b>Total ESP</b>	0.38"	0.15"
<b>Fan Inlet SP</b>	-	-0.15"
<b>Fan Discharge SP</b>	-	ATM
