Report: TAB

Function: Test, Adjust, & Balance

03-31-25 WAWA #7409 CHESTERFIELD, IN

Project: 03-31-25 WAWA #7409 CHESTERFIELD, IN

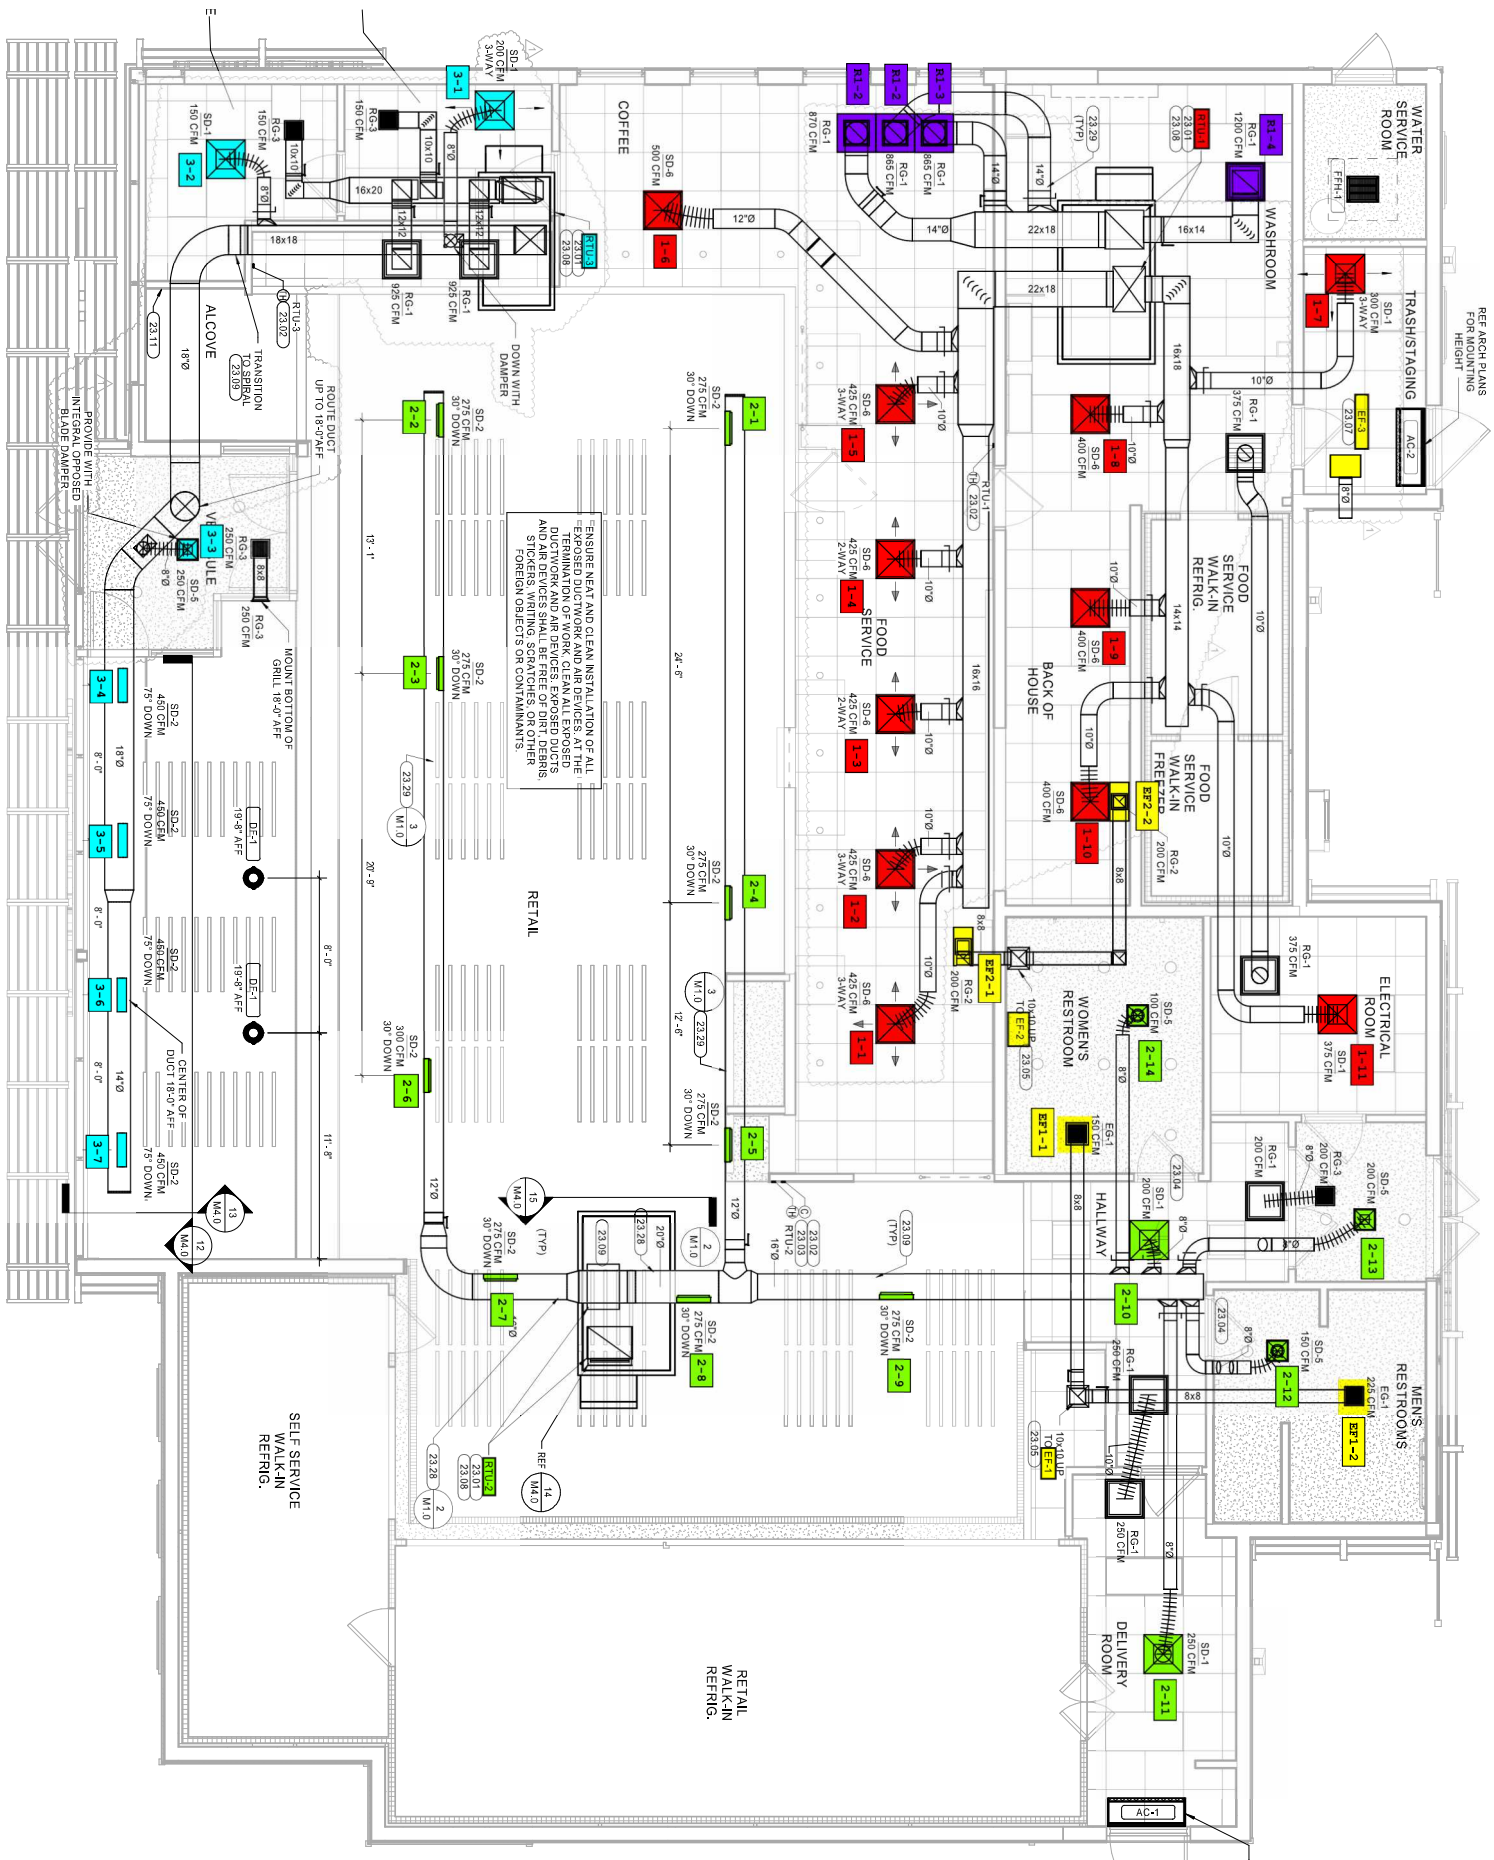
REF ARCH PLANS FOR MOUNTING HEIGHT
