Report: Prelim

Function: Test, Adjust, & Balance

03-31-25 WAWA #7409 CHESTERFIELD, IN

Project: 03-31-25 WAWA #7409 CHESTERFIELD, IN

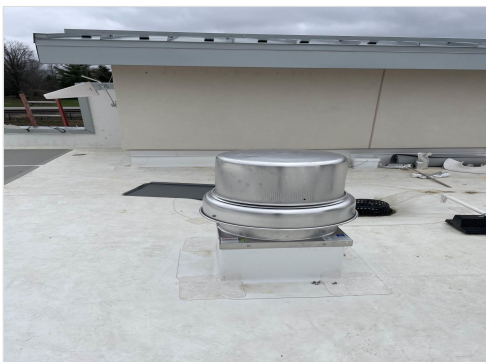
Unit Data - PHOTO LOG

Unit Data		
	Design	Actual
MFG	GREENHECK	GREENHECK
Model Num	GB-098-6	GB-098-6
Serial Num	-	26298976
Type	DOWNBLAST	DOWNBLAST
Configuration	VERTICAL	VERTICAL

Test Data		
	Design	Actual
CFM	375	356
Fan Rotation	-	CCW
System SetPt	-	5 TURNS OUT
Total ESP	0.38"	0.15"
Fan Inlet SP	-	-0.15"
Fan Discharge SP	-	ATM

Fan Sheave- 3.5"

Fan Bore- 0.625"

Motor Sheave/Bore- VP25

CL Distance- 5"

Belt- 3L180
