Report: TAB Report
Function: Test, Adjust, & Balance
Date: 12/12/2025
Completed By: National TAB

PROJECT
02-22-26 QT #1191 COLUMBIA, SC

771 ST. ANDREWS RD

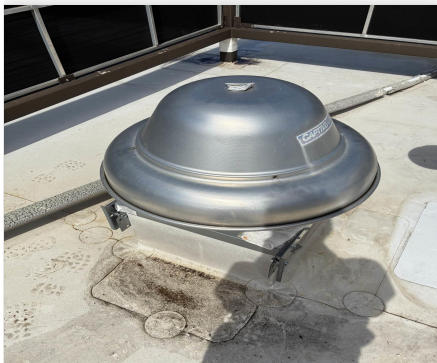
Issue Name : EF-1 Not Operational
Description : EF-1 is not running. The speed controller does not turn the fan on as it should. An electrician should check the wiring of the fan.
Created By : National TAB **Assigned To :** National TAB - Dan Hertenstein
Status : Open
Priority : Urgent **Asset Tag :** EF1
Originated Date : 03/10/2026 - Alex Bauer - National TAB

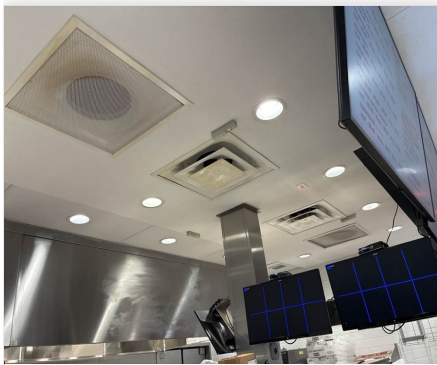
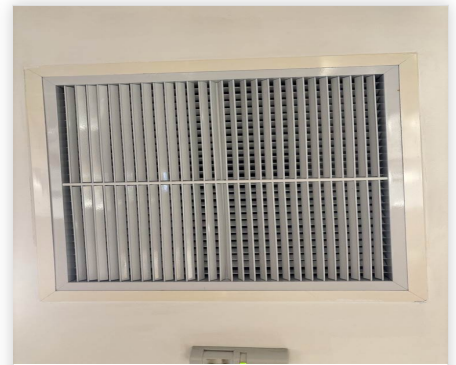
Issue Name : Incorrect Kitchen Diffusers
Description : The kitchen diffusers 3-1 through 3-4 are the incorrect type. They need to be the TITUS 300FS diffuser with the installed deflection blades.
Created By : National TAB **Assigned To :** National TAB - Dan Hertenstein
Status : Open
Priority : High **Asset Tag :** RT-3
Originated Date : 03/10/2026 - Alex Bauer - National TAB

GRILLE, REGISTER, & DIFFUSER SCHEDULE

NO.	MANUFACTURER	MODEL	SERVICE	FACE SIZE	BACK SIZE	DESCRIPTION	NOTES
01	TITUS	300L	04043	18" X 18"	SEE PLAN	34" 90° BLADE TRANSFER GULCH AL. W/FE	02
02	TITUS	300FS	04041	22" X 22"	SEE PLAN	20" 90° DEFLECTION GULCH AL. W/FE	03

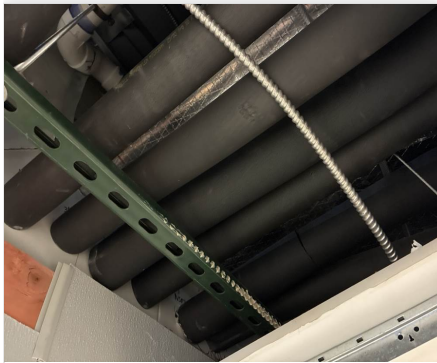
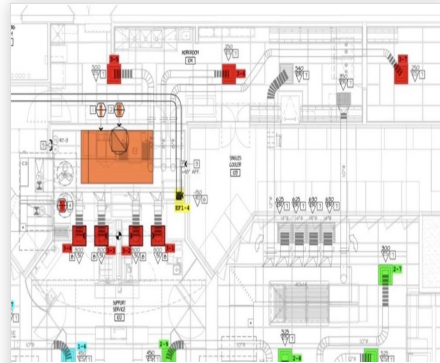
Issue Name : RTU-3 Dampers
Description : The dampers for diffusers 3-5 through 3-7 are inaccessible. They are located behind a wall and solid ceiling where they cannot be reached and adjusted. It would be better if the dampers were in an accessible location so they can be reached and adjusted.
Created By : National TAB **Assigned To :** National TAB - Dan Hertenstein
Status : Open
Priority : High **Asset Tag :** RT-3
Originated Date : 03/10/2026 - Alex Bauer - National TAB

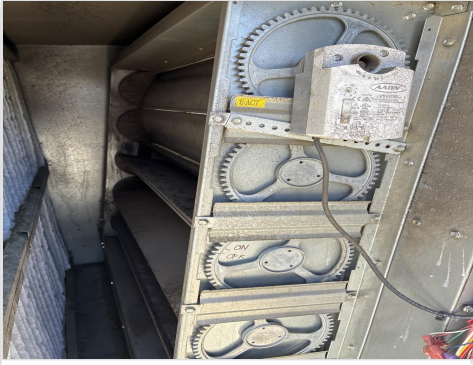
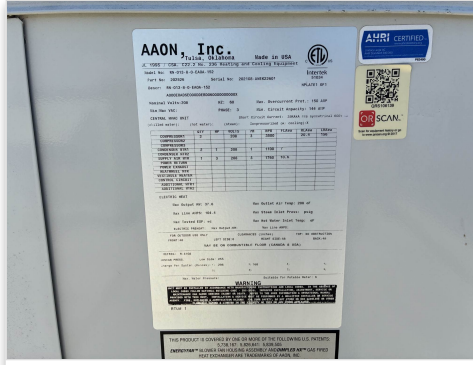
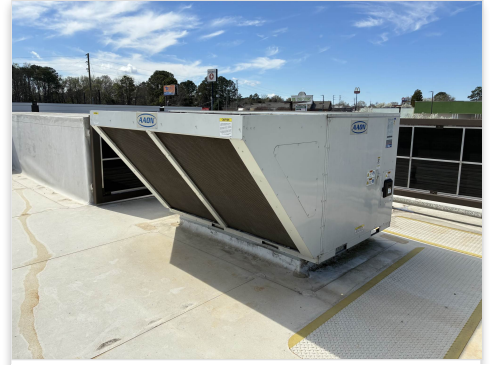
Unit Data - PHOTO LOG

Unit Data	
	Actual
MFG	AAON
Serial Num	202108-ANEK22601
Model Num	RN-013-8-0-EA0A-152
Num OA Filters 1	1
OA Filter Size 1	22.5X44.5
Num Final Filter 1	2
Final Filter Size 1	19.5X46.5X2

Test Data		
	Design	Actual
SF CFM	4200	4098
SF RPM	-	1291
OA CFM (Hoods On)	800	814
OA CFM (Hoods Off)	350	369
RL Voltage	-	145 VFD
RL Amperage	-	7.45 VFD
VFD Max SetPt	-	44 Hz
OA Damper Position (Hoods On)	-	46%
OA Damper Position (Hoods Off)	-	32%

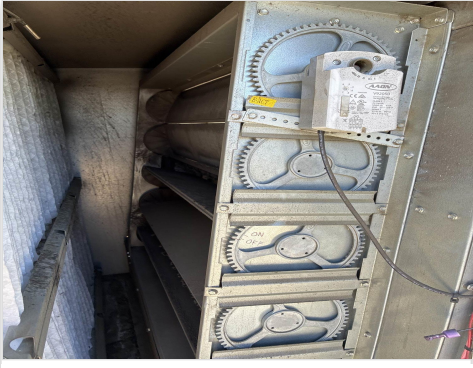
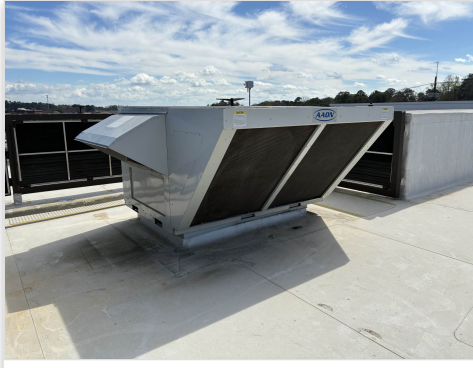
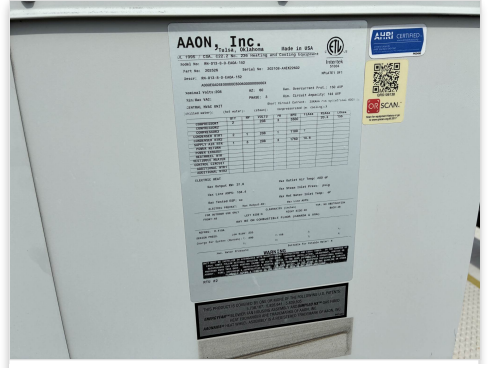
Unit Data - PHOTO LOG

Unit Data	
	Actual
MFG	AAON
Serial Num	202108-ANEK22602
Model Num	RN-013-8-0-EA0A-152
Num OA Filters 1	1
OA Filter Size 1	22.5X44.5
Num Final Filter 1	2
Final Filter Size 1	19.5X46.5X2

Test Data		
	Design	Actual
SF CFM	4200	4397
SF RPM	-	1261
OA CFM (Hoods On)	800	800
OA CFM (Hoods Off)	350	355
RL Voltage	-	139 VFD
RL Amperage	-	7.50 VFD
VFD Max SetPt	-	43 Hz
OA Damper Position (Hoods On)	-	46%
OA Damper Position (Hoods Off)	-	32%

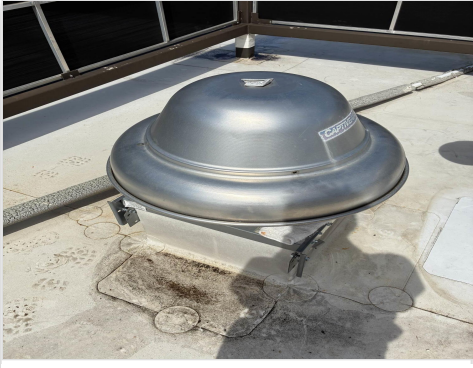
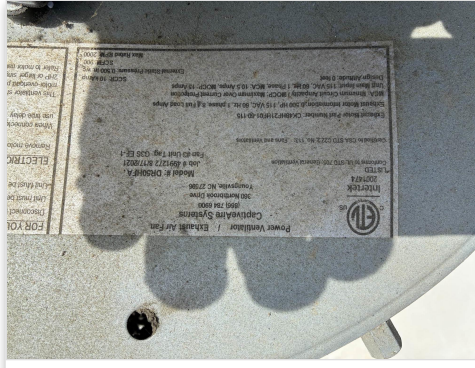
Unit Data - PHOTO LOG

Unit Data		
	Design	Actual
MFG	NA	CAPTIVE AIRE
Model Num	NA	DR50HFA
Serial Num	-	4991272
Type	-	DOWNBLAST
Configuration	-	VERTICAL

Test Data		
	Design	Actual
CFM	750	0
Fan RPM	-	0
Fan Rotation	-	NA
Motor RPM	-	0
System SetPt	-	NA
RL Voltage	-	0
RL Amperage	-	0
Total ESP	-	0
Fan Inlet SP	-	0
Fan Discharge SP	-	ATM

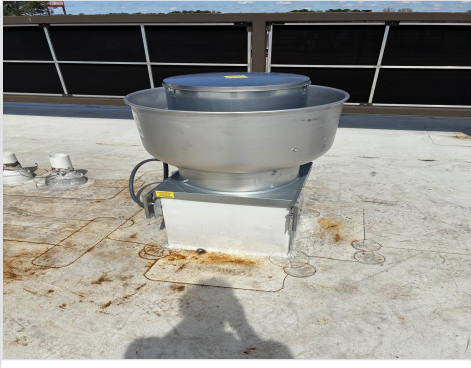
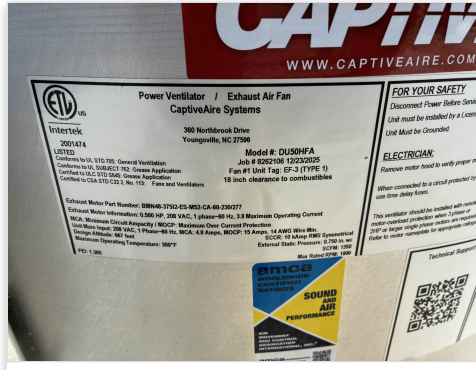
Unit Data - PHOTO LOG

Unit Data		
	Design	Actual
MFG	NA	CAPTIVEAIRE
Model Num	NA	DU50HFA
Serial Num	-	8262106
Type	UPBLAST	UPBLAST
Configuration	VERTICAL	VERTICAL

Test Data		
	Design	Actual
CFM	1350	1298
Fan RPM	-	1302
Fan Rotation	-	CCW
Motor RPM	-	1302
System SetPt	-	68.8 Hz
RL Voltage	-	NA
RL Amperage	-	NA
Total ESP	-	0.29"
Fan Inlet SP	-	-0.29"
Fan Discharge SP	-	ATM
