**Report: FINAL TAB REPORT**  
**Function: Test, Adjust, & Balance**  
**Date: 05/22/2025**  
**Completed By: National TAB**

**PROJECT**  
**04-28-25 CULVERS ROCKMART, GA**

1939 NATHAN DEAN PKWY

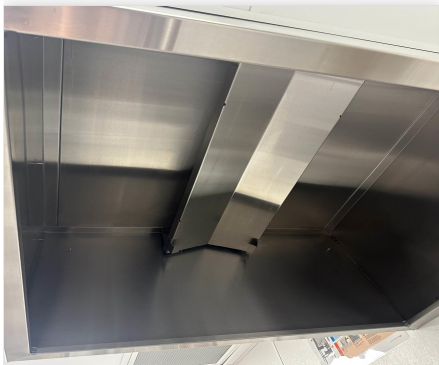
**Issue Name :** HOOD 3 CONDENSATE BAFFLES MISSING  
**Description :** The condensate hood is missing the specified baffle filters.  
**Created By :** National TAB                      **Assigned To :** National TAB - Ben Searles  
**Status :** Open  
**Priority :** Medium                                      **Asset Tag :**  
**Originated Date :** 05/20/2025 - Ben Searles - National TAB

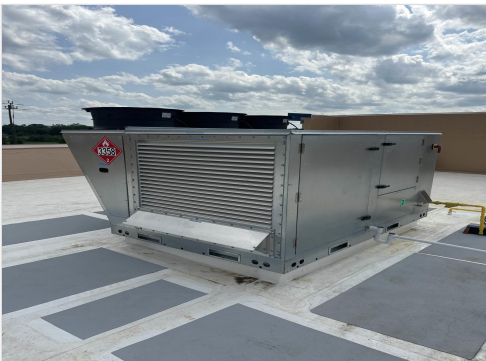
## Unit Data - PHOTO LOG

Asset: RTU1

Test Data		
	Design	Actual
SF CFM	7000	5799
SF RPM	-	1735
RA CFM	5000	3059
OA CFM	2000	2040
RL Voltage	-	208 CONTROL BOARD
RL Amperage	-	26.8 CONTROL BOARD
SF Rotation	-	CCW
SF System SetPt	-	60.3 HZ
RA Damper Position	-	4.0 VDC
Min OA Damper Position	-	6.0 VDC
Min OA Damper Type	-	ECON

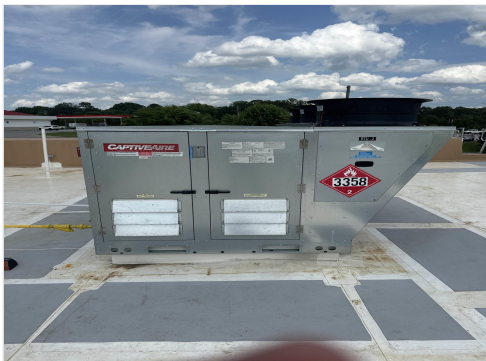
## Unit Data - PHOTO LOG

Asset: RTU2

Test Data		
	Design	Actual
SF CFM	6800	5761
SF RPM	-	1735
RA CFM	4800	3658
OA CFM	2000	2103
RL Voltage	-	209 CONTROL BOARD
RL Amperage	-	26.4 CONTROL BOARD
SF Rotation	-	CCW
SF System SetPt	-	60.3 HZ
RA Damper Position	-	3.9 VDC
Min OA Damper Position	-	6.1 VDC
Min OA Damper Type	-	ECON

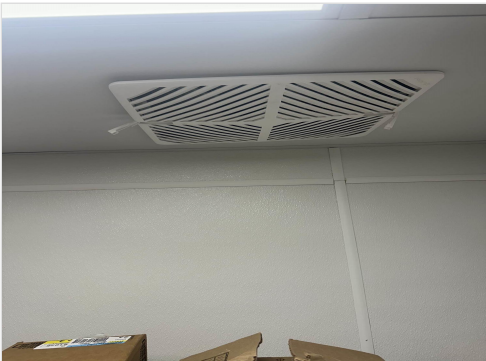
## Unit Data - PHOTO LOG

Asset: EF2

Test Data		
	Design	Actual
CFM	75	69
Fan Rotation	-	CCW
System SetPt	-	HIGH

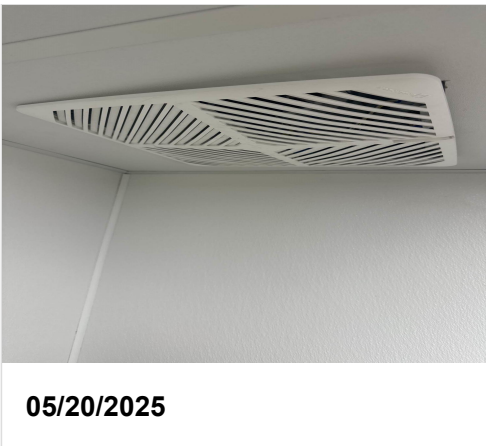
## Unit Data - PHOTO LOG

Asset: EF3

[1] FAN WAS INACCESSIBLE DUE TO STAFF PRESENCE, WHICH PREVENTED THE TECHNICIAN FROM REACHING THE FANS. THESE WILL NEED TO BE BALANCED WHEN THE TECHNICIAN RETURNS TO THE SITE

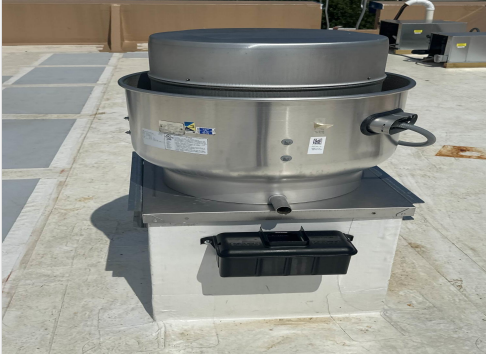
## Unit Data - PHOTO LOG

Asset: KEF1

Test Data		
	Design	Actual
CFM	1500	1518
Fan RPM	-	1085
Fan Rotation	-	CCW
Motor RPM	-	1085
RL Voltage	-	121
RL Amperage	-	7.2
Suction ESP	-	-0.76"
Discharge ESP	-	ATM
Total ESP	1.00"	0.76"

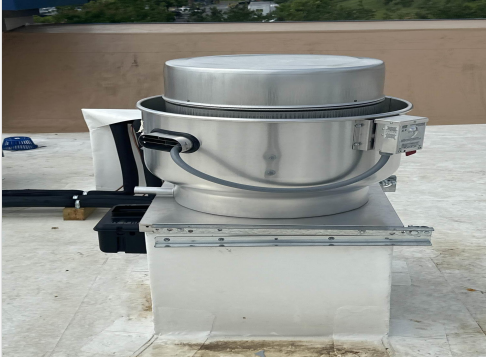
## Unit Data - PHOTO LOG

Asset: KEF2

Test Data		
	Design	Actual
CFM	1500	1499
Fan RPM	-	1138
Fan Rotation	-	CCW
Motor RPM	-	1138
RL Voltage	-	120
RL Amperage	-	7.8
Suction ESP	-	-0.88"
Discharge ESP	-	ATM
Total ESP	1.00"	0.88"

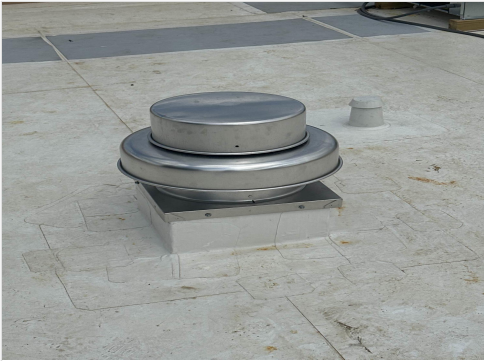
## Unit Data - PHOTO LOG

Asset: KEF3

Test Data		
	Design	Actual
CFM	350	369
Fan Rotation	-	CCW
System SetPt	-	MEDIUM
RL Voltage	-	121
RL Amperage	-	2.5
Total ESP	0.50"	0.39"
Fan Inlet SP	-	-0.39"
Fan Discharge SP	-	ATM

Notes:  
SPEED CONTROLLER INSTALLED AT THE DISHWASHER

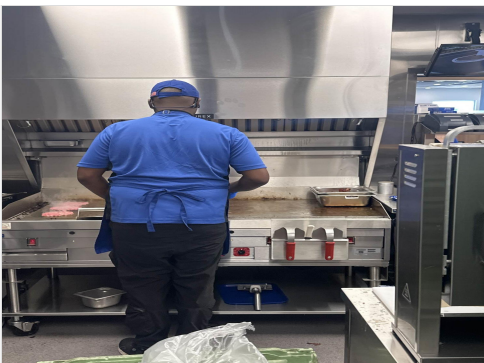
### Unit Data - PHOTO LOG

Asset: HD1

Test Data Exhaust		
	Design	Actual
Filter Type	X-TRACTOR SPARK	X-TRACTOR SPARK
Filter Size 1	16X16	16X16
Filter Qty 1	4	4
Filter AK factor size 1	1.53	1.53
Filter Total AK Area	6.12	6.12
Filter1 FPM	-	273
Filter2 FPM	-	215
Filter3 FPM	-	239
Filter4 FPM	-	265
Filter Ave FPM(corr)	-	248
CFM	1500	1518

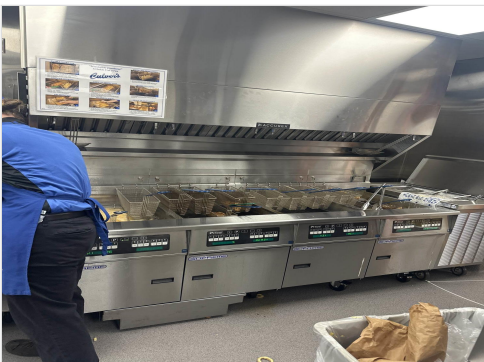
### Unit Data - PHOTO LOG

Asset: HD2

Test Data Exhaust		
	Design	Actual
Filter Type	X-TRACTOR SPARK	X-TRACTOR SPARK
Filter Size 1	16X16	16X16
Filter Qty 1	5	5
Filter AK factor size 1	1.53	1.53
Filter Total AK Area	7.65	7.65
Filter1 FPM	-	209
Filter2 FPM	-	191
Filter3 FPM	-	192
Filter4 FPM	-	189
Filter5 FPM	-	201
Filter Ave FPM(corr)	-	196
CFM	1500	1499

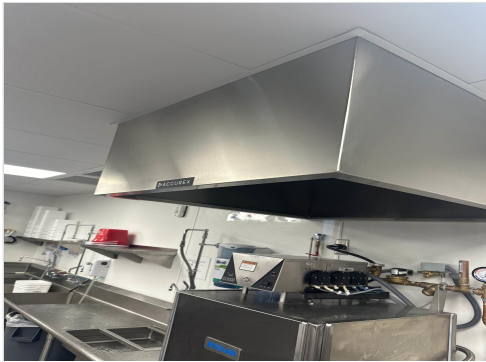
### Unit Data - PHOTO LOG

Asset: HD(Type2)1

Test Data		
	Design	Actual
Exhaust VEL(corr)	-	1086
Exhaust CFM	350	369
